**ASSESSMENT OF THE  
FISH PASSAGE FACILITIES  
AT  
LAKE LODI IN THE MOKELUMNE RIVER**

**September 1992**

**David A. Vogel  
Senior Biologist  
Vogel Environmental Services  
21600 Wilcox Road  
Red Bluff, California 96080**

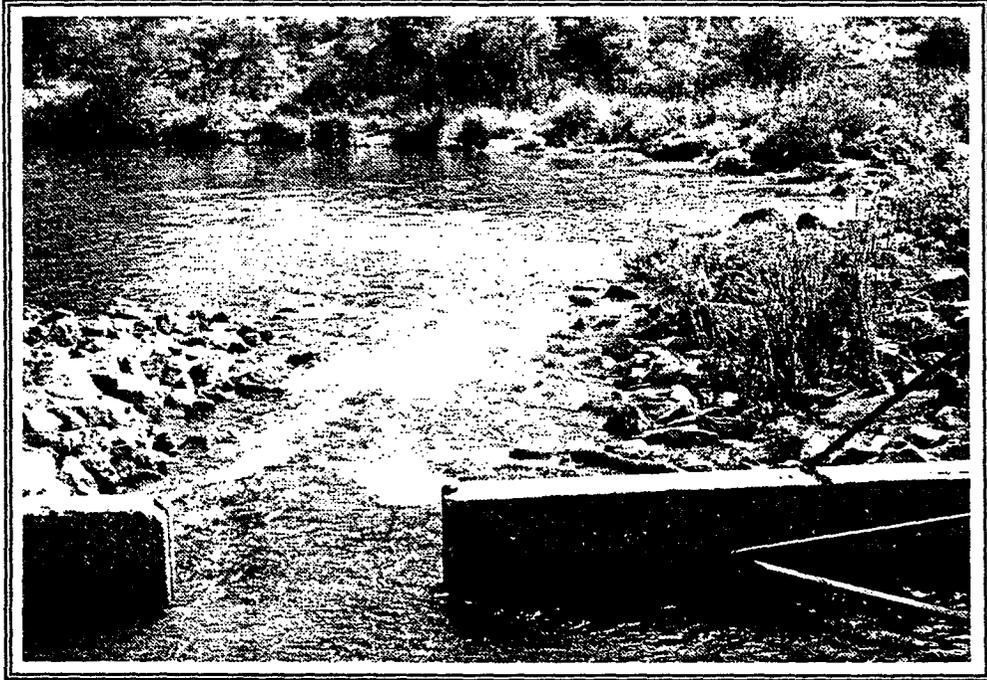
As described in CDFG (1991), the shallow entrance configuration to the fishways at Woodbridge Dam results in suboptimal conditions for attraction because fish attempting to enter the ladders have to swim over a shallow gravel bar under low flow conditions (Figure 6). Vogel et al. (1988) believed that surface entrances to fishways at RBDD may inhibit attraction of salmonids into the fishways. The entrance to the fishways at Woodbridge Dam is much

Figure 6. Fish entrance and flow exit for the Woodbridge Dam fishways, June 2, 1992.

shallower than those at RBDD. Rainey (1991) recommended avoidance of shallow, high-velocity conditions near a fishway entrance. He suggests that a minimum of a 5-ft pool depth outside the entrance is essential because it provides excellent holding water, aids in reducing spill turbulence, and reduces fish passage delay.

Because the existing tailwater conditions of Woodbridge Dam during low flows result in low water surface elevations relative to the entrance to the fishway, the tailwater elevation could be raised to improve fishway entrance conditions. This measure could be accomplished by adding a hydraulic control downstream of the fishway in the river channel (e.g., large boulders). This hydraulic control would serve to raise the tailwater surface elevation higher than existing conditions and allow better fish access into the fishway because of the resultant deeper entrance conditions and the reduction or elimination of the requirement for fish to swim across the shallow riffle into the fishway entrance. This type of stream channel modification was implemented several years ago downstream of Clough Dam on Mill Creek<sup>3</sup>; the modification improved entrance conditions for salmon and steelhead into the dam's fishway. Careful

An additional option for improving fishway entrance conditions may be the addition of a pool to the existing fishway to eliminate the shallow riffle over which fish have to traverse during low flows. The additional pool would allow for better entrance conditions through the creation of deeper water in closer proximity to the large riverine pool immediately downstream of Woodbridge Dam. As described for the benefits derived from raising the tailwater elevation, an additional pool would provide deeper water at the entrance and reduce or eliminate the need for fish to cross the shallow riffle at the fishway entrance. A hydraulic analysis prior to installation would be necessary to ensure the addition of a pool would not create worse fish passage conditions during high river flows.

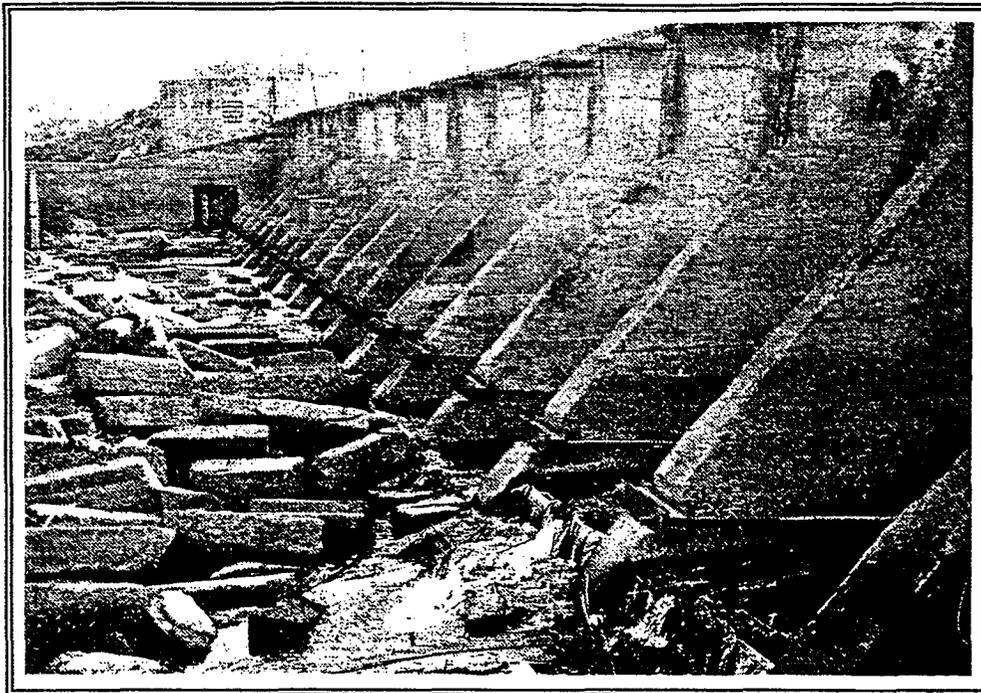
Figure 7. Downstream side of Woodbridge Dam showing riprap, January 25, 1991.

Under medium and high flow conditions at Woodbridge Dam, the addition of a retaining wall and stilling basin immediately downstream of the dam would reduce physical injury to upstream migrating fish attracted to spills over the dam.

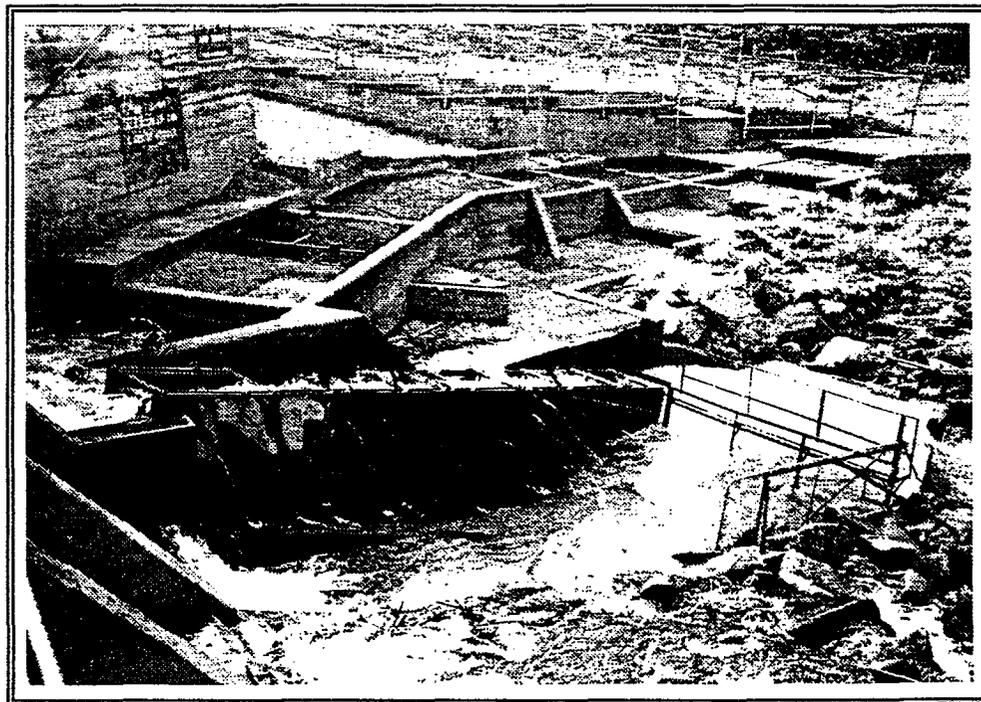
A common entrance pool is provided for both the pool-and-weir fishways and the Denil fishway on Woodbridge Dam (Figure 8). The larger fishways reported by Rainey (1991) for dams on Columbia River tributaries incorporated two to four entrances into the fishways to improve attraction of fish into the fishways. Following field investigations at RBDD, Vogel et al. (1990) recommended the addition of full-depth or multi-level orifices on fishways at the dam to improve fish attraction. The turbulence caused by both fishway flows entering the common entrance pool at Woodbridge Dam could disorient and confuse fish, particularly because each flow exit is perpendicular to the other.

Figure 8. The fishways at Woodbridge Dam; Denil fishway in foreground, pool-and-weir fishways in background, March 23, 1992. Note the common entrance pool on the right.

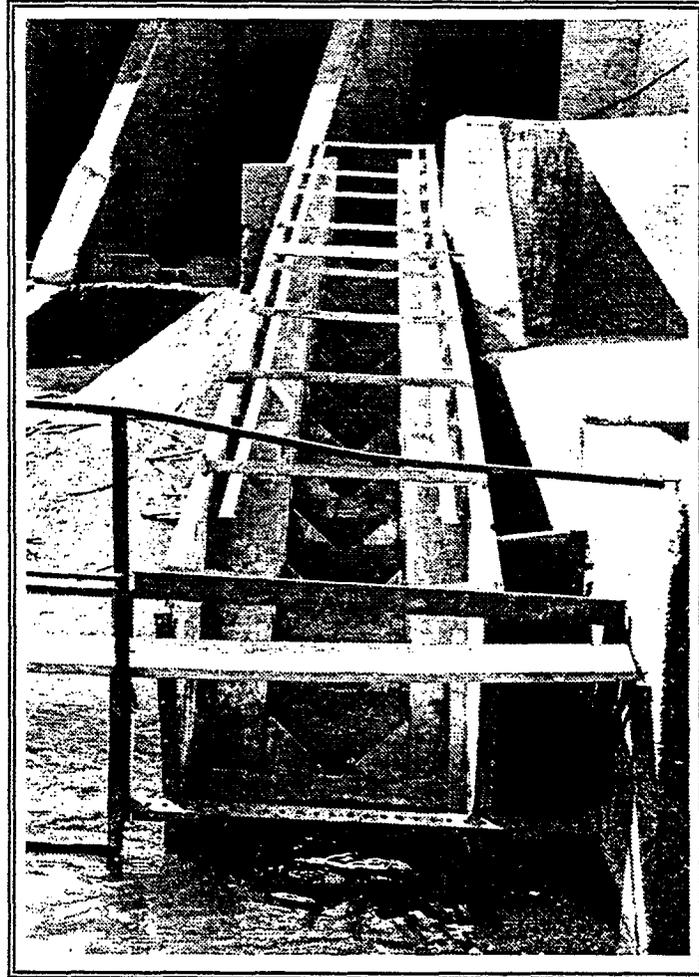
The shallow entrance depth of the Woodbridge Dam Denil fishway could reduce its effectiveness for fish passage. Statick (1969), as cited by Powers et al. (1985), recommended that Denil-type fishway entrances should be submerged to a depth of 2.5 feet. The entrance to the Denil fishway does not appear to be designed or operated at recommended criteria for this type of fishway (Figure 9).

The existing Denil fishway on Woodbridge Dam was reported by CDFG (1991) as having a slope of 11 percent. However, measurements taken from design drawings for the fishway indicated the slope was approximately 23 percent. A figure of the fishway included in CDFG (1991) showed the Denil fishway at a 21 percent slope (Figure 5). It was therefore assumed that the 11 percent value was a typographical error in the CDFG (1991) report. Assuming the existing Denil fishway is placed at either a 21 or 23 percent slope, it is steeper than that reported in the literature for other fish passage facilities and could impair fishway effectiveness. The maximum suggested length for this type of fishway at a 20 percent slope is 30 feet (Powers et al., 1985). The Woodbridge Dam Denil is slightly steeper and longer than these values. In reporting on several Denil fishways used at Cowan, Saskatchewan and Fairford, Manitoba, Canada, Katopodis (1990) stated that the longest Denil fishway section negotiated by fish was 9.5 m at a 12.6 percent slope. Recent fishways installed at Freeport, Ontario had the following design characteristics: east bank fishway, 7.5 m long at 20 percent slope; west bank fishway, three segments each at 10 percent slope with resting pools between segments (Katopodis, 1990). Larinier (1990) reported that more than 100 Denil fishways have been recently installed in France (over a 12-year period), primarily for sea trout and salmon and are generally operated at slopes of between 15 percent to 20 percent.

Figure 9. The Denil fishway (dewatered) at Woodbridge Dam, June 2, 1992. The bottom of the fishway is in the foreground.

The existing Denil fishway on Woodbridge Dam does not appear to provide any additional benefits to fish passage and may actually create worse conditions for fish passage and therefore should be removed. The length, slope, and placement of the Denil fishway are sub-optimal. Fish attempting to use this fishway are subjected to a high degree of turbulence at the entrance and are likely disoriented. Substantial energy expenditure would be required for fish

negotiating the fishway because of the fishway's slope and length; fallback though the fishway and physical injury probably occurs. Because debris can easily become wedged within this type of fishway, reduced performance of the fishway can occur. Debris can create undesirable conditions which may cause physical injury to fish passing through the fishway. Removal of the Denil fishway would also eliminate the high degree of turbulence in the common entrance pool for both the Denil and pool-and-weir fishway; this will allow for better hydraulic conditions for fish at the entrance to the pool-and-weir fishway.

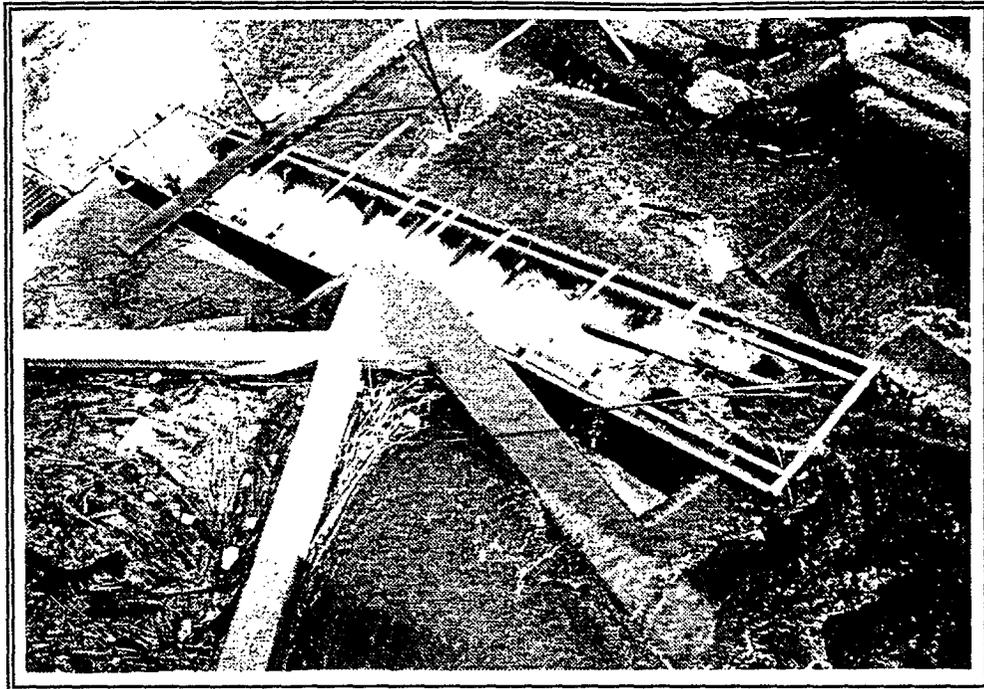
Adequate O&M of fishways is an important consideration of fishways (Rainey, 1991). The accumulation of riverine debris can clog fishways and significantly reduce their efficiency in fish passage performance. On two of three site visits to Woodbridge Dam, riverine debris was wedged in a fishway. Vogel et al. (1988) recommended a more aggressive O&M program for fishways at RBDD as a means of improving fishway efficiency. Based on observations during the site visits and the flow entrance configuration of the Denil fishway on Woodbridge Dam, it is probable that an inadequate O&M program may contribute to reduced fish passage at the dam. During a site visit on January 25, 1991, the top of the Denil fishway (flow entrance) was jammed with riverine debris making the fishway impassible for fish (Figures 10 and 11). During a site visit on March 25, 1992, a large board was found partially blocking the entrance to the base of both fishways in the entrance pool.

Figure 10. Denil fishway at Woodbridge Dam, January 25, 1991. Note debris at flow entrance.

All fishways require some degree of routine O&M to ensure the fishways are operating properly. Lack of routine O&M can result in reduced performance of the fishways when riverine debris becomes wedged within the fishway or hydraulic conditions are altered and impede fish passage. The Woodbridge Dam fishways should be inspected on a daily basis during the major migratory periods for salmon and steelhead migration to ensure good fish passage conditions.

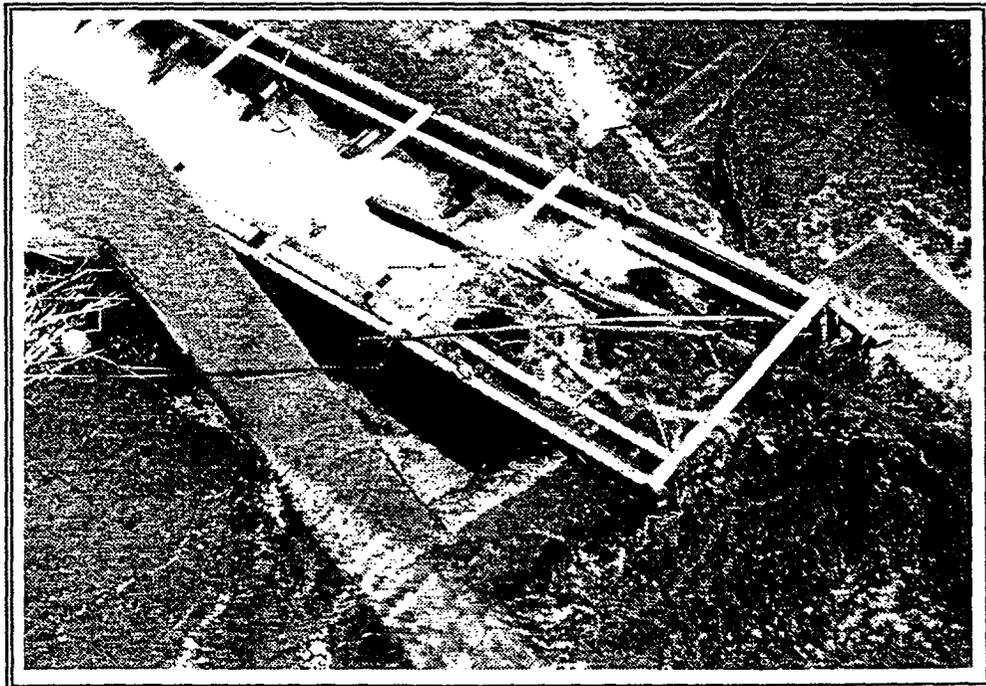
Figure 11. Top of the Denil fishway at Woodbridge Dam, January 25, 1991. Note riverine debris at the flow entrance.

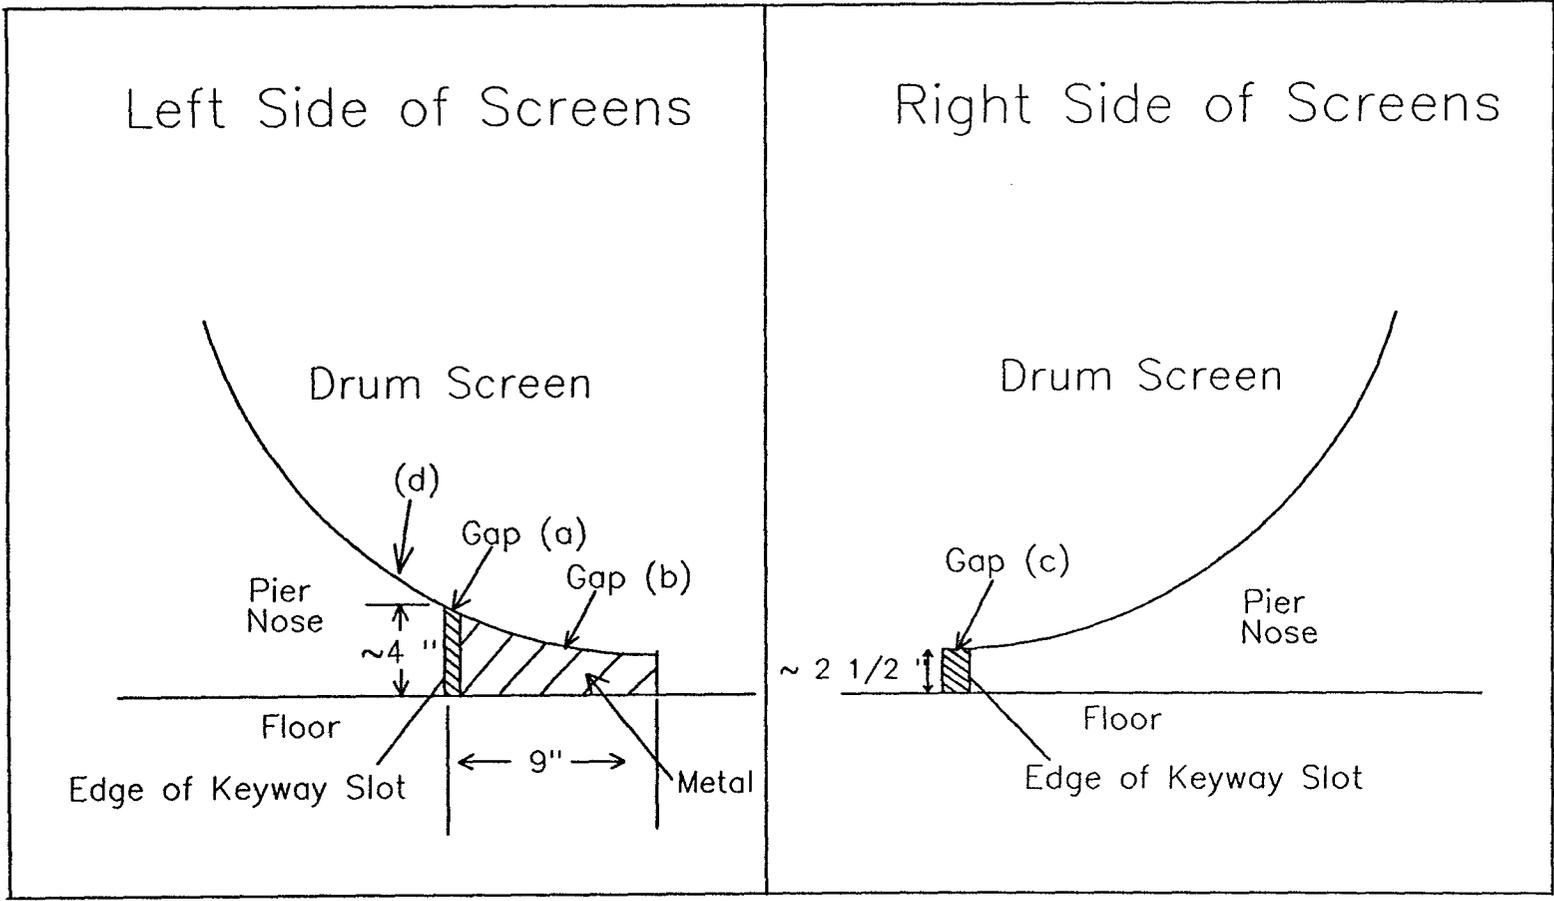
Numerous large gaps were located under the screens which could entrain fish when water is being diverted into WID canal. Figure 15 shows the general location where the gaps occurred at the base of the fish screens and Table 1 gives the specific locations and dimensions of the gaps located. In all but one case, the gaps were located in the concrete keyway slots for the fish screens. These keyway slots are where the entire drum screen and frame are lifted and lowered between the concrete support piers. Fish accessing these slots can easily enter the canal behind the screens by following the slots and entering the canal on the back side (downstream side) of the screen where no seals are present. The gaps are large enough for smolt, juvenile, and fry-sized salmonids to be entrained into the WID canal. There was one instance where one of the rubber side seals was damaged and a gap of approximately 6 inches by 3/8 inch was present. Figure 16 shows the location of the latter gap; in this photograph, note the white pen positioned between the concrete pier and the screen structure. The pen is inserted at the location of the damaged rubber seal. In this photograph, you can also see the metal base of the screen structure positioned in the keyway slot to the right of the pen. This area is comparable to the diagram of the left side of the screens shown in Figure 15. Figure 17 shows the location on the right side of the screens where the keyway slot gaps are present. Note the white pen inserted into the keyway slot. This area is comparable to the diagram of the right side of the screens shown in Figure 15. Following this inspection, CDFG staff repaired the gaps between the screens and concrete piers prior to the filling of Lake Lodi (Anders Christensen, WID Manager, personal communication).

Figure 15. Side views of the Woodbridge Irrigation District fish screen bays showing locations of gaps between drum screen frame and support piers.

The gaps in the bottom of the screen keyway slots should be eliminated to avoid entrainment of fish into the WID canal. A permanent type of seal (e.g., hard rubber or brush) should be installed on the base of each side of the screen frame in advance of installation for the irrigation season. Alternatively, temporary seals could be installed once the screens are in place but prior to inundation; these seals would have to be replaced each time the screen frame is lifted.

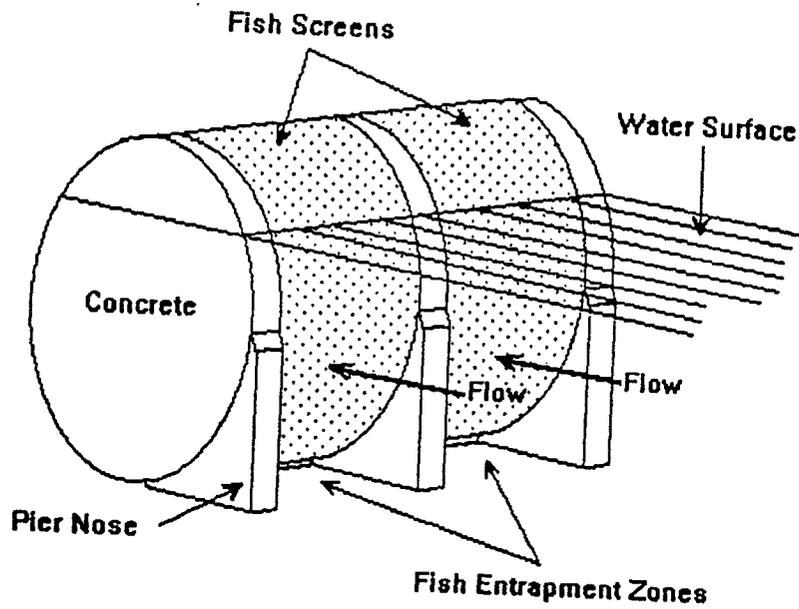
The most notable observation made during the inspection on March 23, 1992 was the presence of large concrete pier noses jutting approximately 5 feet out in front of the base of the fish screens (Figure 18). Those pier noses are shown in Figures 13 and 14. A closeup of the pier nose can be seen in Figure 19. The presence of these pier noses is undesirable because they create hazardous conditions for fish. Modern-day fish screen structures do not possess this feature and are designed with the concrete support piers flush with the contour or curvature of the rotary fish screens. The reason for designing the pier noses flush with the screen is to allow fish to follow a path of least resistance past the screens until they enter a downstream fish bypass. Existing CDFG fish screen design criteria states, "Screen faces shall be placed flush with any adjacent screen bay piers or walls to allow an unimpeded flow of bypass water parallel to the screen face". The presence of the pier noses interrupts tangential flow along the face of the screens toward the fish bypass system. Young downstream migrant salmonids entering a screen bay between the pier noses encounter only flow being entrained in a perpendicular direction through the screens. The fish can escape these areas only by swimming against the flow to escape these "entrapment zones" (Figure 18). This behavior is uncharacteristic of downstream migrant salmonids. Fisher (1976) believed that fish approaching the WID fish screen "sounded" in front of the screens; this behavior would make

Figure 18. Conceptual diagram of two Woodbridge Irrigation District fish screens showing location of fish entrapment zones.

them vulnerable to the entrapment zones at the base of the structure. Rainey (1985) pointed out that under these conditions, juvenile fish must either sustain swimming velocity until a bypass entrance is found or they must seek a small opening at inside or bottom seals. Emphasizing the danger to fish, he stated, "The unfortunate reality of a screen perpendicular to flow is that fish must be strong, innovative, and lucky to survive". Similar types of fish entrapment zones were recently found on the CDFG fish screen at the Glenn-Colusa Irrigation District diversion on the Sacramento River (Thompson, 1992).

The pier noses added to the fish screen support structure since original construction should be eliminated as shown in Figure 24. This measure will improve conditions for young fish traversing the screens to the fish bypass system and eliminate fish entrapment zones. It will help improve tangential flow past the screens to the fish bypass system and thereby improve fish transport to the fish bypass. The purpose for this measure is to eliminate locations in front of the fish screens where young fish would have to swim upstream (i.e., against the current) to escape hazardous areas. Removal of the pier noses will help minimize fish exposure time to the screens and allow easier access by fish to the bypass system. Reduction in fish exposure time in front of the screens will help reduce the potential for predation, impingement, and entrainment.

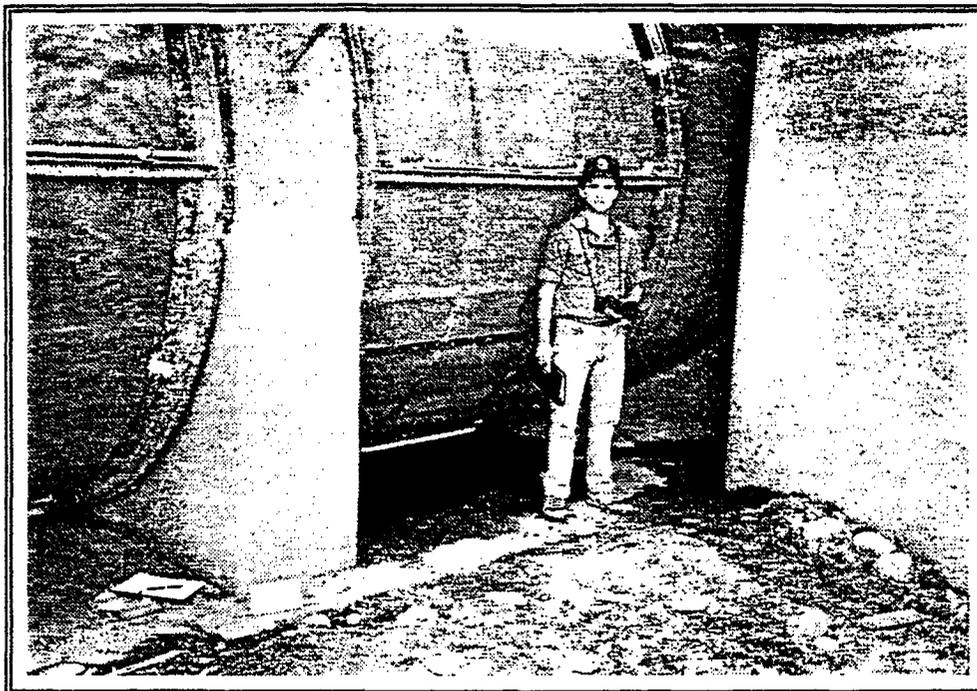
Figure 19. Entrance to the fish bypass (on the right) at the Woodbridge Irrigation District fish screens, March 23, 1992. Note the concrete pier nose on the left.

The entrance to the fish bypass system was inspected during the site visit on March 23, 1992 prior to the filling of Lake Lodi. The entrance is adjacent to the downstream-most fish screen (Figures 12, 13, and 19). Within the bypass, a large vertical trashrack was present. Mounted to the trashrack was a plywood board with a notch 6 ft high by 3 1/16 inches in width (Figures 21 and 22). The bottom of the rack was positioned on top of an additional piece of wood which resulted in the bottom of the notch being positioned 2 feet off the concrete floor (Figure 21). It appears that the plywood board was not an original feature of the fish bypass system and was simply lashed onto the vertical metal trashrack grates. This added feature in front of the bypass is unusual because it is a generally accepted practice to avoid such abrupt flow transitions and narrow entrances into a fish bypass system. Juvenile fish are extremely

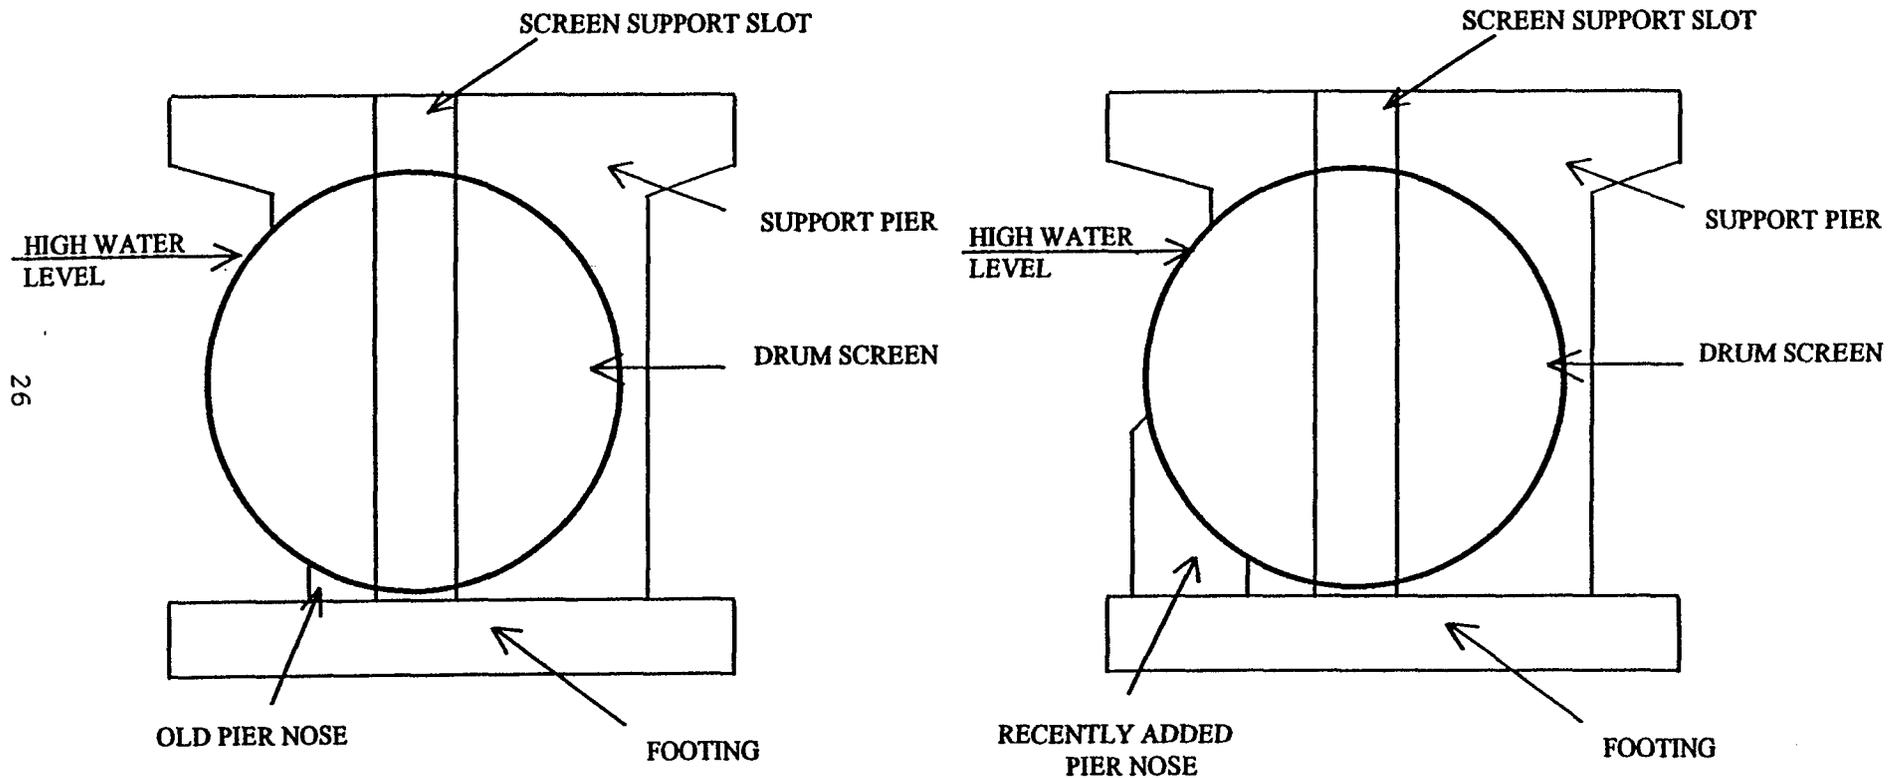
In examining the original design drawings for the WID fish screen structure, it is apparent that a relatively recent addition to the pier noses was made following original construction. The original pier noses were positioned close to the base of the fish screens whereas the addition onto the piers extended the pier noses approximately 5 feet in front of the base of the fish screens (Figure 20). It is not known why this modification was made to the structure, but doing so created worse conditions for fish than were present with the original design.

Figure 20. Cross-sectional profile of the Woodbridge Irrigation District fish screen concrete support piers showing original construction (left) and recently added pier nose (right).

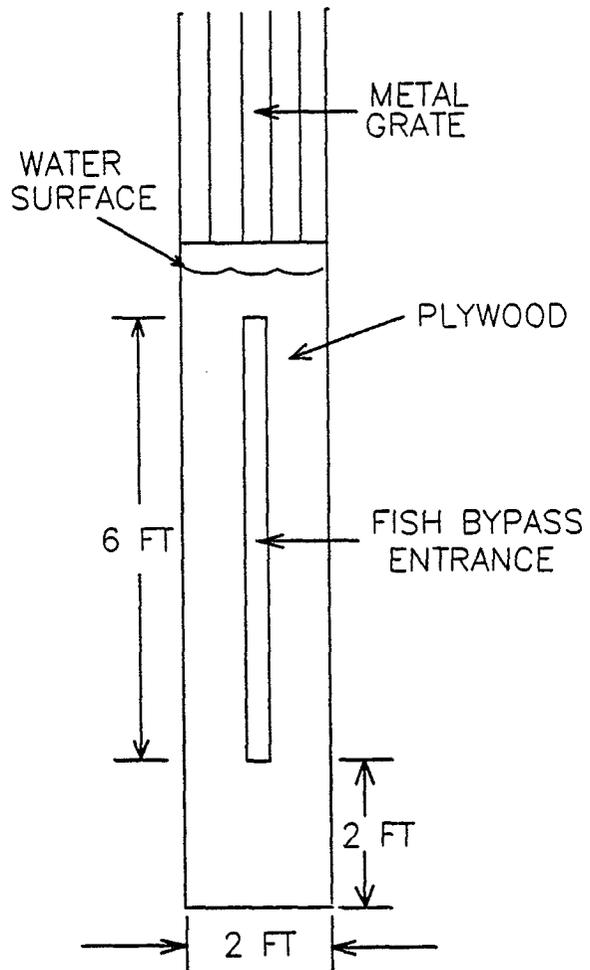
Figure 21. Front view of the trashrack and slotted board used at the entrance to the Woodbridge Irrigation District fish screen bypass.

Upon observing this behavior of fish swimming back and forth in front of the fish screens on June 2, 1992, I inspected the fish bypass entrance and found that a large tree limb was wedged in the bypass and partially blocked the small slotted entrance through the plywood board; I subsequently removed the limb and cleaned the entrance. Based on the large amount of spider webs and cobwebs present in front of the bypass, it was evident the bypass had not been inspected for a lengthy period of time. The presence of riverine debris in the fish bypass entrance could cause fish avoidance away from the structure and very likely accounted for the juvenile salmon behavior previously described.

The slotted plywood board over the fish bypass entrance should be removed during periods when the bypass system is intended to function as designed. The constriction in flow and width of the entrance into the bypass system very likely impairs the effectiveness of the system.

The entrance to the entire fish bypass system should be open at the surface to improve ambient light penetration into the fish bypass entrance. This will allow for greater visual orientation for fish entering the system. This type of open-surface bypass entrance was designed and installed on the new Tehama-Colusa Canal fish screens.

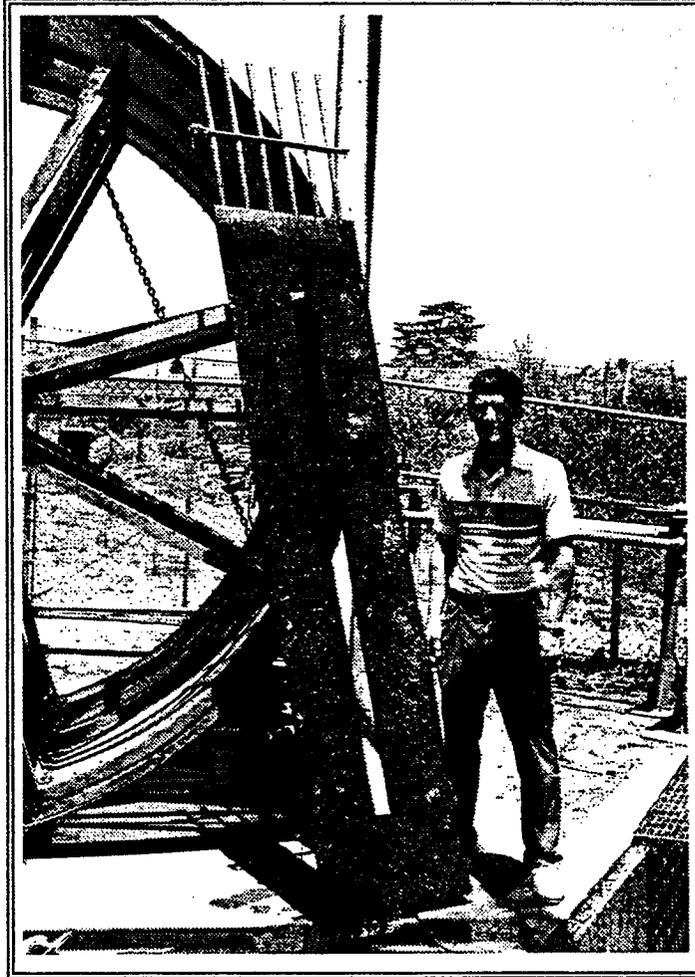
Figure 22. Slotted board used at the entrance to the fish bypass at the Woodbridge Irrigation District fish screens, June 2, 1992.

sensitive to changes in hydraulic conditions (Rainey, 1985). Niggel (1964), as cited by Rainey (1985), found that fish response to a flow acceleration in a uniform channel with a flow constriction at the lower end resulted in fish holding upstream of the point of flow acceleration. These conditions would make the young fish highly susceptible to predation by predatory fish.

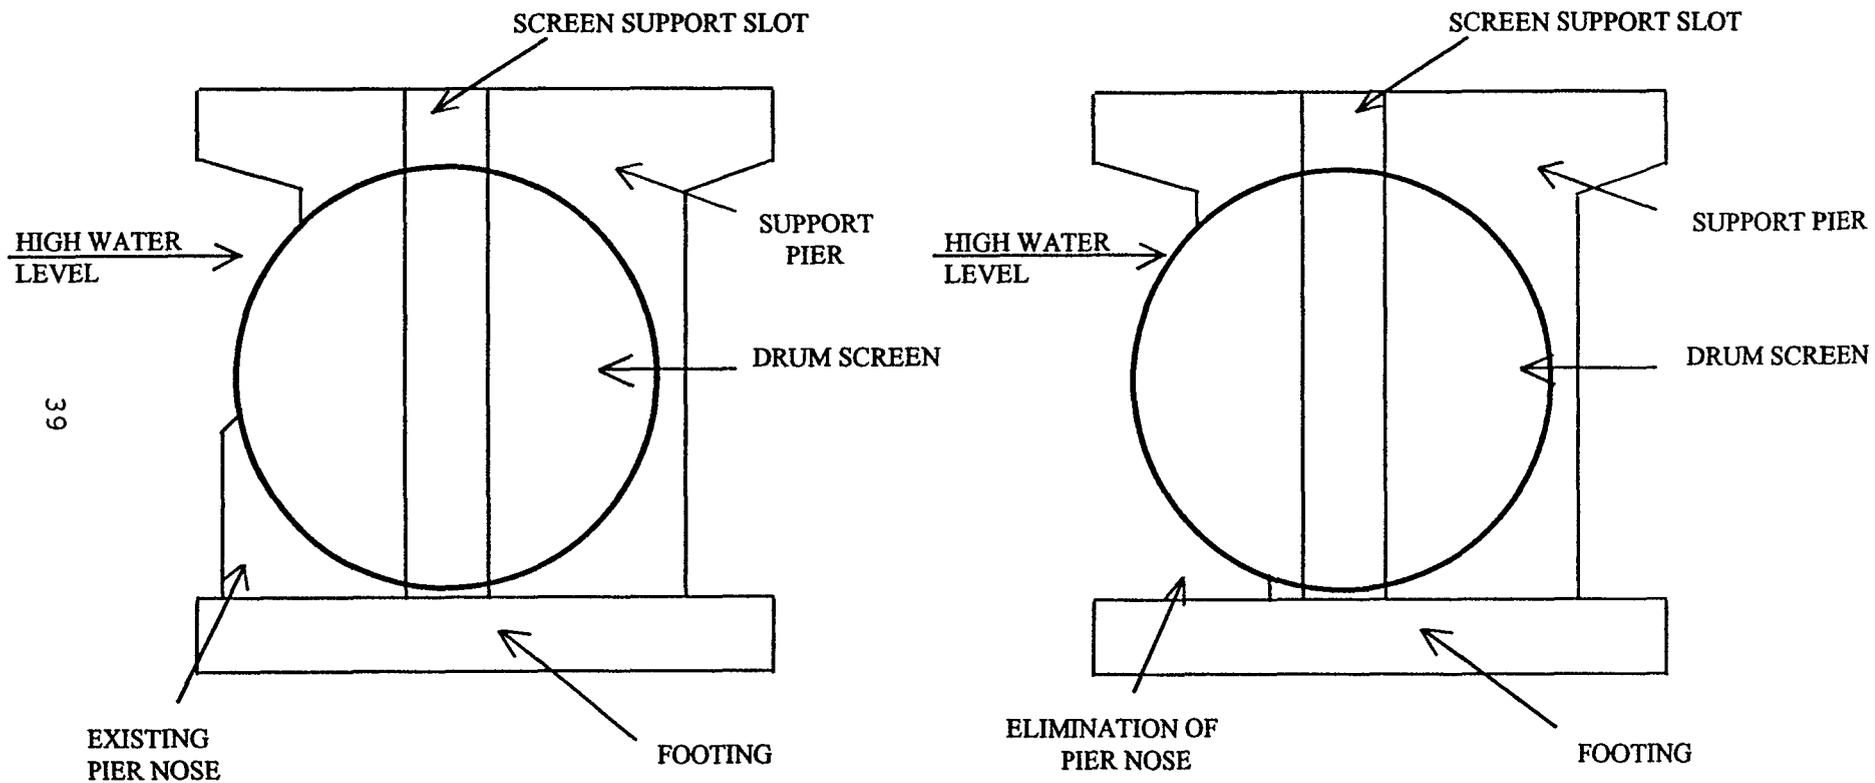
Figure 24. Cross-sectional profile of Woodbridge Irrigation District fish screen concrete support pier showing existing condition (left) and recommended modification to eliminate pier nose (right).
