PLANNING DIVISION
SACRAMENTO FLOOD CONTROL SYSTEM REEVALUATION
Initial Appraisal Report - Upper Sacramento Area

**US Army Corps
of Engineers**
Sacramento District
South Pacific Division

May 1995

Initial Appraisal Report - Upper Sacramento Area

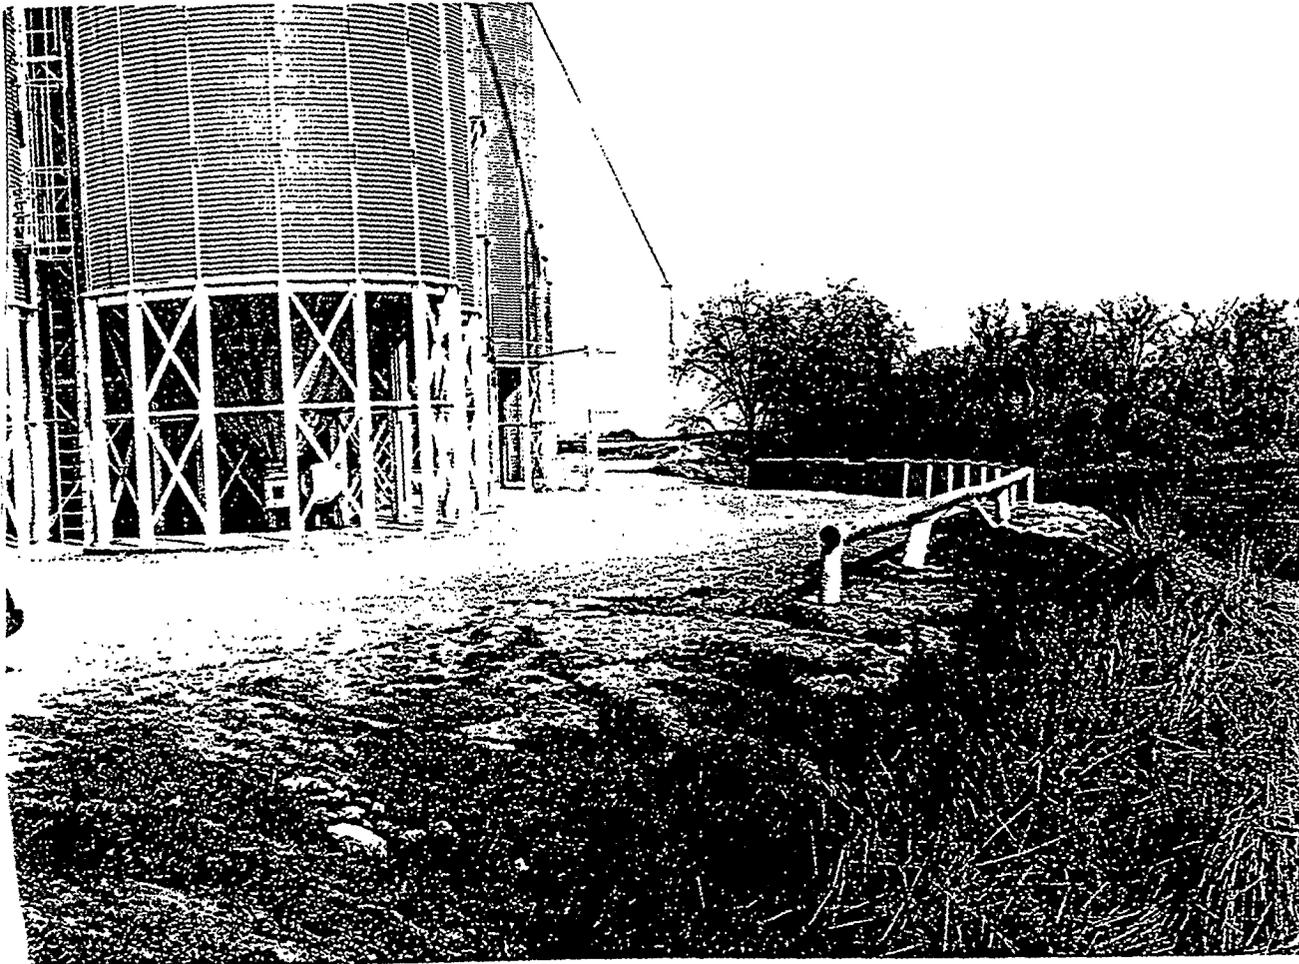
FIGURE 1

Bypass and caused severe seepage problems on the western levee near Robbins; a flood fight was needed to prevent potential disaster. High water came within 1 foot of the levee crown at Sacramento River mile 102.0 right (Site C in this study, see Figure 1 and Plate 4)

Levee Height Deficiency, Site C
River Mile 101.8 Right, Waterside, Looking North,
Summer 1994

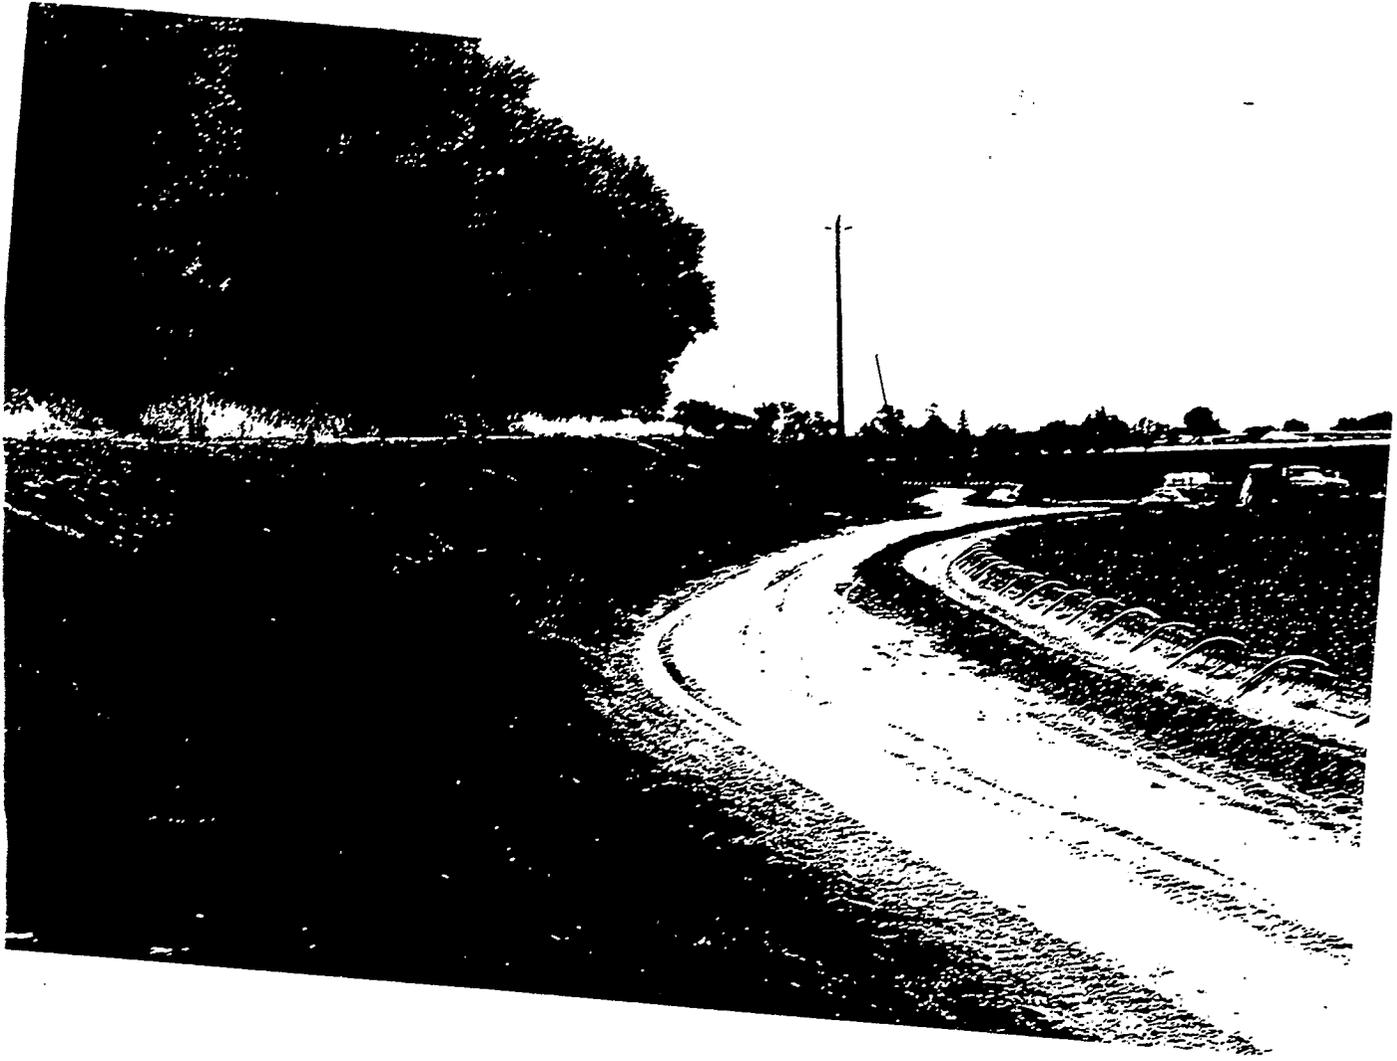
FIGURE 3

Seepage Area, Site D, Sacramento River
Mile 119.6 Right, Landside, Looking Southeast,
Summer 1994

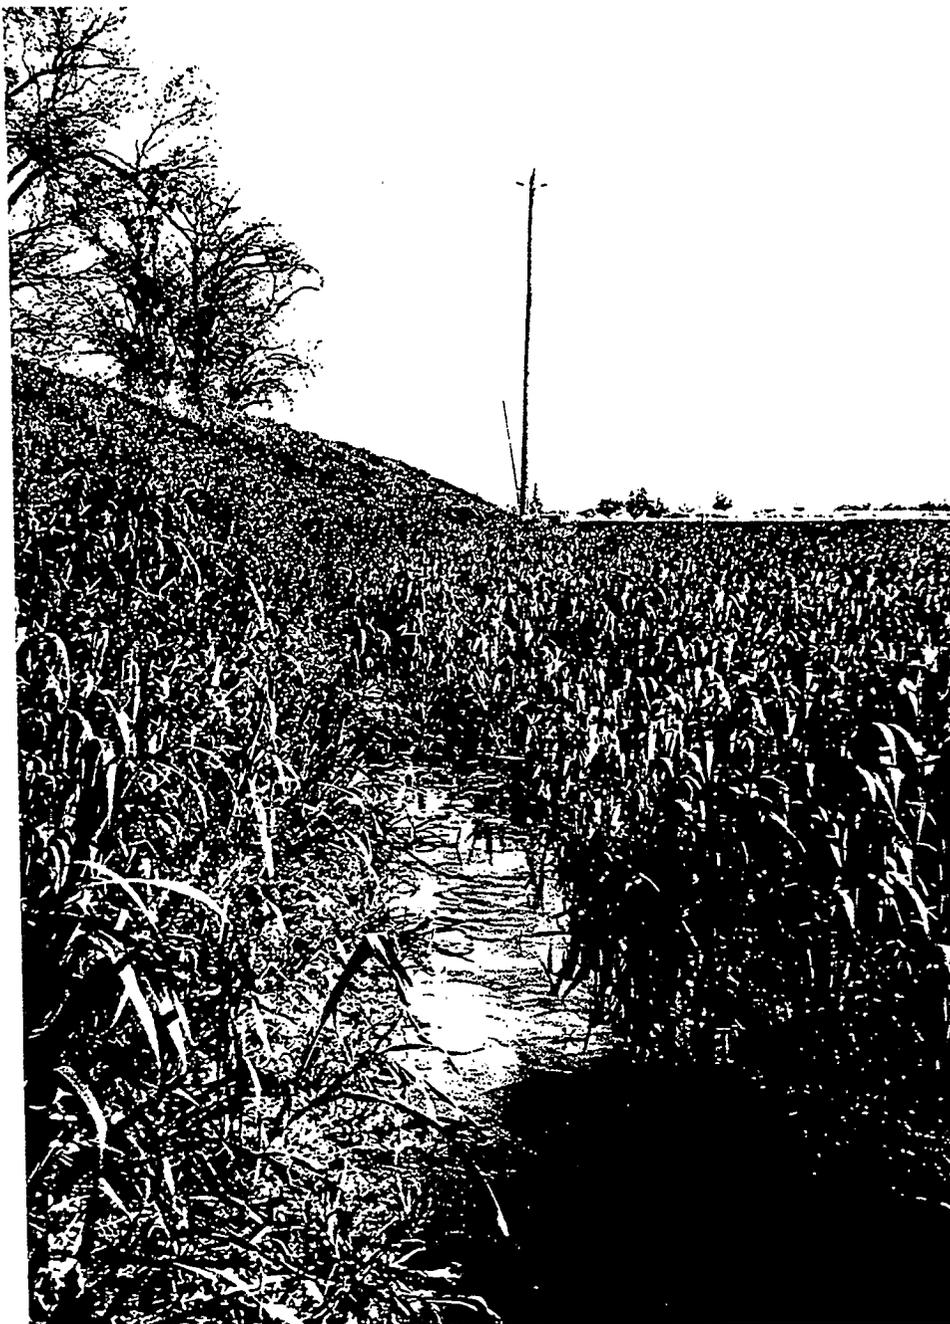
FIGURE 4

Site D, Same Location as Figure 3, March 17, 1995,
Seepage During High Water

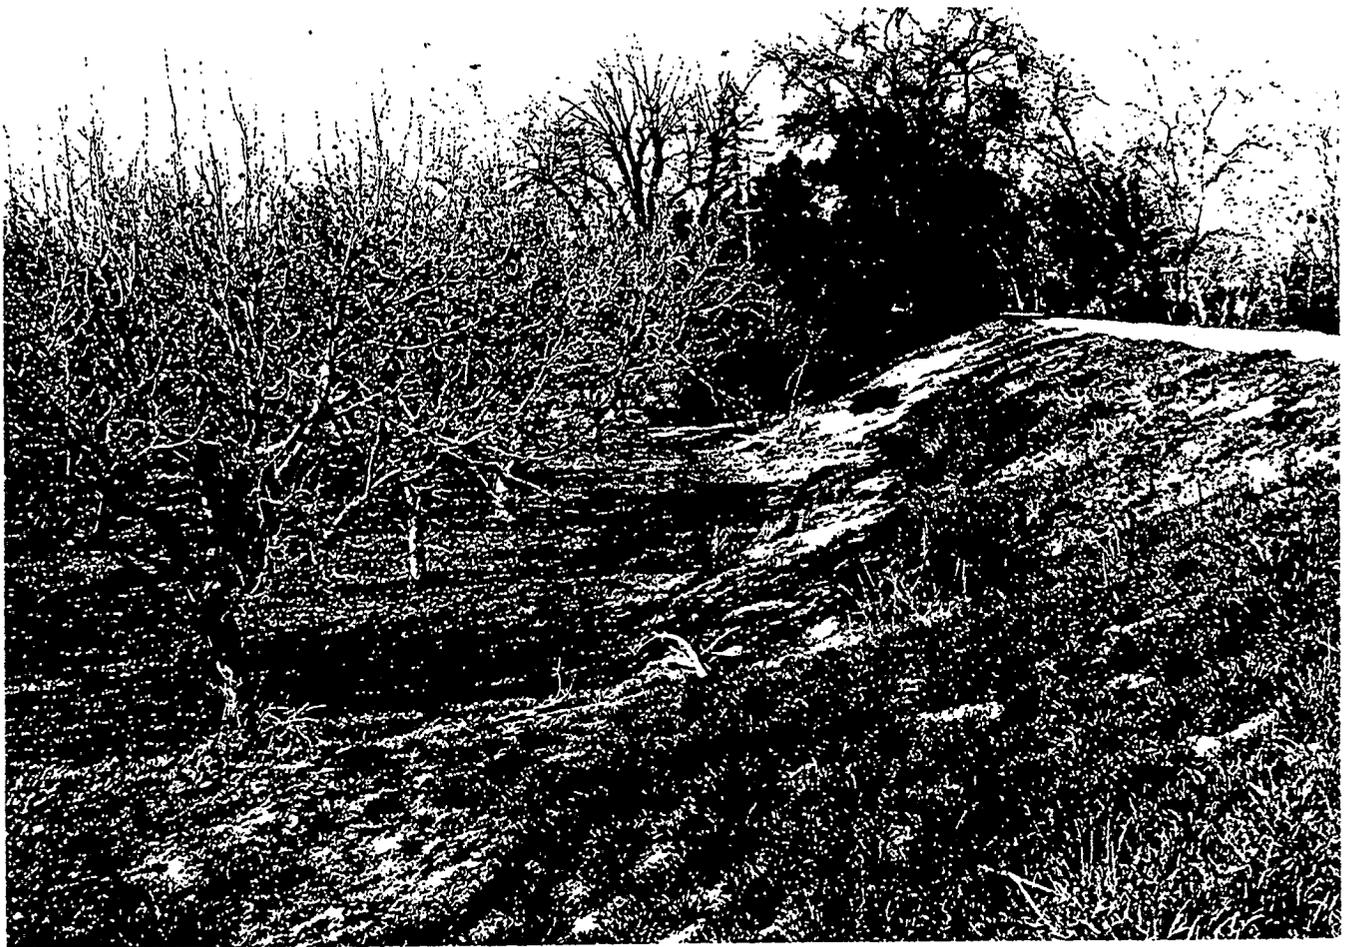
FIGURE 5

Seepage Area, Site E
Sacramento River Mile 140.8 Right, Landside, Looking West,
Spring 1994

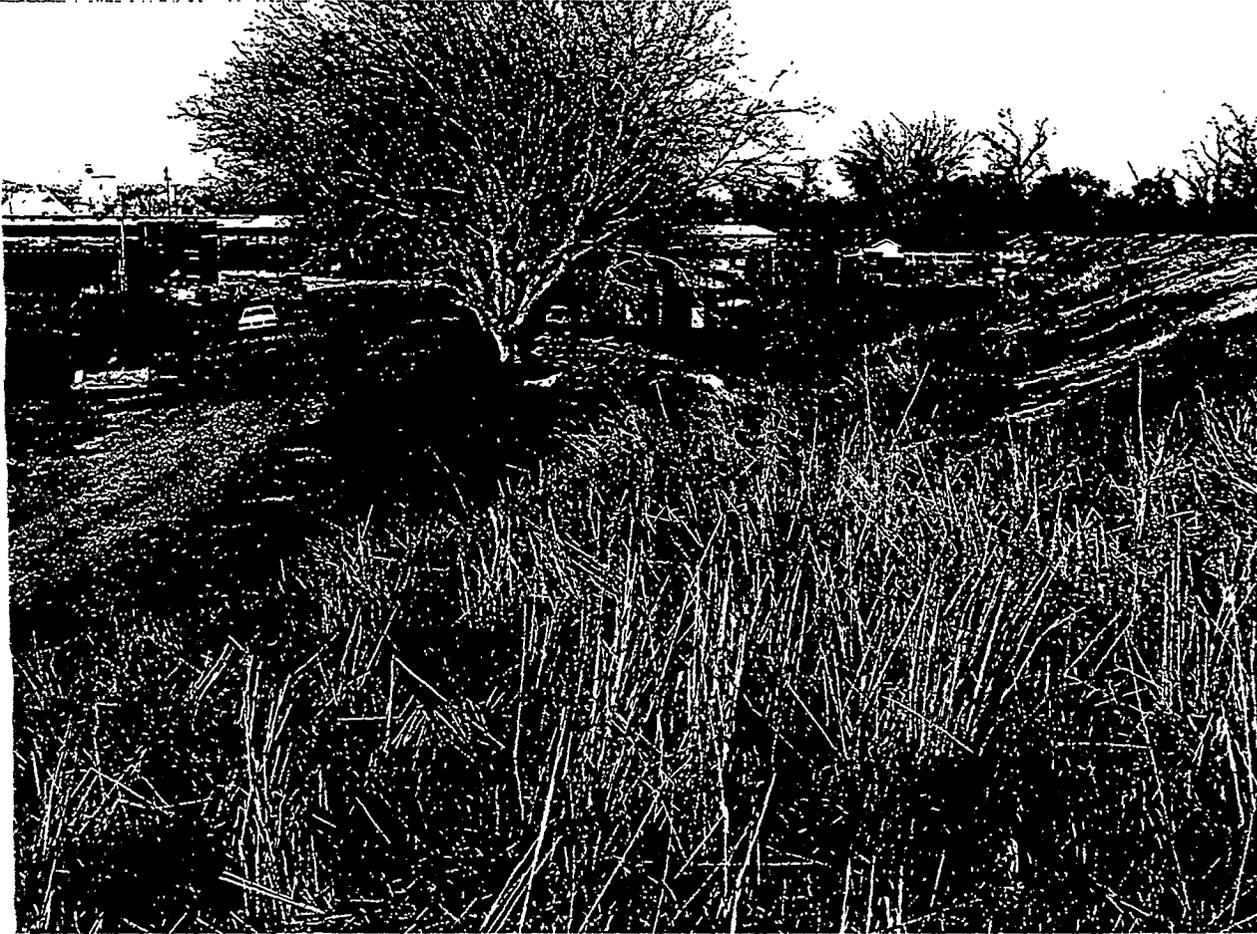
FIGURE 6

Seepage Area, Site E
Sacramento River Mile 142.9 Right, Landside, Looking West,
Spring 1994
