Threatened Levees on Sherman Island

Roger Foott¹, M. ASCE, Richard Sisson², M. ASCE, and
Roy Bell³, M. ASCE

Severe levee cracking was observed along a section of a levee in the Sacramento Delta area of California. An extensive program of geotechnical investigation and treatment was performed. The results of the investigation point to the danger of considering only limiting equilibrium factors of safety for highly deformable peat soils, since large deformations may be initiated long before critical stability is indicated.

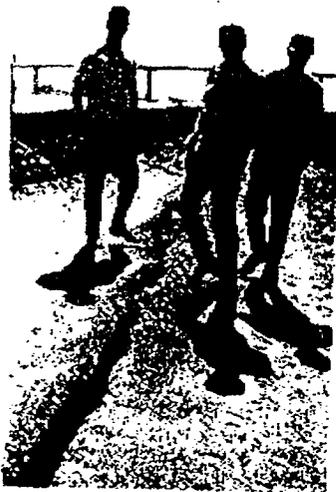
In the summer of 1990, a sizeable array of cracks developed along a reach of the levee approximately 1000 ft long. The cracks were located in the landside berm of the levee, in the sides of the levee embankment, and on the top of the levee. They were typically aligned along the levee giving the general appearance of the toe of the levee berm having been pulled laterally outwards. Crack movements on the embankment progressed quite rapidly, with the cracks frequently opening to a width of one or two inches. Vertical offsets as much as 12 in. also developed across some of the cracks. However longitudinal displacement along the cracks was not observed. Figure 1 shows a typical photograph of a crack; Figure 2 presents a schematic section through the levee showing a characteristic crack array.

Figure 1 Photograph of Crack

The cracks extended across the levee crown into the waterside slope and, in addition to stability concerns, presented a very real threat that San Joaquin River water would flow relatively unimpeded through them into the island. Since the levee at this location is predominantly composed of sand, erosion and piping could then easily breach the levee and flood the island. The prospect of

The levee embankment was compacted using an Essick VF-54T vibrating sheepsfoot roller towed behind a D6 crawler tractor, which provided a substantial vibratory compactive effort with excellent maneuverability. It was found that when the vibrator was applied with its longitudinal axis above and parallel to a crack, the crack would close and heal in a very satisfactory manner. By this process the levee cracks were sealed and the integrity of the levee embankment restored.

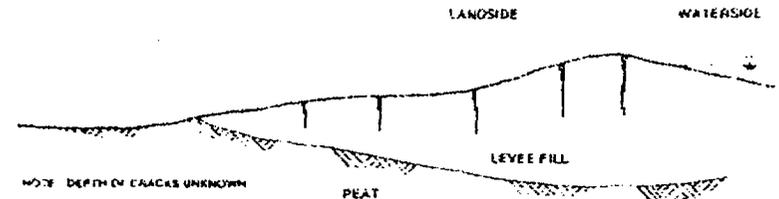
Figure 2 Schematic Section Showing Typical Crack Array

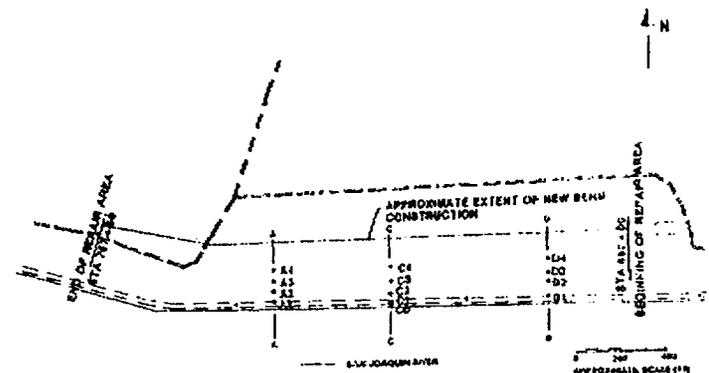
plan is shown in Figure 3, with the location of sections A, C and D, borings, inclinometers and piezometers also shown. A database for Section A was developed first and used for analysis of the area, with data for Sections C and D developed thereafter. The three sections were found to be very similar, allowing data from all sections to be considered collectively.

Figure 3 Site Plan of Main Crack Area

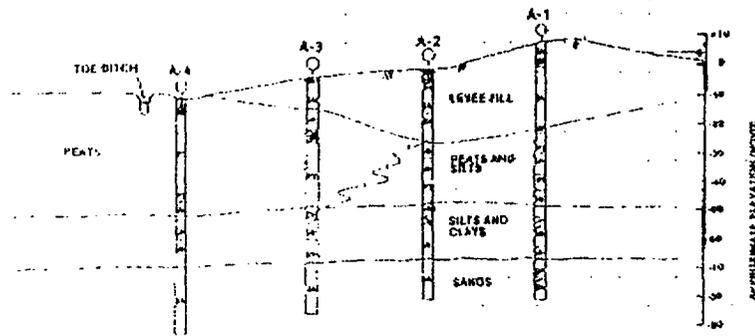
Figure 4 presents the profile through the levee at Section A, including the subsurface soil strata. A thick levee fill is apparent, overlying interbedded silts and peats beneath the levee crest and thought to be old natural levee deposits, which grade into thick peat deposits beneath and beyond the landside berm. A silty clay deposit beneath the peat then underlies the entire site, above a deeper stratum of sandy soils. A toe ditch is present outside the berm.

The increased depth of levee fill to landside of the levee crown is notable. This characteristic was even more apparent in Sections C and D. It is thought to reflect increased compressibility of the peaty soils as compared to the natural levee deposits. The likely cause of this situation is that the natural levee at the higher levels would typically have experienced air drying and stiffening during the deposition process (see discussion below). Thus levee filling on the landside of the natural levees would have caused greater compression of the subsoils and experienced more settlement than filling at the levee crown, which appears to be located directly over the highest area of the natural levee soils.

Figure 4 Soil Profile at Section A

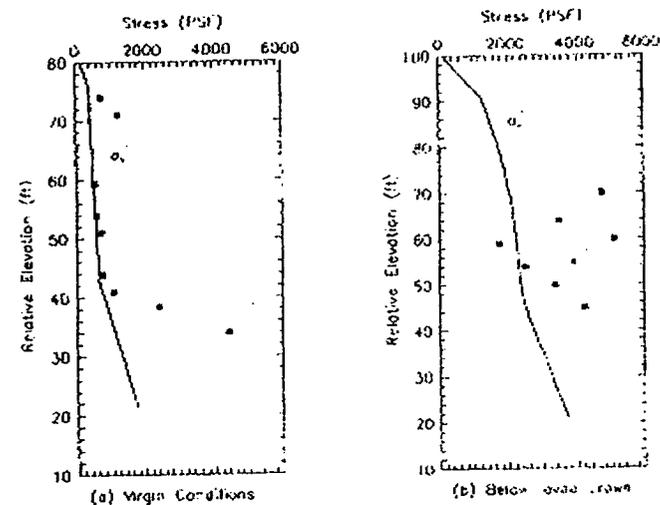
A comparison of vertical effective stress and maximum past pressure data beneath the levee embankment

(Borings A1, C1 and D1) is presented in Figure 5b. A much higher vertical effective stress profile applies at this location than in the virgin soils of Figure 9, reflecting the addition of about 30 ft of fill. Much higher prestress values are also evident, with some of the values falling very considerably above the effective stress line. These very high values are not consistent with virgin consolidation of weak peat and clay having occurred under the levee loads. Instead they suggest that some areas in the foundation soils had been heavily prestressed long before the levee fills were placed. A possible explanation for this situation lies in the presence of natural levee deposits below the present levee embankment. Natural levees are subject to drying and strengthening, and depending on the frequency of flooding and the height of the banks, layers of highly consolidated material may have formed in the study area.

Figure 5: Stress History Profile

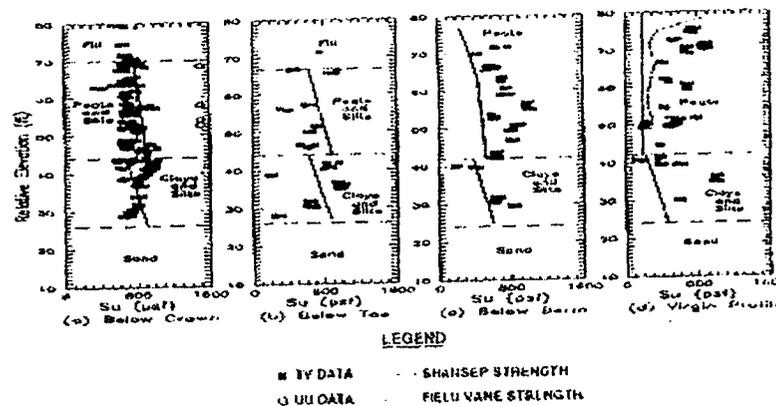
The resulting comparisons are shown in Figure 6. Figure 6a relates to the levee crown (Borings A1, C1, D1) and shows the SHANSEP profile plus Torvane data and UU data. The Torvane was used to obtain a quick indication of undrained strength in cohesive soils, and assemble a sizeable database of strength values relatively inexpensively. Landva (1986) identified limitations of the test in peats, so definitive strength values would generally not be expected, but the test does indicate approximate strengths and their variability. Figure 6a shows that the SHANSEP data fall at the upper end of the range of Torvane data in the peats and silts and usually within the body of the Torvane data in the silty clays. The UU data are all much higher than the SHANSEP values, perhaps indicating that better quality cohesive and peat samples were selected for laboratory testing (in order to avoid tests on silt samples which have little value). Figures 6b and 6c show a comparison of SHANSEP and Torvane data at the A2, C2, D2 and the A3, C3, D3 offsets, respectively. Figure 6b again shows Torvane data lying below the SHANSEP strengths in the peats and above and below the SHANSEP values in the clays, while Figure 6c shows the Torvane values to be generally above the

SHANSEP strength profile. The effective stress values are progressively reduced from Figure 6a through 6c, reflecting reduced thickness of levee fill. Figure 6d presents the same comparison for the unloaded virgin soil profile (Borings A4, C4, D4) and also shows the DWR field vane shear test results. The Torvane data are now usually much higher than the SHANSEP profile. The field vane data are also much higher, although they would typically require "correction" to yield appropriate design values. A correction factor of about 2/3 would be required to yield the SHANSEP strengths, within the expected range for the present soils. In this case, the SHANSEP data have been estimated using an assumed uniform vertical effective stress profile of about 600 psf throughout the peat, to include the effect of surface drying (see Figure 5b).

Figure 6 Shear Strength Profile

Based on the above, the SHANSEP strength values were judged to represent a reasonable basis for design. It seems likely that the Torvane data overestimate strengths in the very weak, virgin profile, probably in part due to fibrous reinforcing of the soil by organic material. It then seems probable that this Torvane tendency for strength overestimation gives way to a slight tendency for underestimation of strengths at the higher stress levels beneath the levee embankment, possibly reflecting an increased sample disturbance effect with the Torvane, plus the increased presence of silt within the peaty layer. However, to avoid the possibility of overestimat-

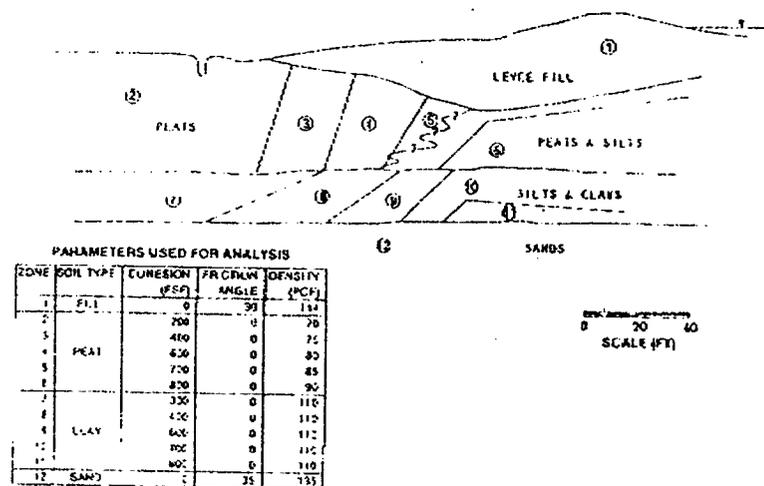
The next stage in the stability assessment was the development of strength contours within the foundation soils for the Section A levee cross section. Based on standard correlations, fill material strength properties of $C=0$, $\phi=30^\circ$ were also selected. By using the strength contours to divide the foundation soil into zones of assumed uniform conditions, the stability model of figure 7 was then obtained.

Figure 7 Stability Model

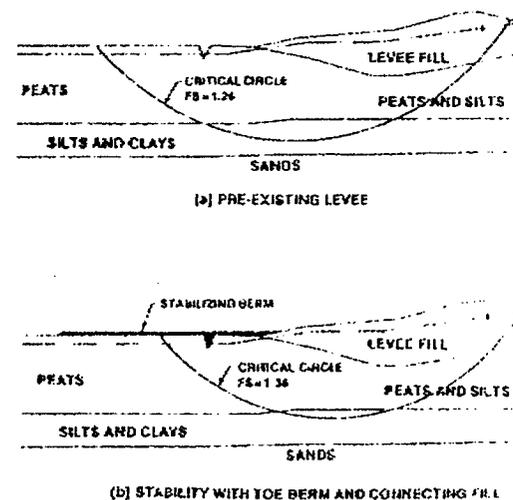
Stability was analyzed for a number of conditions using the above described strength profiles, which are considered to be generally conservative. The factor of safety for the pre-existing levee configuration was calculated as 1.26. The increase in stability resulting from placing an 80 ft wide, 2 ft thick berm outside the toe ditch, plus a fill connecting this new berm to the original berm was investigated. It resulted in a factor of safety of 1.36. These analyses and the critical stability surfaces are summarized in Figure 8. Addition of a further 2 ft of fill over a width of 16 ft at the levee

crowns reduced the safety factor to 1.35. None of the indicated factors of safety are such that major instability would be expected, particularly in view of the conservative approach used to select shear strengths. Factors of safety close to unity would generally be expected before gross shear failure will occur.

Figure 8 Results of Stability Analyses

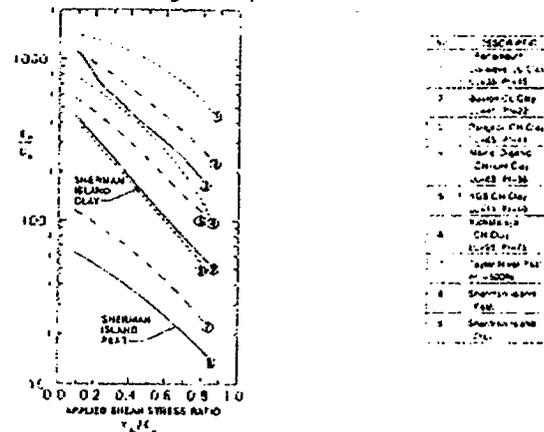
The stability analyses and observed field behavior strongly suggested that the levee distress was not the result of a classical limiting equilibrium slope stability failure. The problem appeared instead to relate to deformation of the peaty foundation soils, which are known to be highly deformable and creep susceptible. Figure 9 demonstrates this characteristic by comparing the deformation modulus values measured in the DSS tests on the peat and the silty clay, with modulus values for a variety of cohesive soils. Generally, soils with lower moduli are more deformable (and probably more creep susceptible, see Foott and Ladd, 1981). The peat has by far the lowest modulus of all the soils (note the logarithmic vertical axis in Figure 9).

Figure 9 Direct Simple Shear Modulus Values

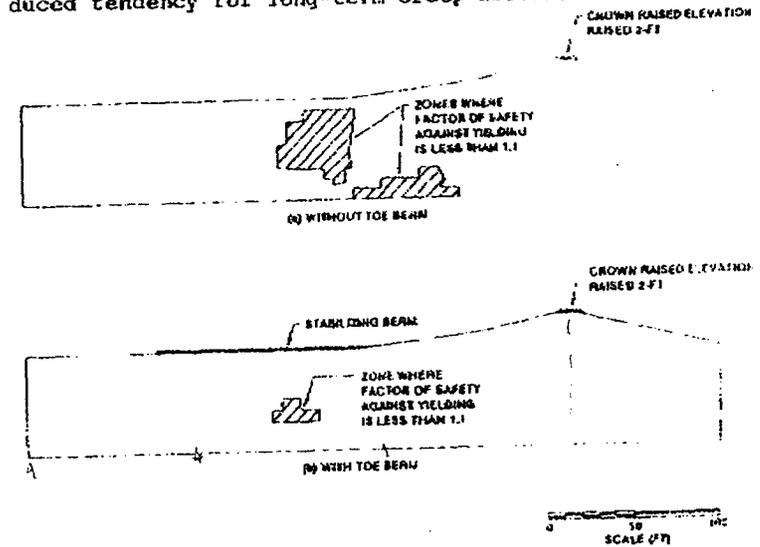
cal results of Figure 11, which compares the zones of highly stressed soil in the levee foundation following crown restoration without the increased toe berms (Figure 11a) and with them (Figure 11b). The zone of highly stressed soil with the enlarged berms is much smaller than without them, indicating enhanced stability and reduced tendency for long-term creep deformations.

Figure 11 Deformation Analysis Stress Levels

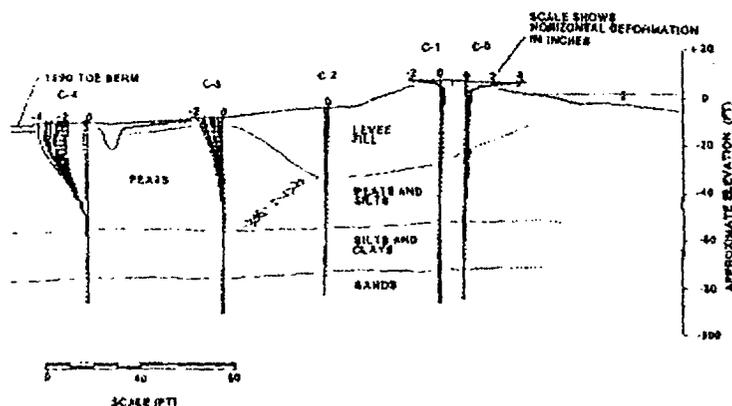
Figure 12 Deformations at the Crack Area

The observed cracking phenomenon may be more reasonably explained by considering the highly deformable and creep susceptible nature of the peat soils present beneath and to the landside of the levee embankment. The very low modulus values of the peat mean that it will typically deform considerably at applied loads significantly less than those required to cause failure. Thus conventionally adequate stability factors of safety are not a guarantee against excessive deformations and lateral movements of the peat material, with resultant cracking of the overlying fill. This situation is particularly acute when fill is placed over virgin peat, which may be very highly deformable until it has had time to consolidate and strengthen.

A likely explanation of the observed cracking is therefore that the pre-existing levee had suffered settlement and lateral movements of the underlying peat, particularly beneath its sizeable berms. These movements were probably related to a lowering of the water table on the landside of the levee, which by removing buoyancy effects has a net result similar to adding levee load. (Water table lowering was particularly likely to have occurred near the main area of cracking, where ongoing drought conditions were combined with a discontinuation of periodic flooding of the adjacent field to cause unusually dry conditions.) The peat deformations could then cause cracking of the levee which might typically start at the levee toe and progress into the embankment area. Reports of cracking of the landside slope of levees at time of drought are not uncommon and probably are frequently due to this cause.
