**SALMON SPAWNING HABITAT REHABILITATION IN  
THE MERCED, TUOLUMNE, AND STANISLAUS  
RIVERS, CALIFORNIA: AN EVALUATION OF PROJECT  
PLANNING AND PERFORMANCE**

**UNIVERSITY OF CALIFORNIA  
WATER RESOURCES CENTER  
REPORT No. 90  
ISBN 1-887192-04-2  
JUNE 1996**

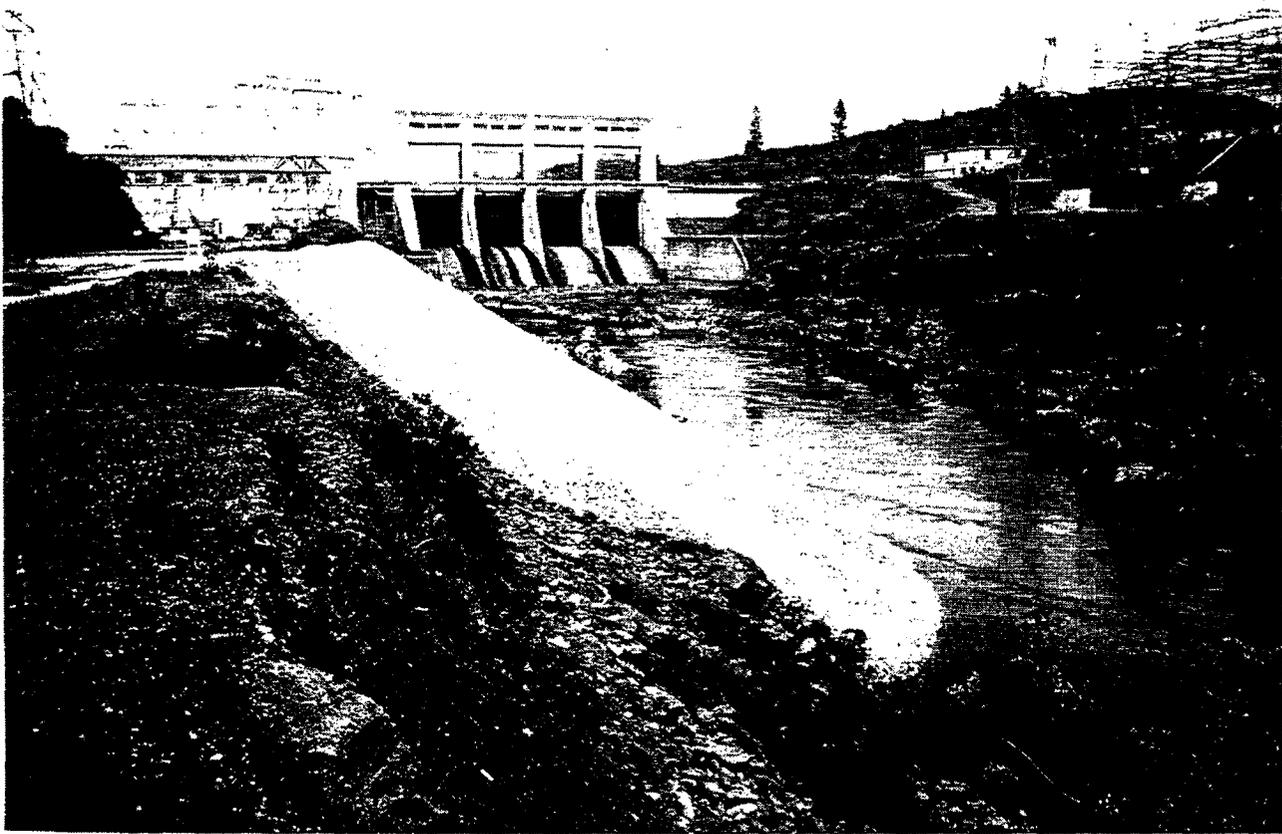
Figure 4. Gravel replenishment to the Sacramento River below Keswick Dam. (Photograph by Kondolf, January 1991)

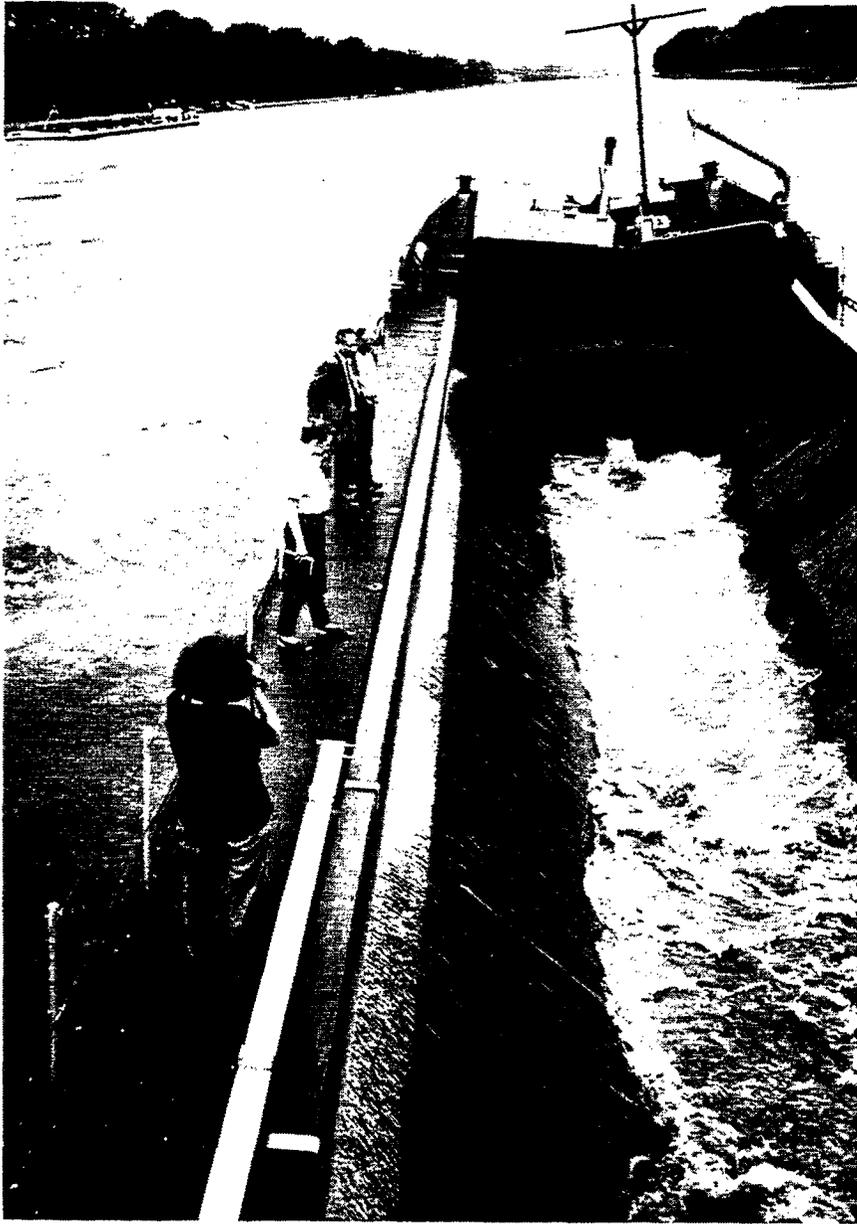
Figure 6. The barge, mostly empty, feeding gravel in to the River Rhine downstream of the Barrage Iffezheim.

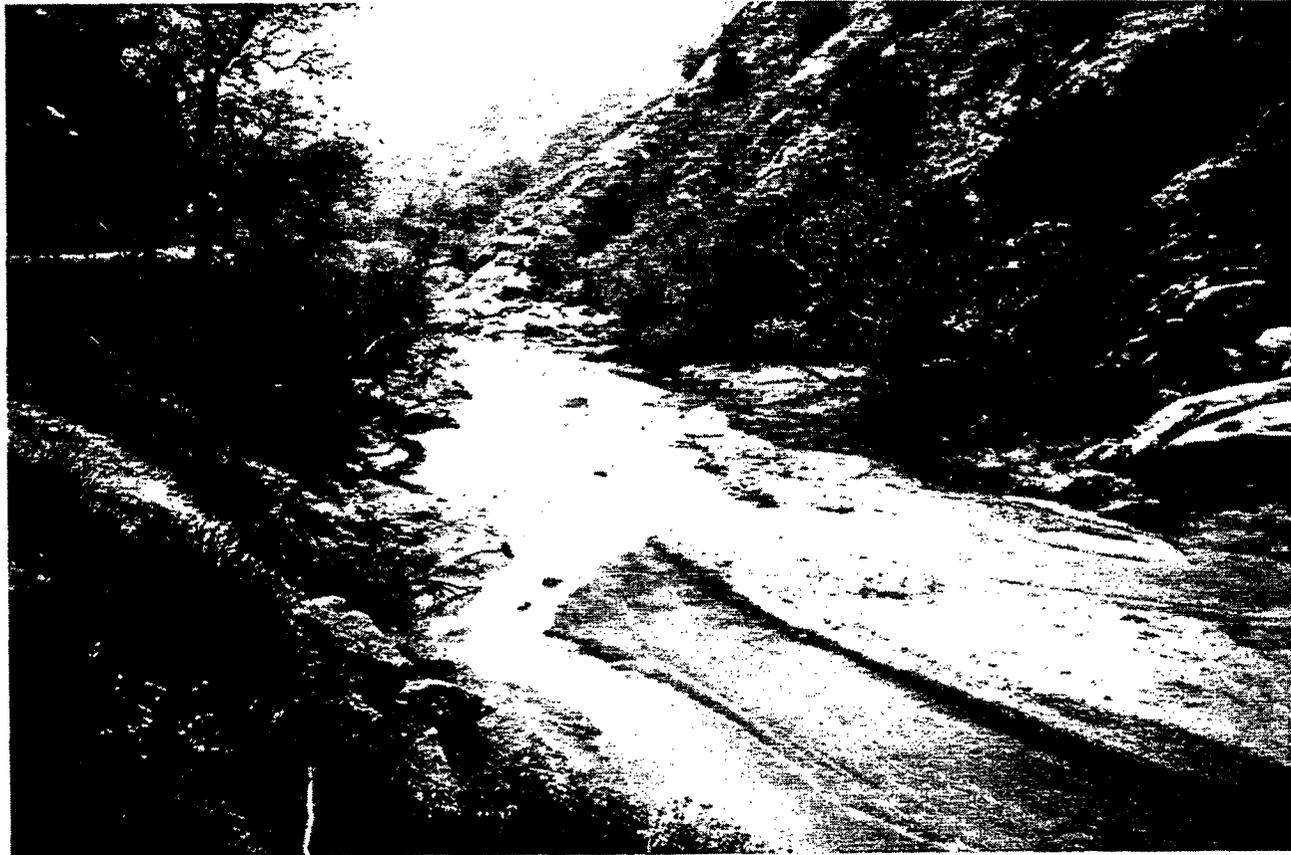
Figure 8. Sand deposited in the bed of the Kern River as a result of sluicing from Democrat Dam in 1986. (photograph by Kondolf, December 1990)

If sediment is permitted to accumulate in the reservoir and is subsequently discharged as a pulse (sediment *sluicing*), the abrupt increase in sediment load may alter substrate and aquatic habitat conditions downstream of the dam. The most severe effects are likely to occur when sediment accumulated over the flood season is discharged during baseflow (by opening the outlet pipe or sluice gates and permitting the reservoir to draw down sufficiently to resuspend sediment and move bedload), when the river's transporting capacity is inadequate to move the increased load. On the Kern River, Southern California Edison Company (an electric utility) obtained agency permission to sluice sand from Democrat Dam in 1986, anticipating that the sand would be washed from the channel the subsequent winter. However, several years of drought ensued, and the sand remained within the channel until high flows in 1992 (figure 8) (Dan Christenson, California Department of Fish and Game, Kernville, personal communication, 1992).

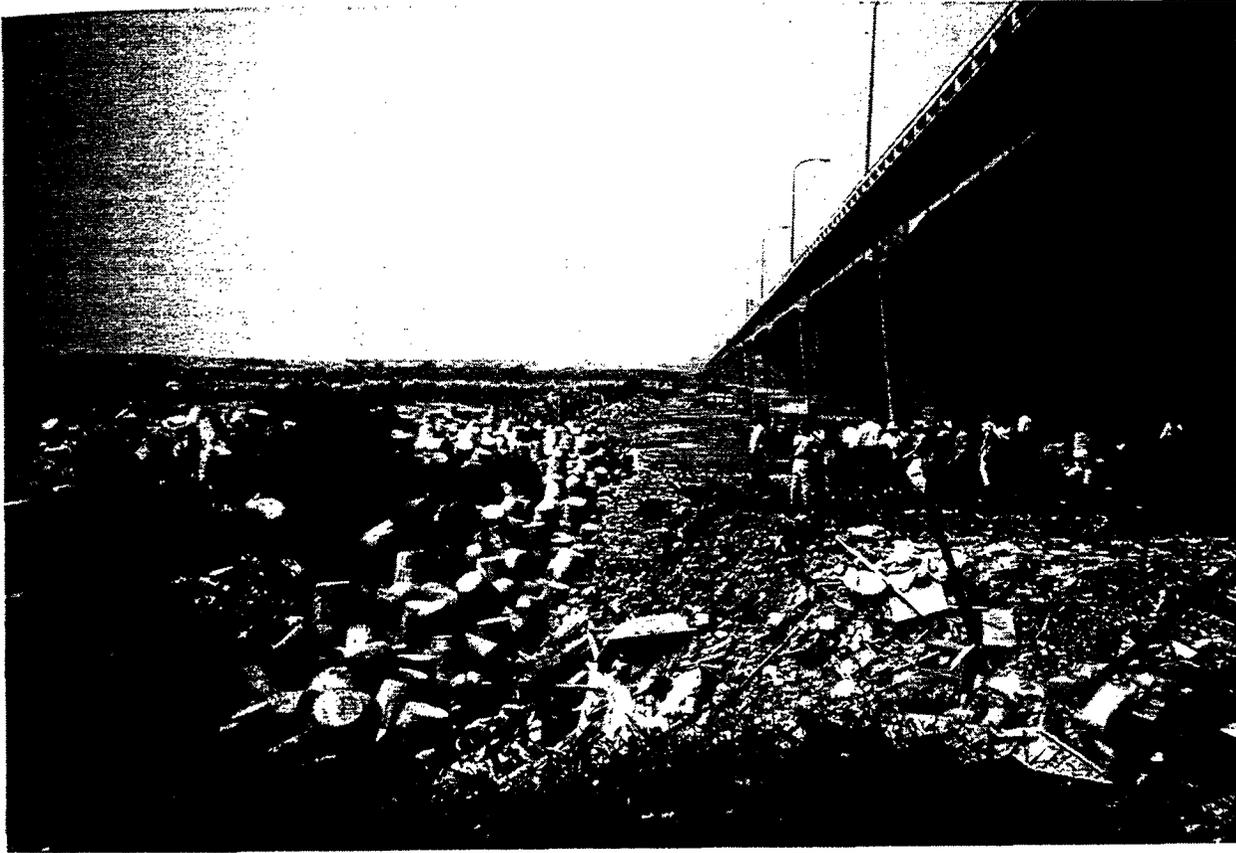
Figure 11. Bed erosion and massive grade control structures installed downstream of the Kaoping Bridge, Kaoping River, Taiwan. (photograph by Kondolf, October 1995)

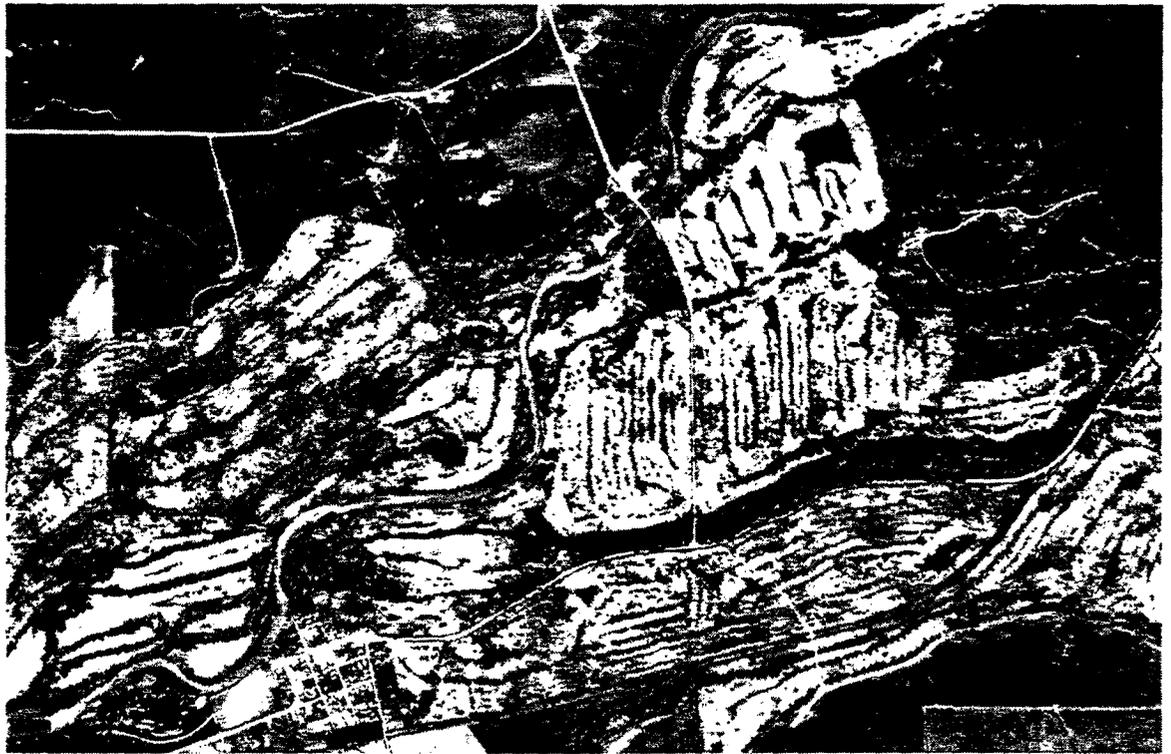
Figure 30. Tailings left behind by gold dredgers on the Merced River floodplain. The town of Snelling is located in the upper, right-hand quadrant. (photo: Agricultural Stabilization and Conservation Service)

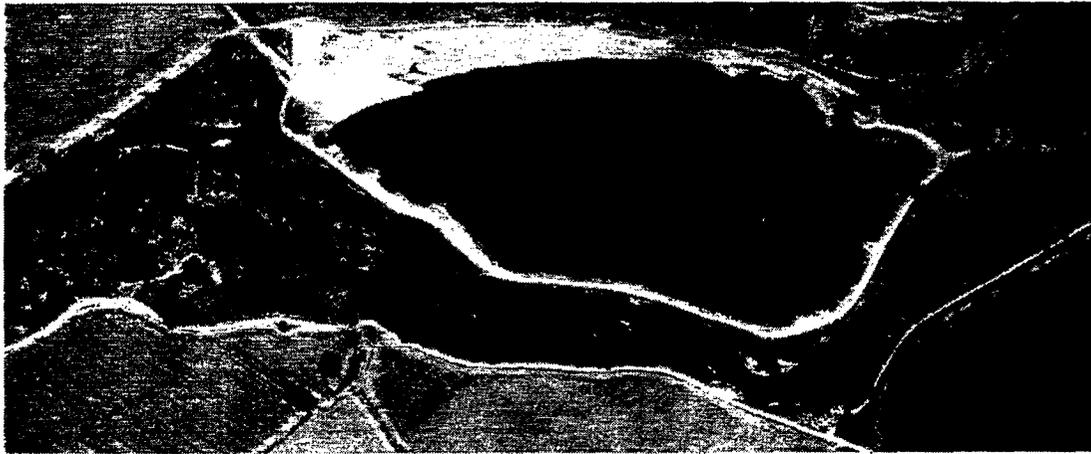
Figure 33. Typical terrace aggregate mining pit. The pit in photograph is mine number 20 (table 19). (photo: U.S. Bureau of Reclamation)

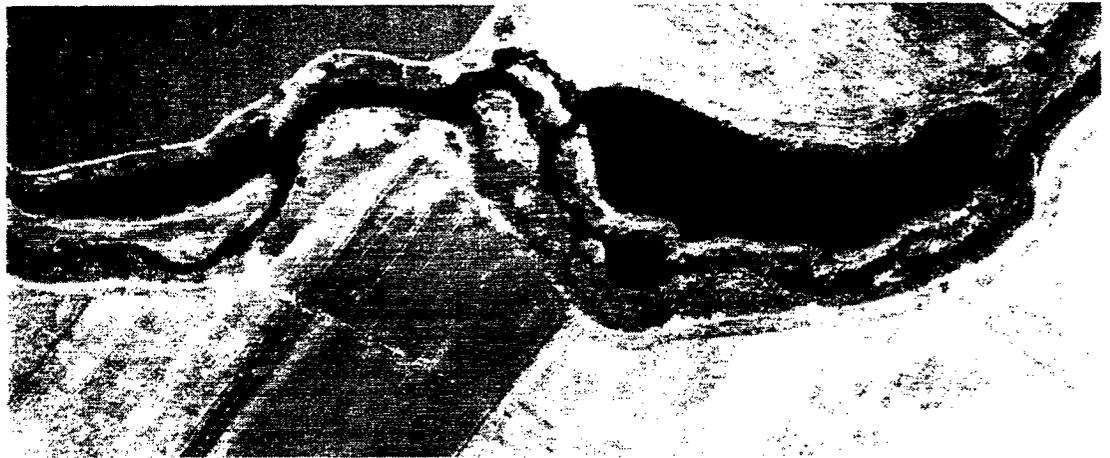
Figure 36. Aerial view and cross section of a captured terrace pit (table 19, mine number 23). Note the 3.5-m increase in depth and three-fold increase in channel width caused by the pit capture. (photo: U.S. Bureau of Reclamation)
