SAN LUIS NATIONAL WILDLIFE REFUGE
LOS BANOS, CALIFORNIA

ANNUAL NARRATIVE REPORT
Calendar Year 1989

U.S. Department of the Interior
Fish and Wildlife Service
NATIONAL WILDLIFE REFUGE SYSTEM

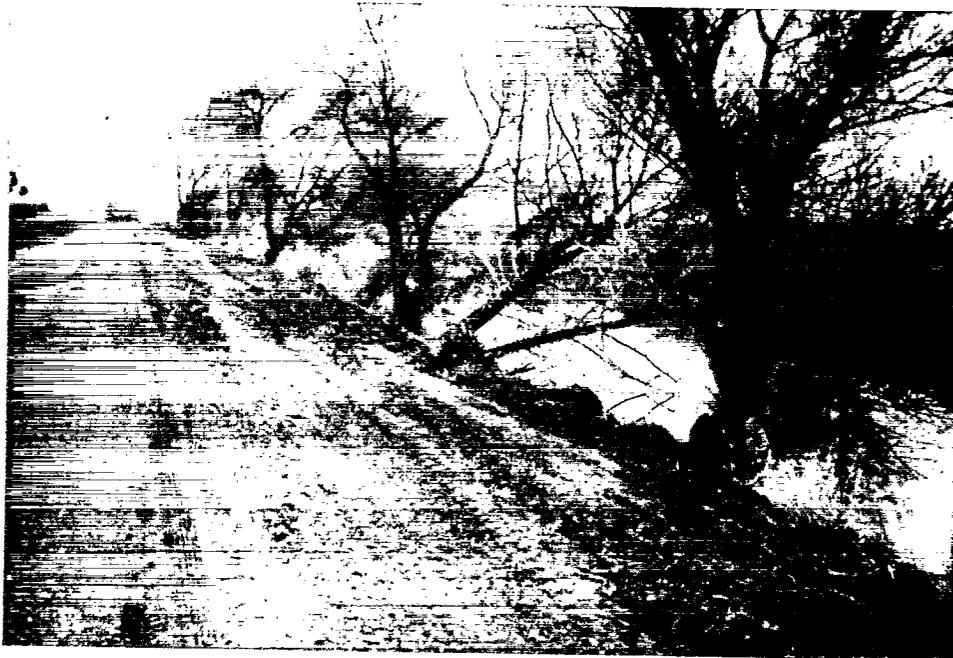
Trimmed trees and underbrush enabled San Joaquin inspection and maintenance. View looking south along C Canal towards south boundary. 2/89 RAB

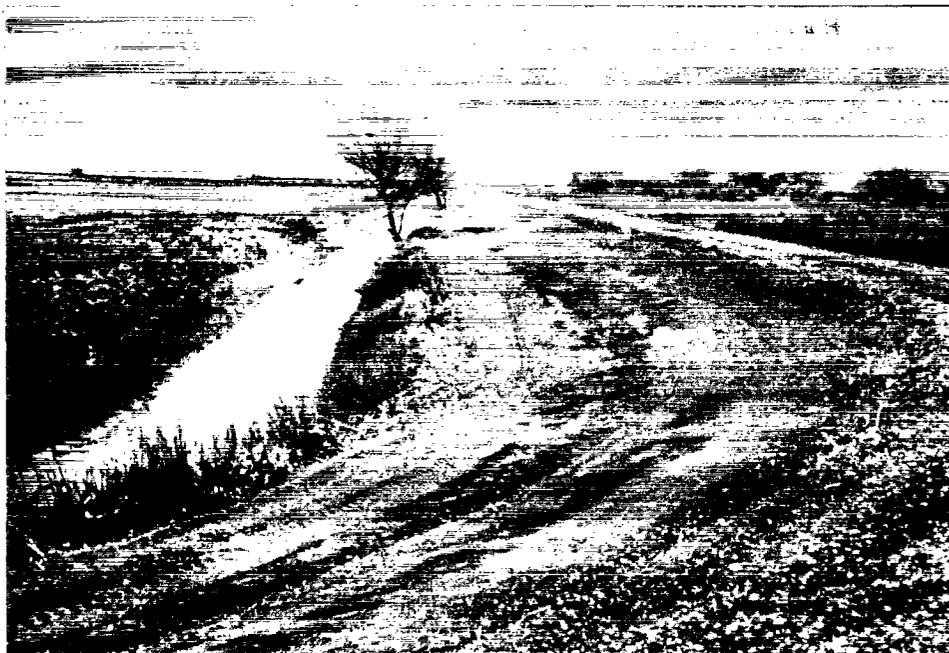
San Joaquin levee at East Marsh graded for weed and rodent control. 3/89 RAB

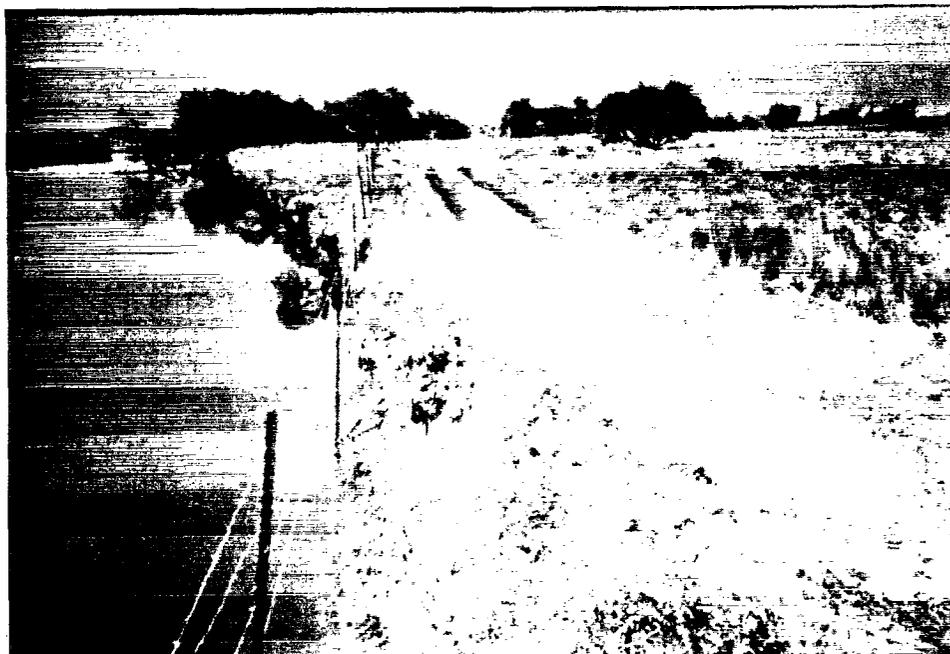
Erosion along Salt Slough leaves fence high and dry. Note proximity of road to eroded bank. 9/89 RAB

Several wildfires have been associated with refuge fishermen (see Section F.9). Lack of gravelled parking lots and deteriorated access roads with tall vegetation add to the fire danger and detract from the fishing experience. Refuge personnel gravelled a low water crossing on the access road north of the Elk Pasture in 1988. However, further erosion of the east bank of Salt Slough has endangered the integrity of the access road in several places. There are sections of barbed wire fence along Salt Slough that have been lost or made ineffective due to increased erosion and loss of the slough bank.

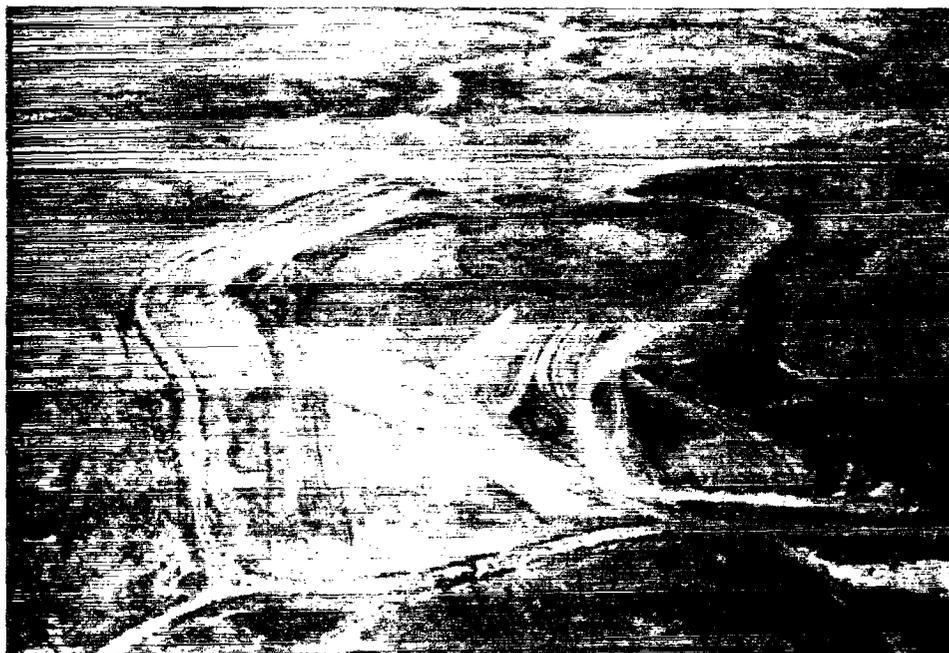
Moffit 4N - borrow sites created new wetlands. (Aerial
view looking south to north). 8/89 DJS

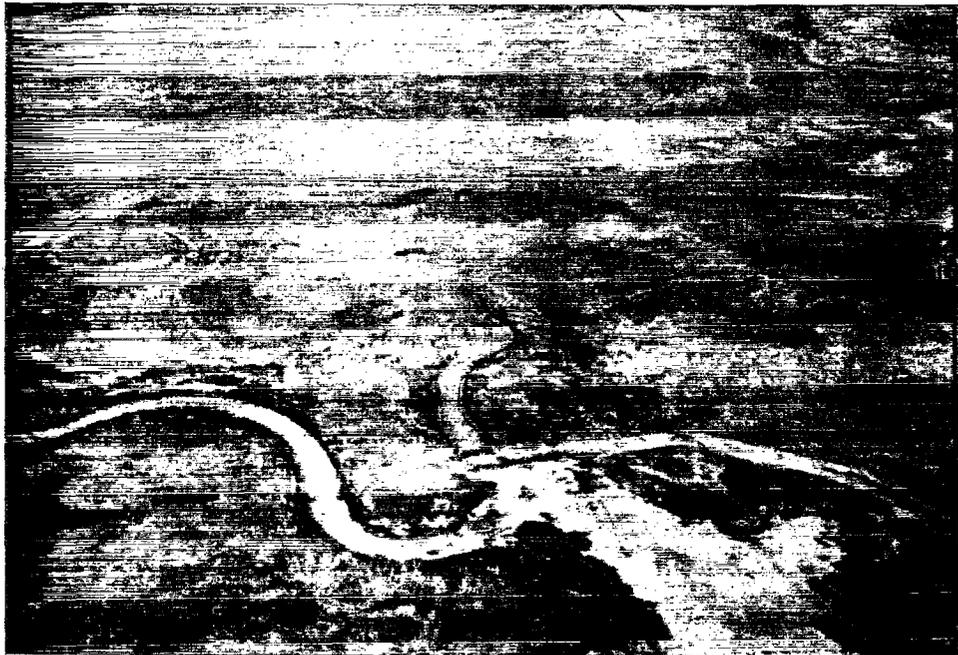
Aerial view south to north of Moffit 3N borrow site
for A and C Canal project. 8/89 DJS

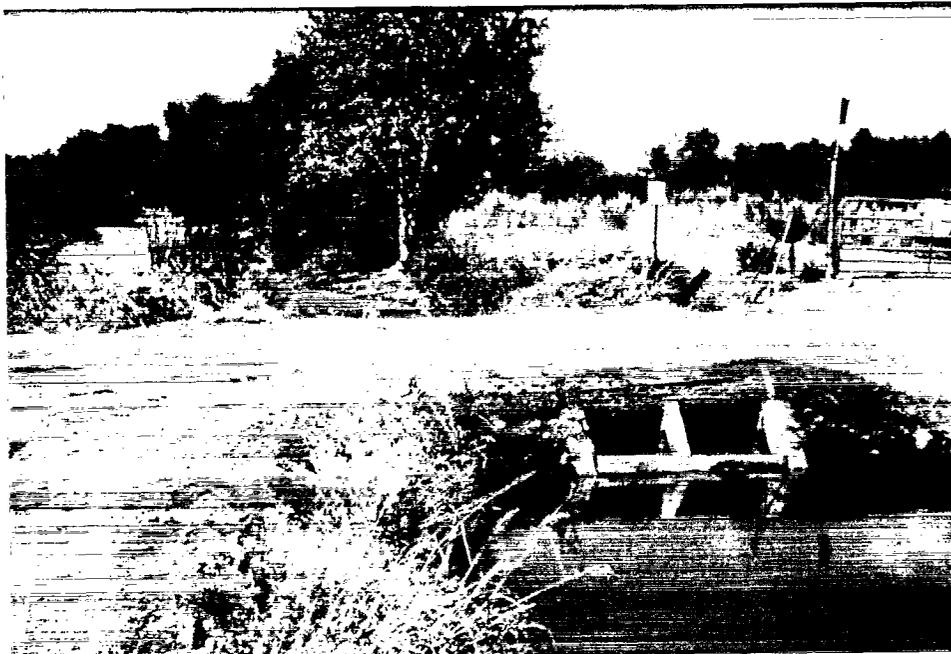
Old C Canal inlet structure at refuge boundary prior to replacement. 8/85 GRZ

SLCC personnel installed double metal gates on each side of the new boundary line weir (C Canal) and spread gravel for all-weather access. As per previous agreement, SLCC personnel re-gravelled and re-graded portions of the tour route from the refuge entrance to the terminus of the Island C Canal.

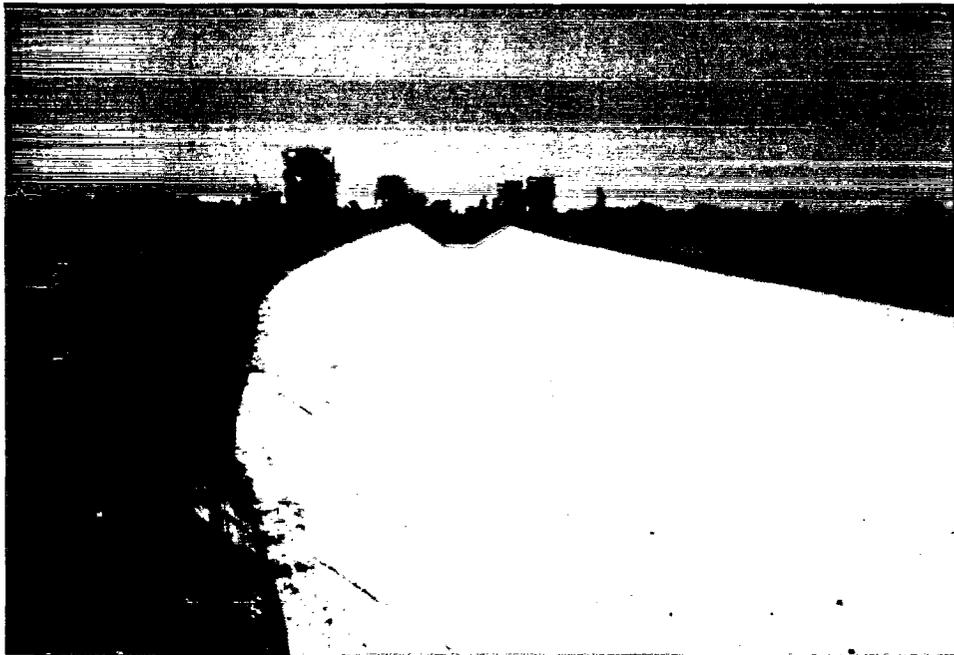
Finished section of concrete lining on C Canal. Note edge is about 3" thick. 3/89 RAB

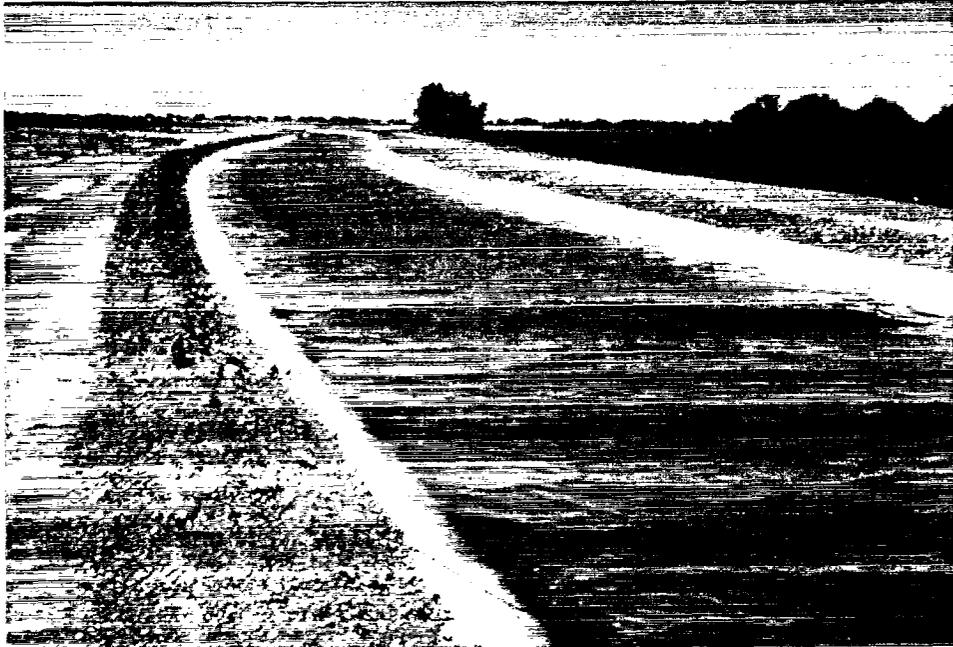
Refuge water delivery via new concrete lined C Canal.
7/89 GRZ

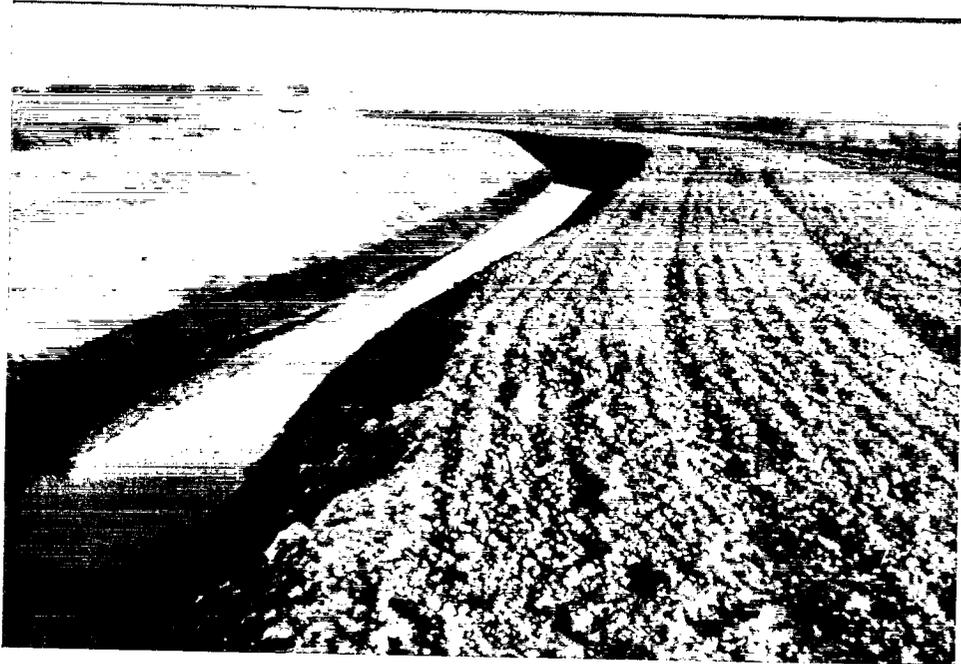
Interceptor canal/riparian corridor constructed by the San Luis Canal Company in the South Strip unit. "Take Pride in America" project. 1/90 GRZ

In an attempt to perform an activity which would qualify for the "Take Price in America" campaign, the San Luis Canal Company used their excavator to dig a meandering 3,700 ft. long by 6 ft. deep interceptor canal within the southern portion of the South Strip, an ex-agricultural unit. This canal, which was designed by Refuge Manager Zahm and Primary Assistant Houk, has 7 inset ponds with gradually sloping banks on the northern side of the canal. These small ponds will hold water, thus elevating the water table for a variety of native trees and shrubs which will ultimately be planted on the sloping banks. Emergent vegetation (essentially cattails and bulrush) will be allowed to flourish in the canal proper. This canal, set up on an east to west gradient, will capture ground water and canal seepage which currently impacts crop production within the adjacent Bowles Corporation farm land. This water will ultimately be re-utilized within other portions of the refuge. This project will serve as an outstanding example of government and private sector cooperation which will result in a total win-win situation for both parties.

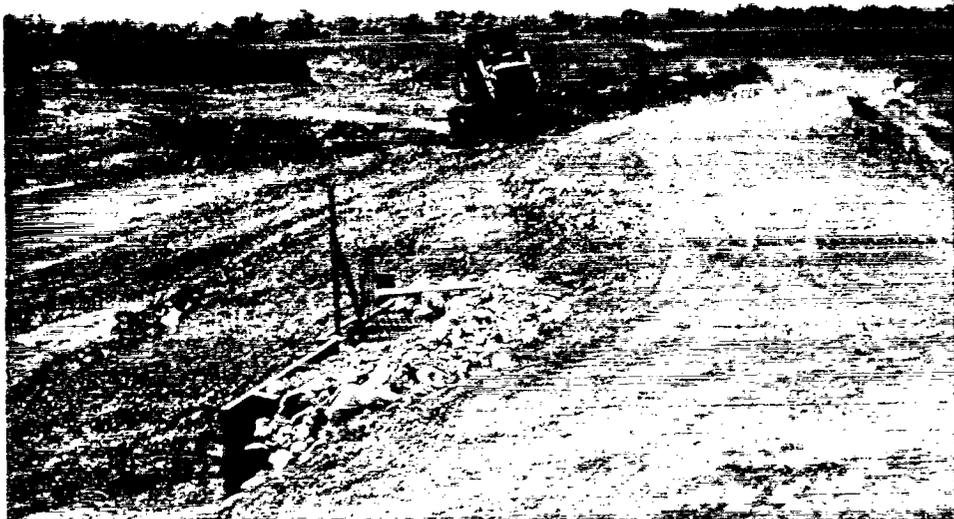
Shearer cleaning channel near new outlet structure in West Teal unit. 5/89 RAB
