**ASSESSMENT OF THE  
FISH PASSAGE FACILITIES  
AT  
LAKE LODI IN THE MOKELUMNE RIVER**

**September 1992**

**David A. Vogel  
Senior Biologist  
Vogel Environmental Services  
21600 Wilcox Road  
Red Bluff, California 96080**

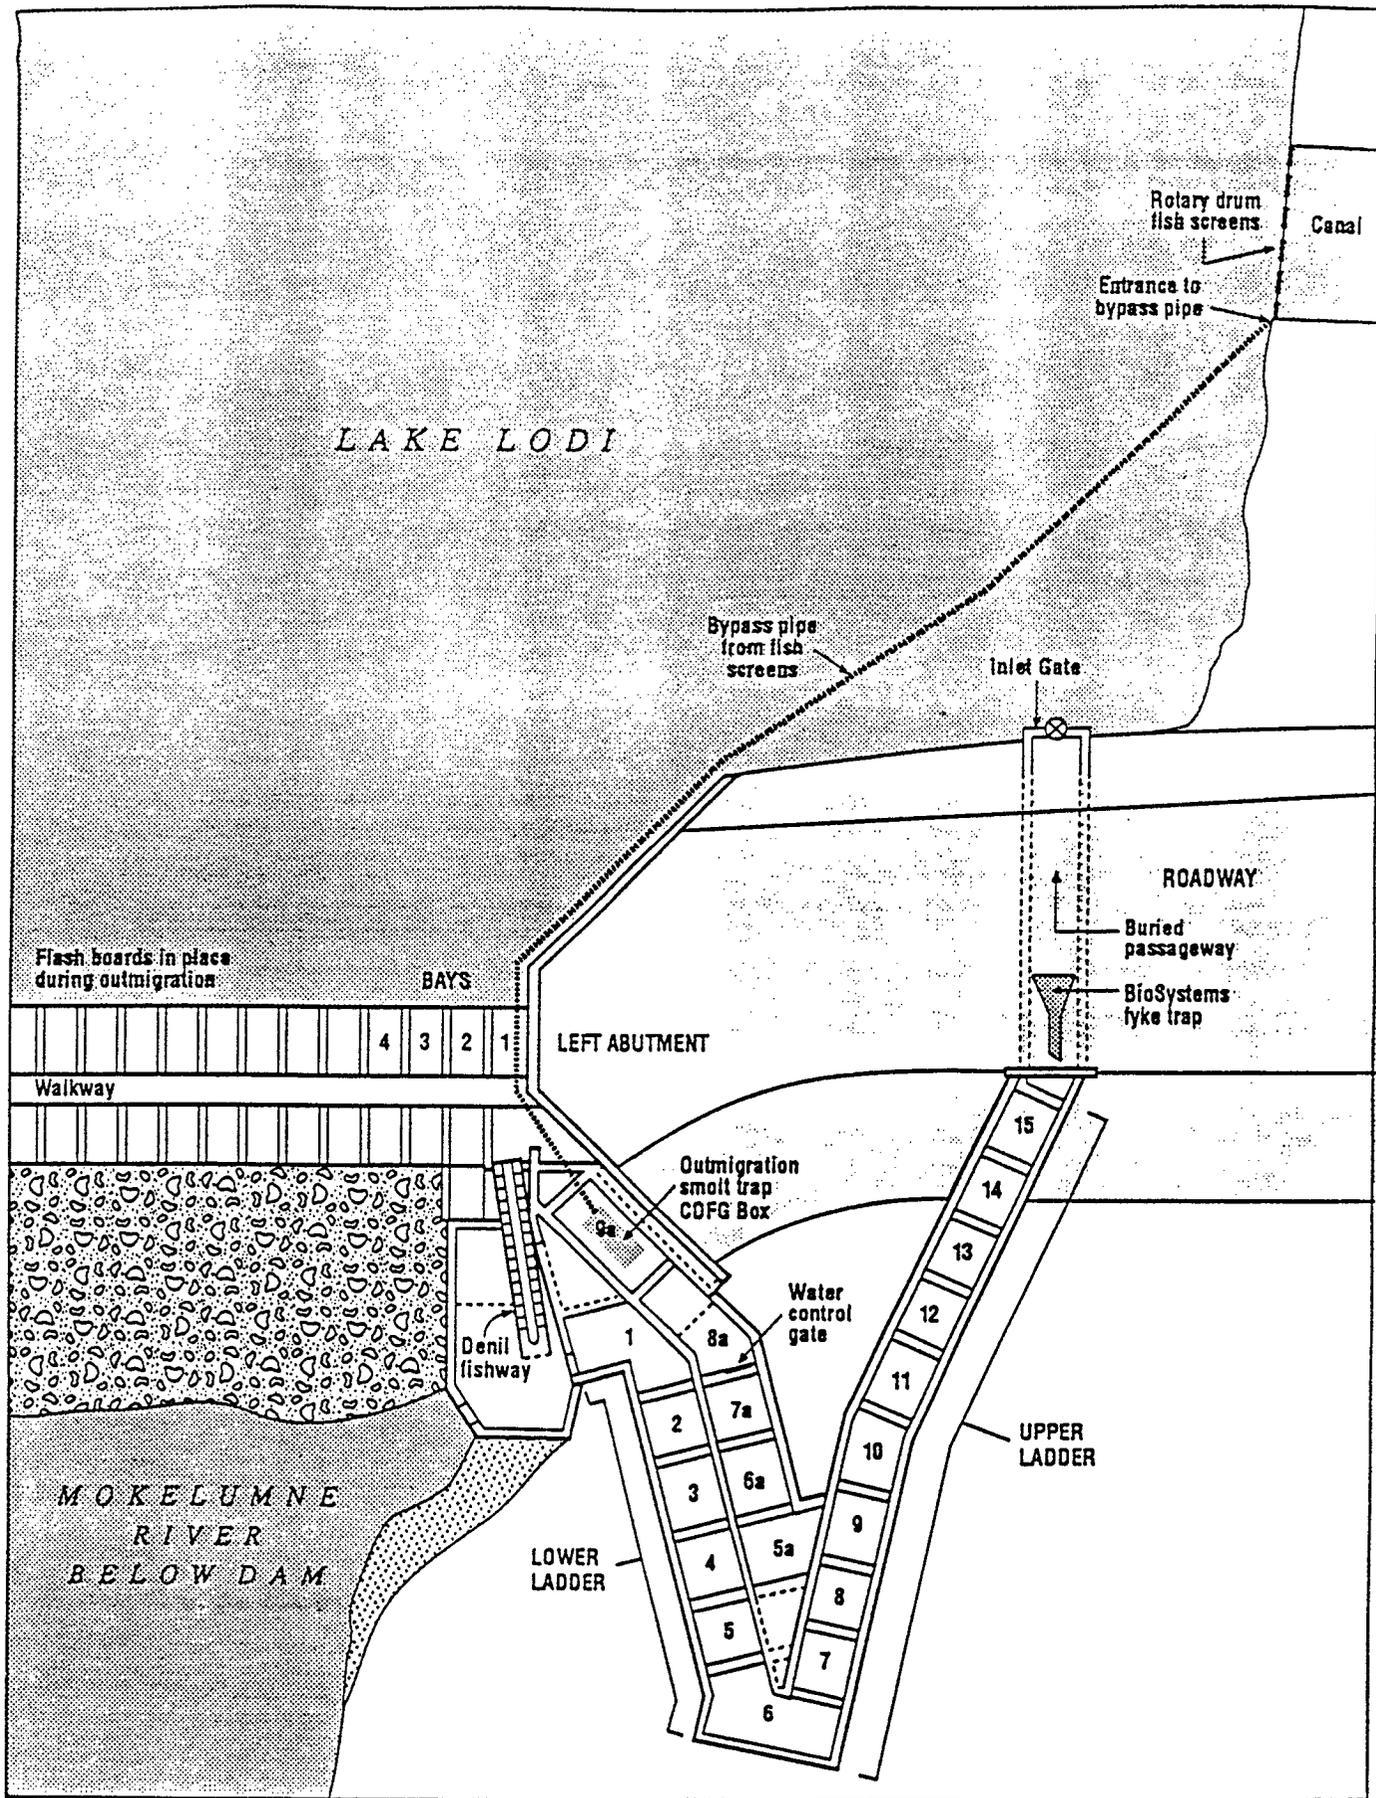
Figure 4. Plan view of Woodbridge Dam showing fish ladders, smolt outmigration traps: CDFG box and BioSystems fyke trap.

"The pool-and-weir fishway is located near the left abutment. The upper pool-and-weir fishway consists of 16 pools and 16 weirs (pools 1 through 15) beginning at an entrance pool and ending with a conduit through the left earth-fill abutment and is used when the dam is at the high flashboard level (Figure 4). Auxiliary flow can be added to the first and/or fourth pools by a series of pools (9A through 5A) beginning at the first bay near the left abutment. During the low flashboard level condition, the lower pool-and-weir fishway, pools 1 through 4 and 5A through 9A, can be used in conjunction with the Denil fishway. Typical fishway pool dimensions are 10 ft in width and 9 ft in length. Two of the pools (pools 1 and 6) are turn pools with larger dimensions. The weirs are 4 ft wide and are located along the left edge of the fishway. The conduit through the earth-fill abutment is a 7-ft wide by 9-ft high tunnel with a gated entrance extending into the lake to control flow into the fishway."

"Additional water can be added to fishway Pool 4 as an attraction flow in the lower portion of the fishway. This additional water flows over weirs already full with water from the upper portion of the ladder. While the addition of auxiliary water is necessary for attraction into the ladder, Pool 4 is not the ideal location. Additional water produces additional turbulence in the downstream pools creating the potential for disorientation. A better location to add attraction water is in fishway Pool 1 where the added flow will not affect flow conditions in the lower ladder. This would create uniform flow conditions throughout the fishway and reduce the amount of disorientation and delay during passage."

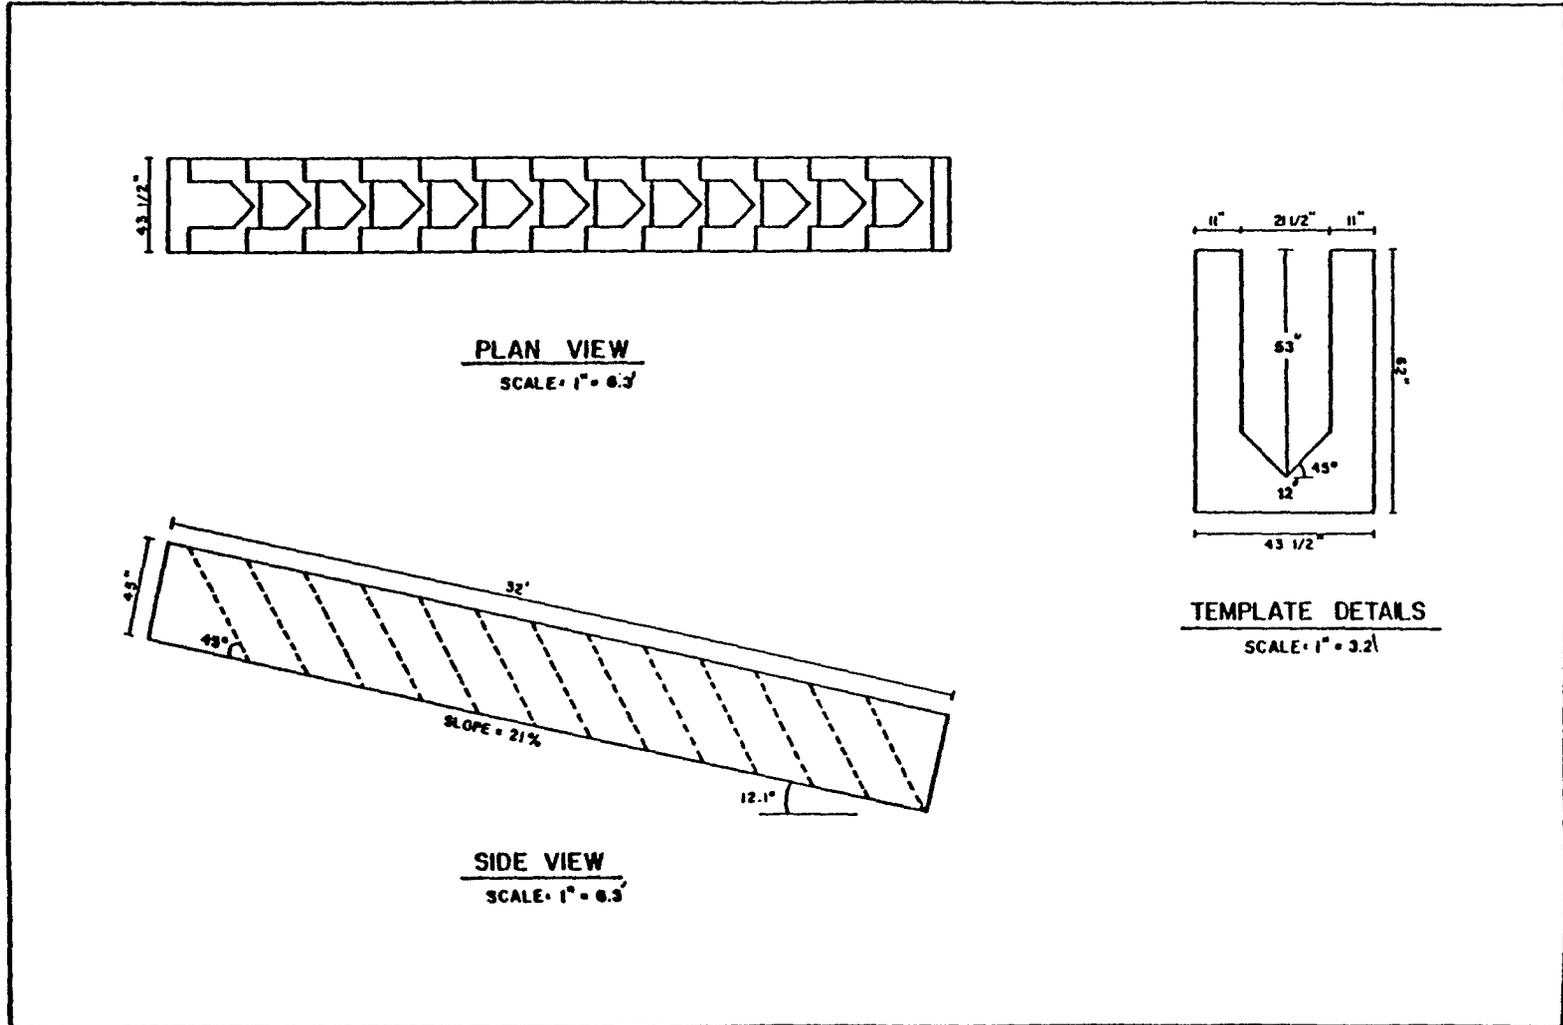
Figure 5. Denil fishway details, Woodbridge Dam, lower Mokelumne River, California (from CDFG, 1991).

"The Denil fishway at Woodbridge Dam is constructed from angle iron and plywood to form the chute with the roughness template inserts built from 2 x 12-in lumber (Figure 5). Inside the plywood sidewalls, the fishway is 43.5 in wide. With the templates extending from each sidewall 11 in, the space down the center of the fishway is 21.5 in wide. The templates are spaced 38 in apart and are installed at a 45° angle with the floor. The fishway is 32 ft long and sits at a 11% slope."

The existing Denil fishway on Woodbridge Dam was reported by CDFG (1991) as having a slope of 11 percent. However, measurements taken from design drawings for the fishway indicated the slope was approximately 23 percent. A figure of the fishway included in CDFG (1991) showed the Denil fishway at a 21 percent slope (Figure 5). It was therefore assumed that the 11 percent value was a typographical error in the CDFG (1991) report. Assuming the existing Denil fishway is placed at either a 21 or 23 percent slope, it is steeper than that reported in the literature for other fish passage facilities and could impair fishway effectiveness. The maximum suggested length for this type of fishway at a 20 percent slope is 30 feet (Powers et al., 1985). The Woodbridge Dam Denil is slightly steeper and longer than these values. In reporting on several Denil fishways used at Cowan, Saskatchewan and Fairford, Manitoba, Canada, Katopodis (1990) stated that the longest Denil fishway section negotiated by fish was 9.5 m at a 12.6 percent slope. Recent fishways installed at Freeport, Ontario had the following design characteristics: east bank fishway, 7.5 m long at 20 percent slope; west bank fishway, three segments each at 10 percent slope with resting pools between segments (Katopodis, 1990). Larinier (1990) reported that more than 100 Denil fishways have been recently installed in France (over a 12-year period), primarily for sea trout and salmon and are generally operated at slopes of between 15 percent to 20 percent.

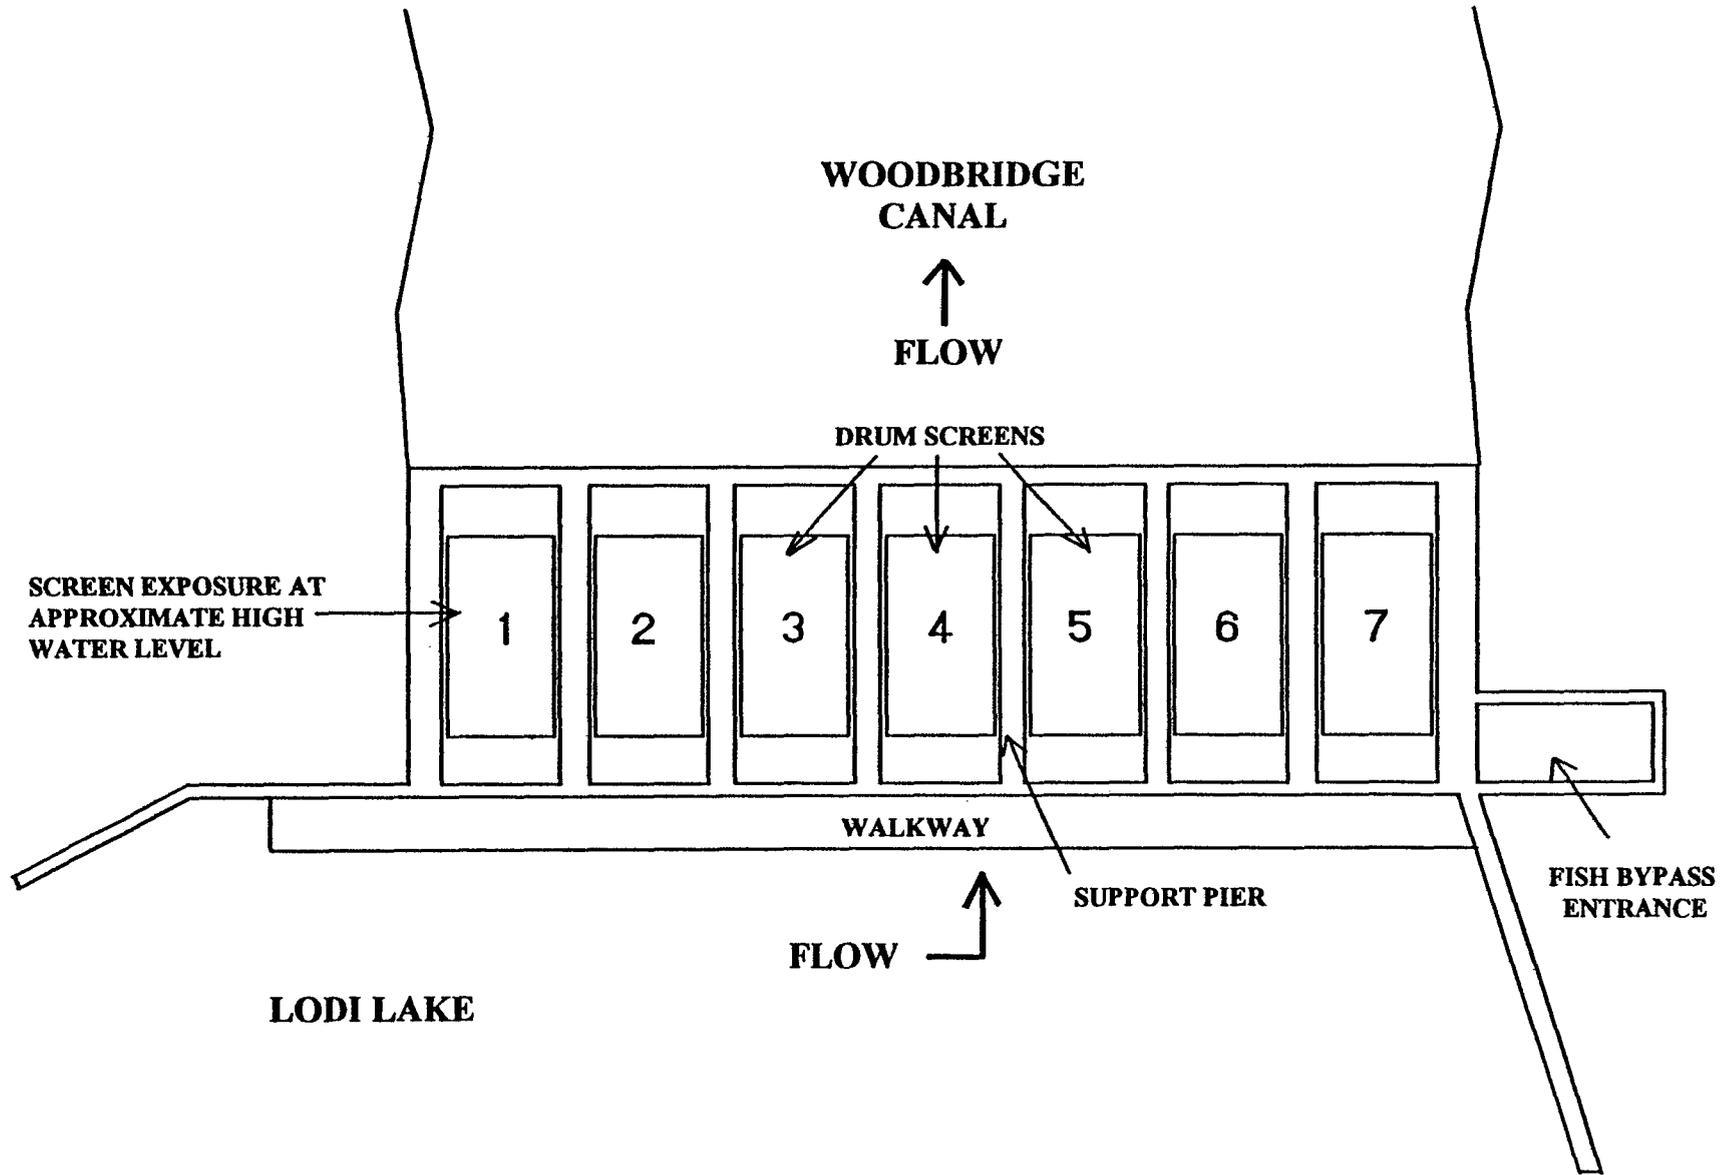
Figure 12. Plan view of the Woodbridge Irrigation District fish screens.

"The diversion was unscreened until 1968, when WID and DFG installed a screen facility on the canal. Currently, the Woodbridge Canal fish screen is operated and maintained by DFG and consists of 7 rotating drum screens (Figure 12). Irrigation water enters Woodbridge Canal from Lodi Lake as it flows through the screen facility. These screens prevent downstream migrating salmon from entering the canal. These screens are approximately 6.75 ft wide and 10 ft in diameter covered with rigid stainless steel woven wire cloth consisting of 4 meshes per in., 0.080 in. diameter wire, and square openings measuring 0.24 in. diagonally (0.17 in. square). The screens rotate in such a way that accumulated debris on the screen face is carried over the top and is washed off the downstream side. A juvenile chinook salmon and steelhead trout collection and

The entrance to the fish bypass system was inspected during the site visit on March 23, 1992 prior to the filling of Lake Lodi. The entrance is adjacent to the downstream-most fish screen (Figures 12, 13, and 19). Within the bypass, a large vertical trashrack was present. Mounted to the trashrack was a plywood board with a notch 6 ft high by 3 1/16 inches in width (Figures 21 and 22). The bottom of the rack was positioned on top of an additional piece of wood which resulted in the bottom of the notch being positioned 2 feet off the concrete floor (Figure 21). It appears that the plywood board was not an original feature of the fish bypass system and was simply lashed onto the vertical metal trashrack grates. This added feature in front of the bypass is unusual because it is a generally accepted practice to avoid such abrupt flow transitions and narrow entrances into a fish bypass system. Juvenile fish are extremely

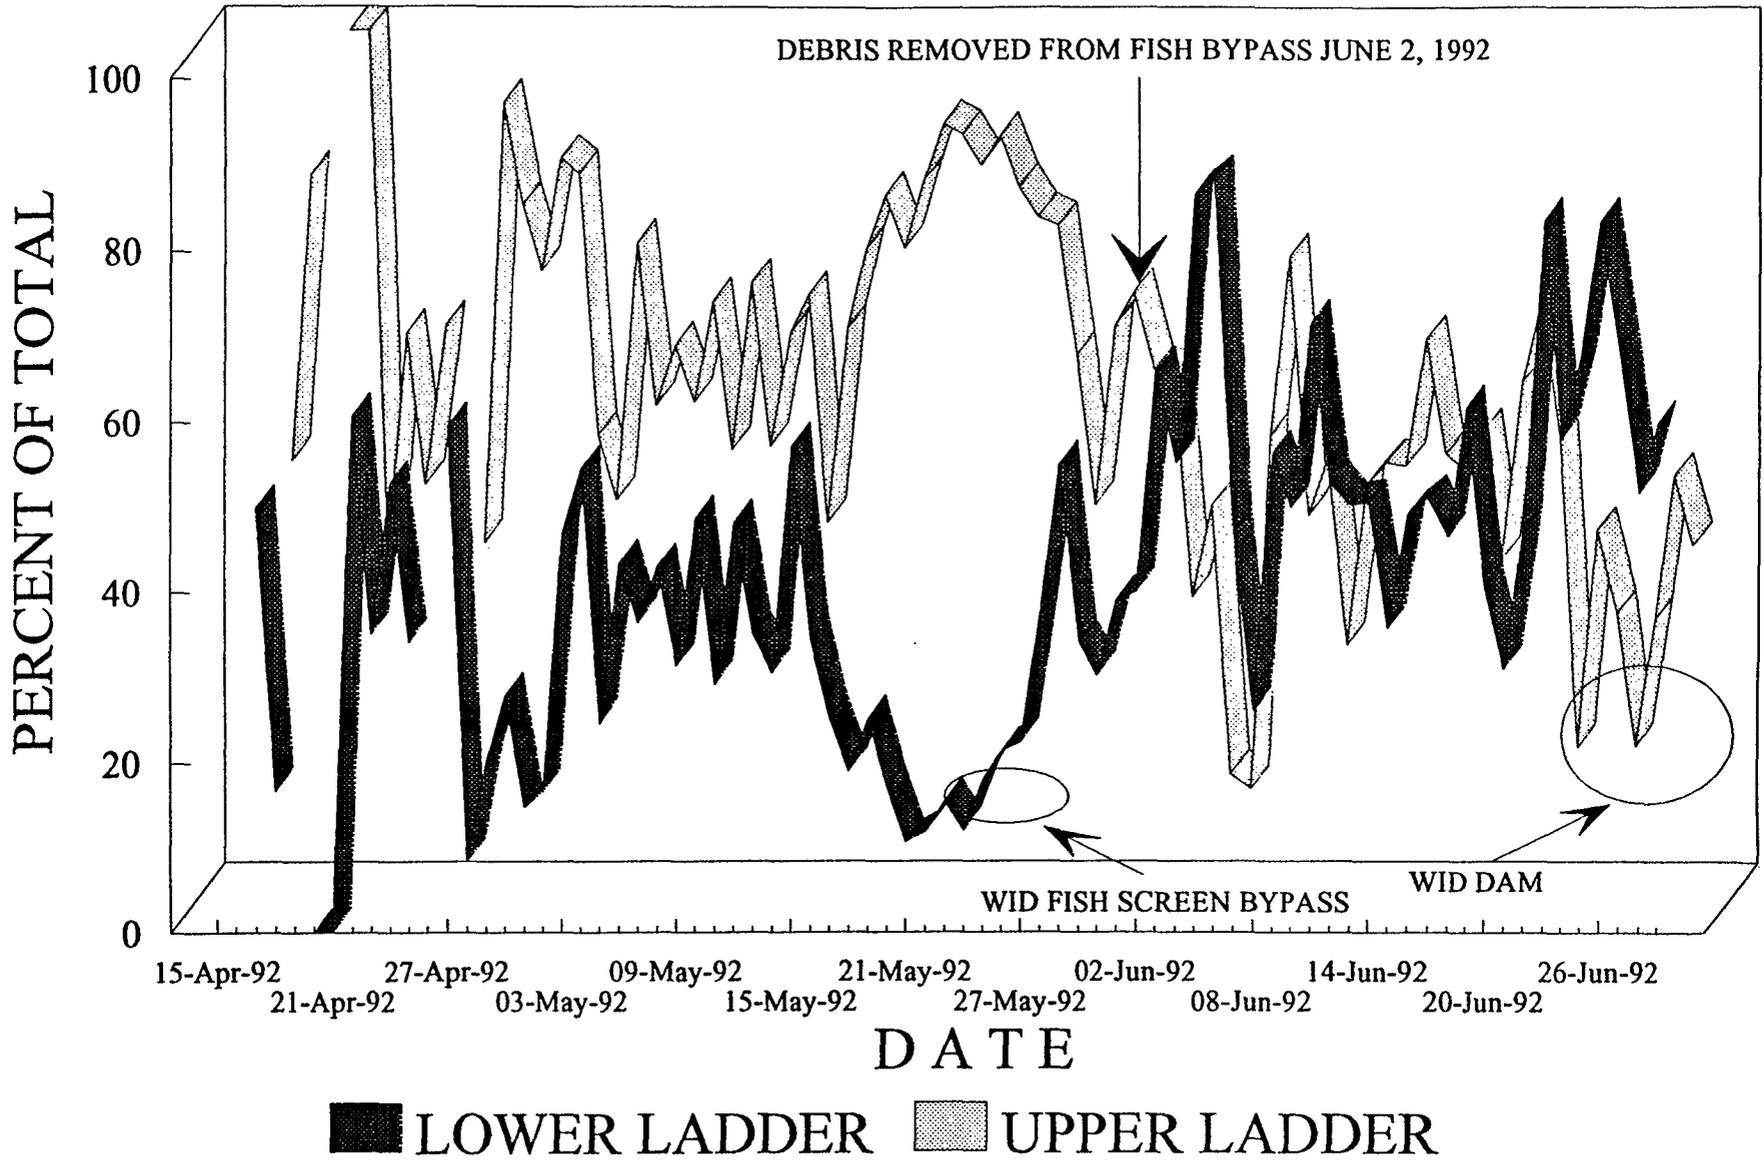
Trapping of downstream migrant salmon at Woodbridge Dam was conducted for EBMUD by BioSystems personnel prior to and following the removal of the large tree limb in the bypass entrance. The fish trapping is conducted at two locations at the dam which are shown in Figure 4. The lower ladder trap captures those fish passing through the WID fish screen bypass system and the upper ladder trap captures those fish entering the upper fish ladder at the dam. As can be seen from preliminary results from daily capture rates for each of the fish traps, the proportion of fish utilizing the WID fish screen bypass increased substantially following the removal of the riverine debris in front of the bypass entrance on June 2 (Figure 23), indicating that the debris likely adversely affected the performance of the bypass entrance. The fish bypass entrance has been inspected and cleaned on a continuous basis since June 2 (Anders Christensen, WID Manager, personal communication).

Figure 23. Proportion of downstream migrant salmon captured at Woodbridge Dam in the lower ladder (fish screen bypass) and the upper ladder, April 15 to June 26, 1992.
