PLANNING DIVISION
SACRAMENTO FLOOD CONTROL SYSTEM REEVALUATION
Initial Appraisal Report - Upper Sacramento Area

**US Army Corps
of Engineers**
Sacramento District
South Pacific Division

May 1995

Initial Appraisal Report - Upper Sacramento Area

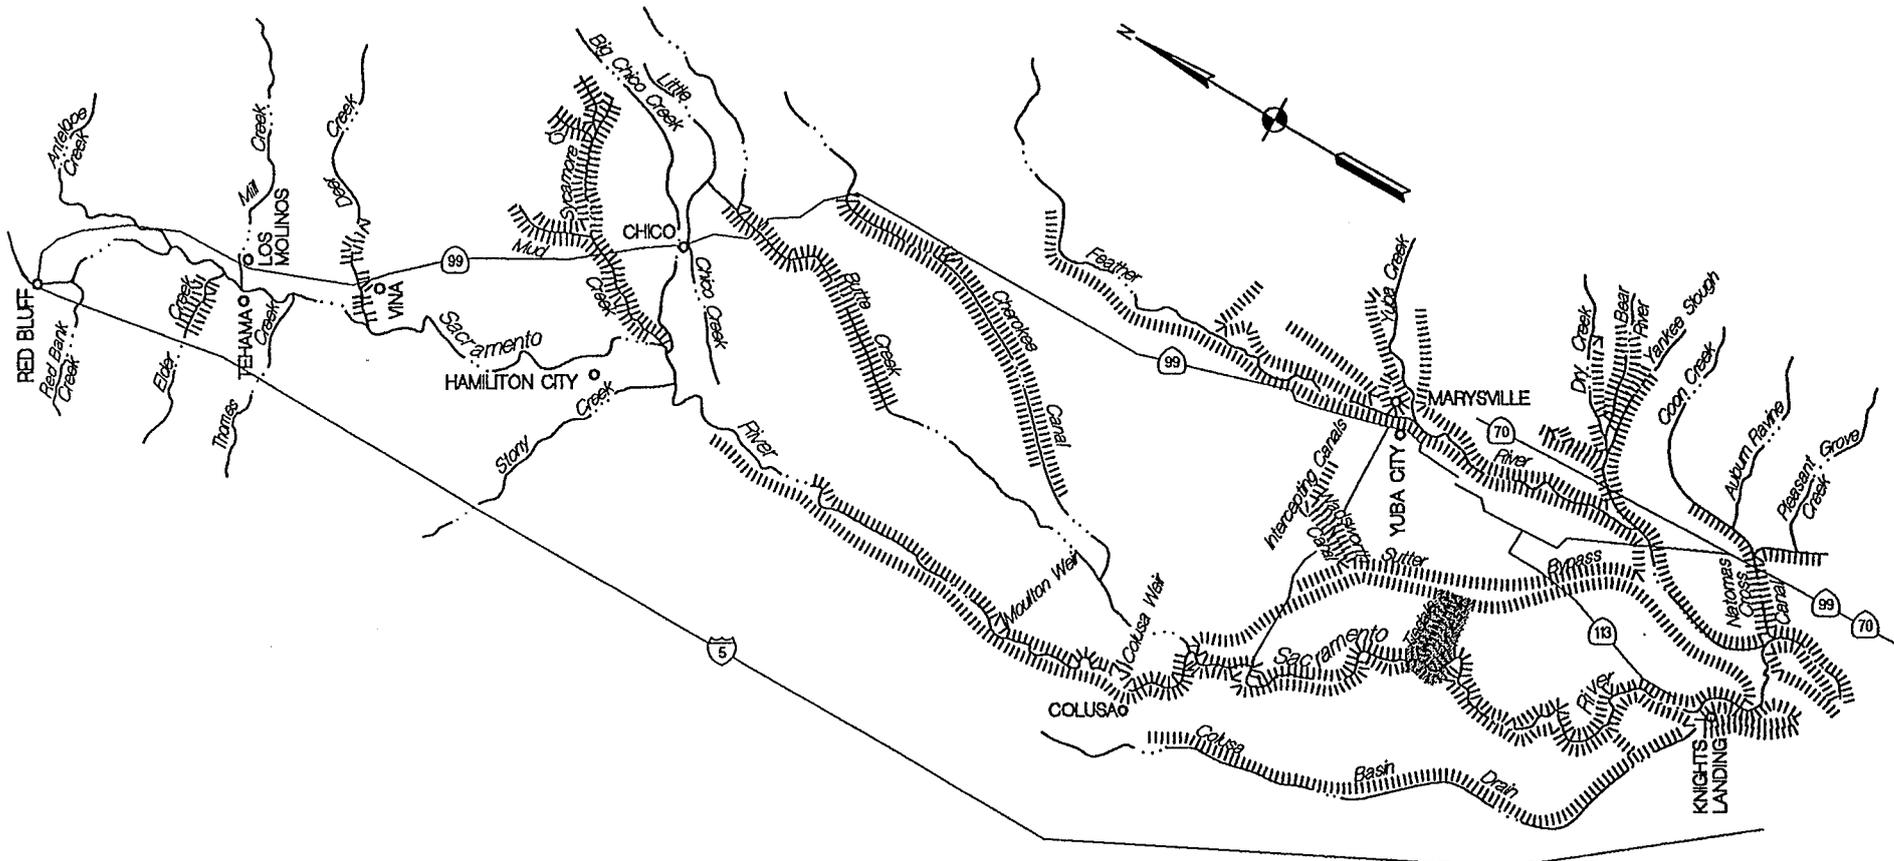
As indicated in the Hydrology Section, the design flow could be conveyed within the design water surface in most of the Sacramento River and tributaries and bypasses in the Phase V study area on the basis of available information from the February 1986 flood. Since the February 1986 flood, significant physical changes have taken place in the Sacramento River Flood Control Project.

Figure 34 shows the reaches that could not convey the design water surface in February 1986. As previously discussed in the "Sacramento River Flood Control System

(3) Implementation of maintenance measures by The Reclamation Board to eliminate or compensate for the local areas with design flow deficiencies (see Figure 34). Under the above assumptions and using guidance contained in ER 1105-2-100, with-project-condition levels of flood protection were based on the ability of the project to pass floods greater than the design levels. Benefits were claimed for the area under the frequency-damage curve between the design level of flood protection and the nondamaging level of flood protection.

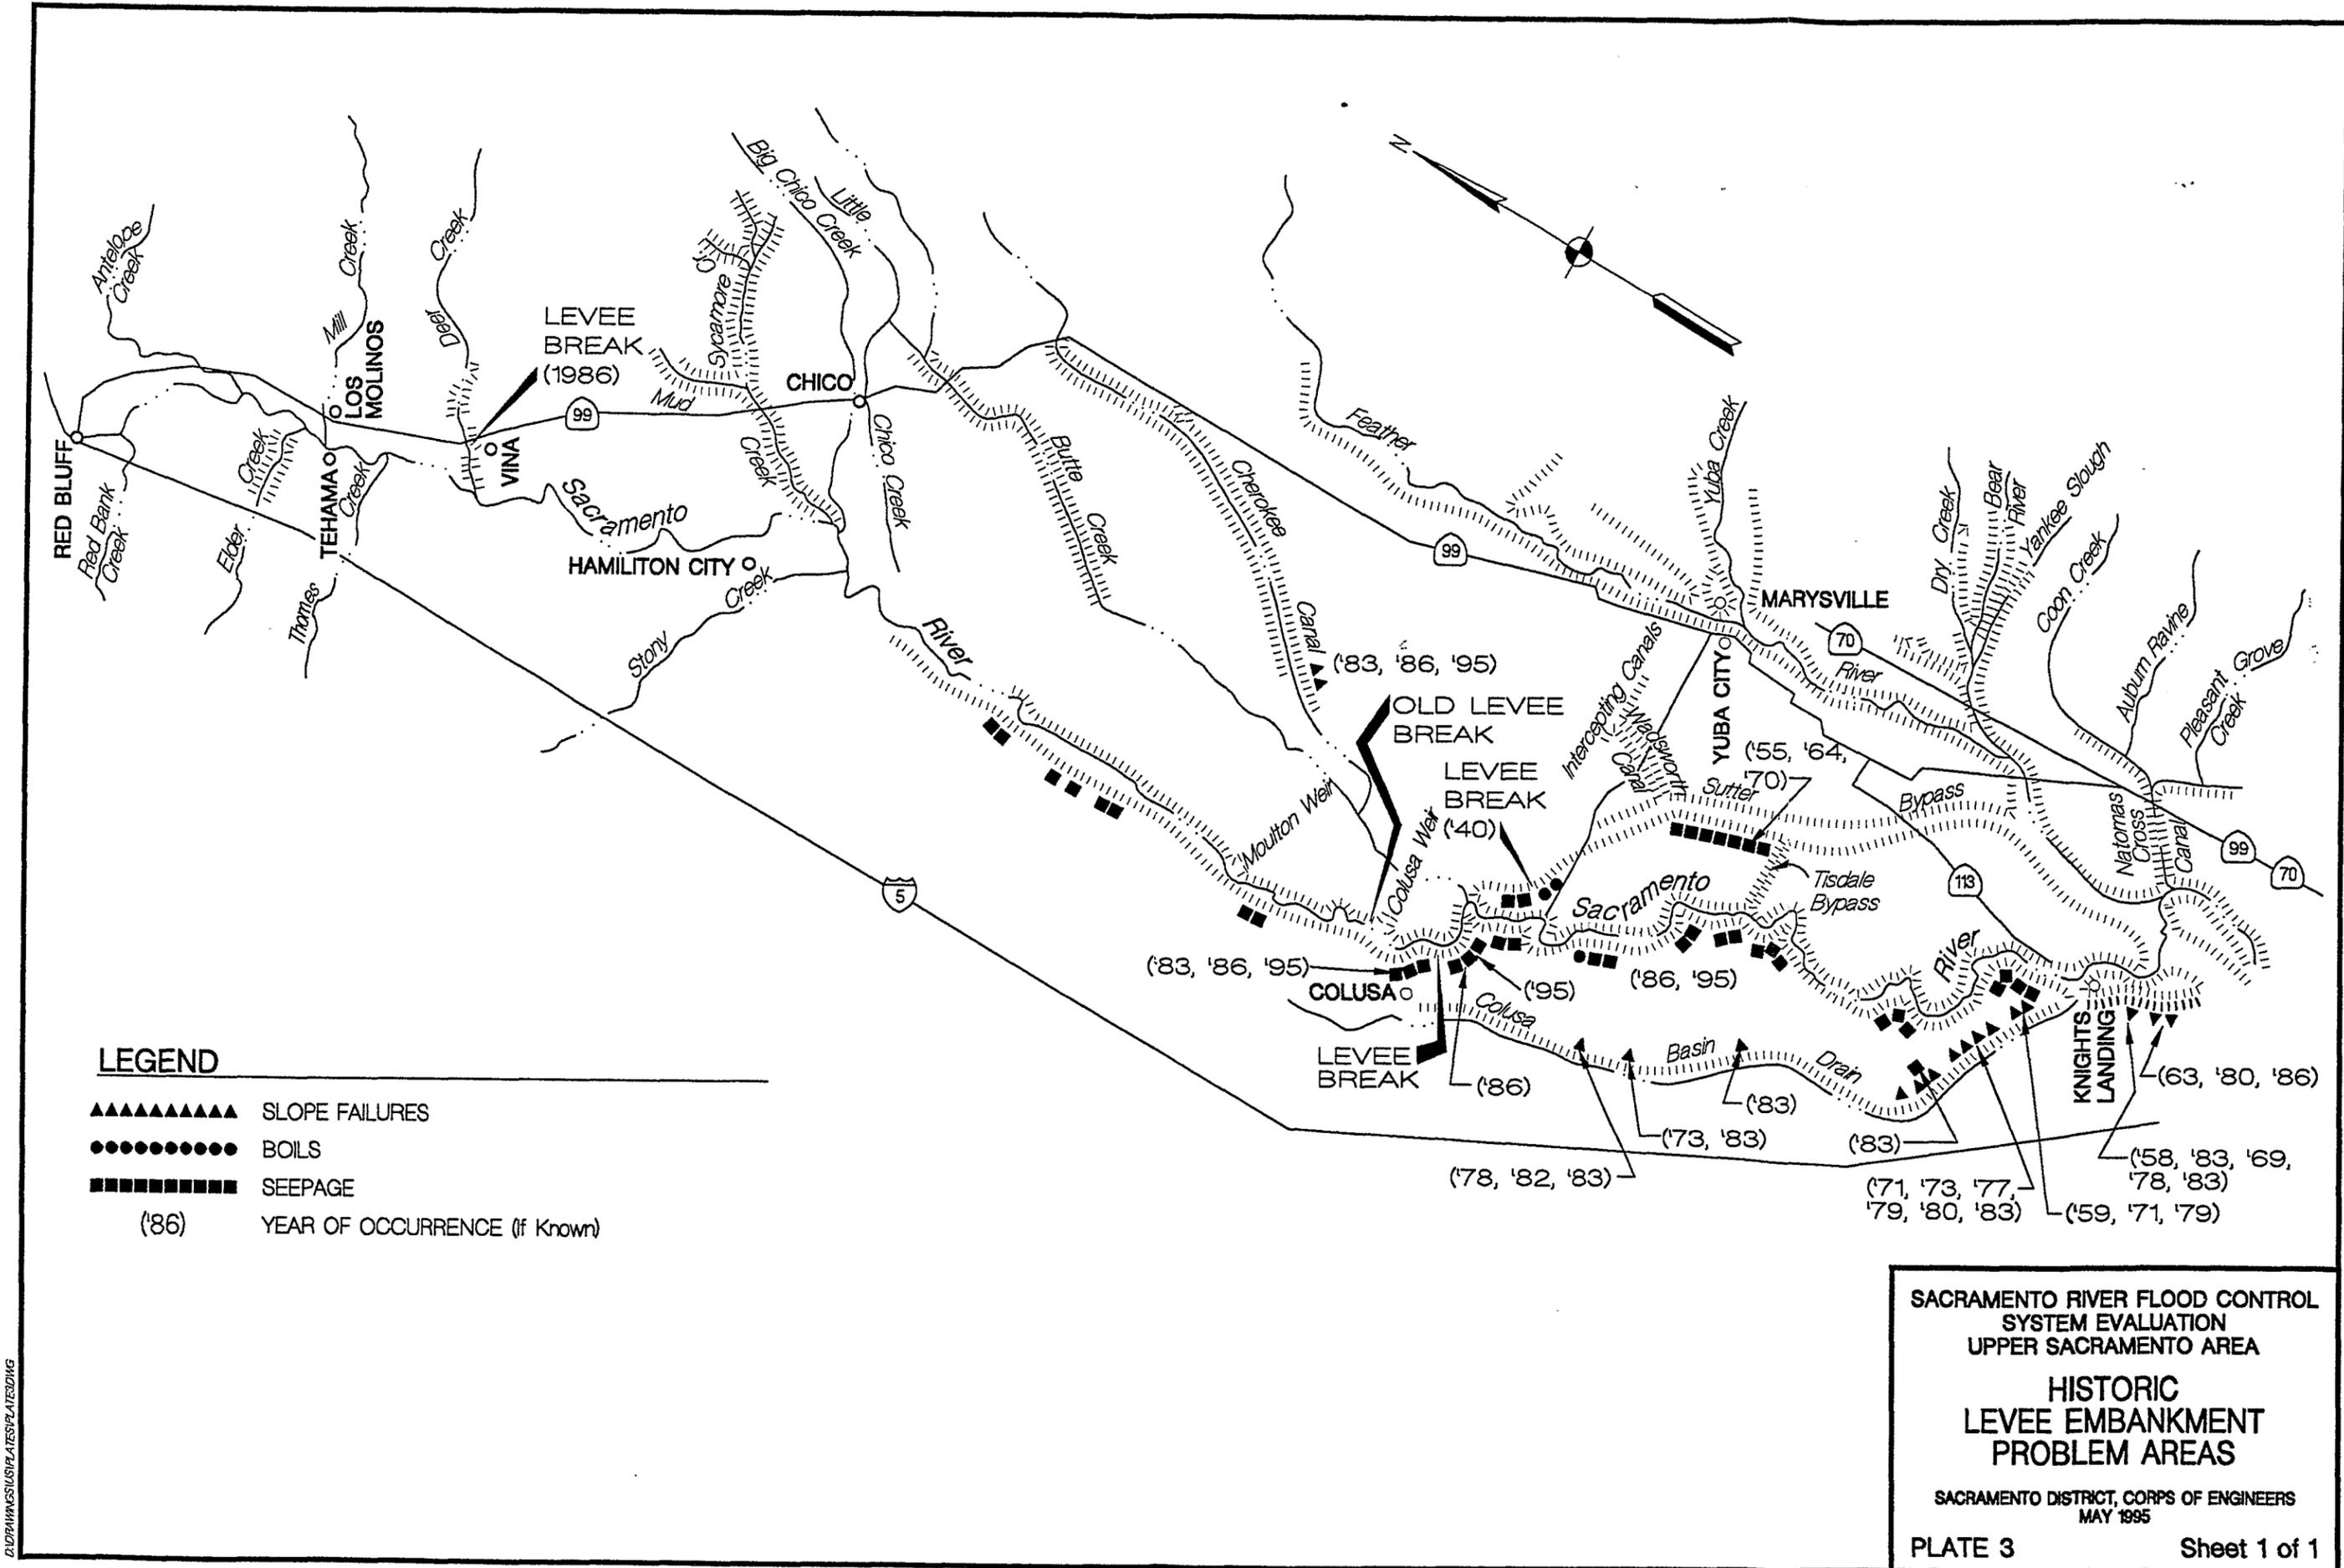
PLATE 4 Sheet 1 of 1

Bypass and caused severe seepage problems on the western levee near Robbins; a flood fight was needed to prevent potential disaster. High water came within 1 foot of the levee crown at Sacramento River mile 102.0 right (Site C in this study, see Figure 1 and Plate 4)

- ▲▲▲▲▲▲▲▲ SLOPE FAILURES
- BOILS
- ■ ■ ■ ■ ■ ■ ■ SEEPAGE
- (86) YEAR OF OCCURRENCE (if Known)

Specifically, Phase V construction would consist of levee reconstruction at five sites—three along the Sacramento River from Knights Landing (river mile 90) to Colusa (river mile 143) and two along the Colusa Basin Drain just west of Knights Landing (see Plate 4 for site locations). The design methods proposed at each site depend on the soil conditions, structure of the existing levee, and the type and extent of repairs required. Specific design methods proposed for each site are described below.

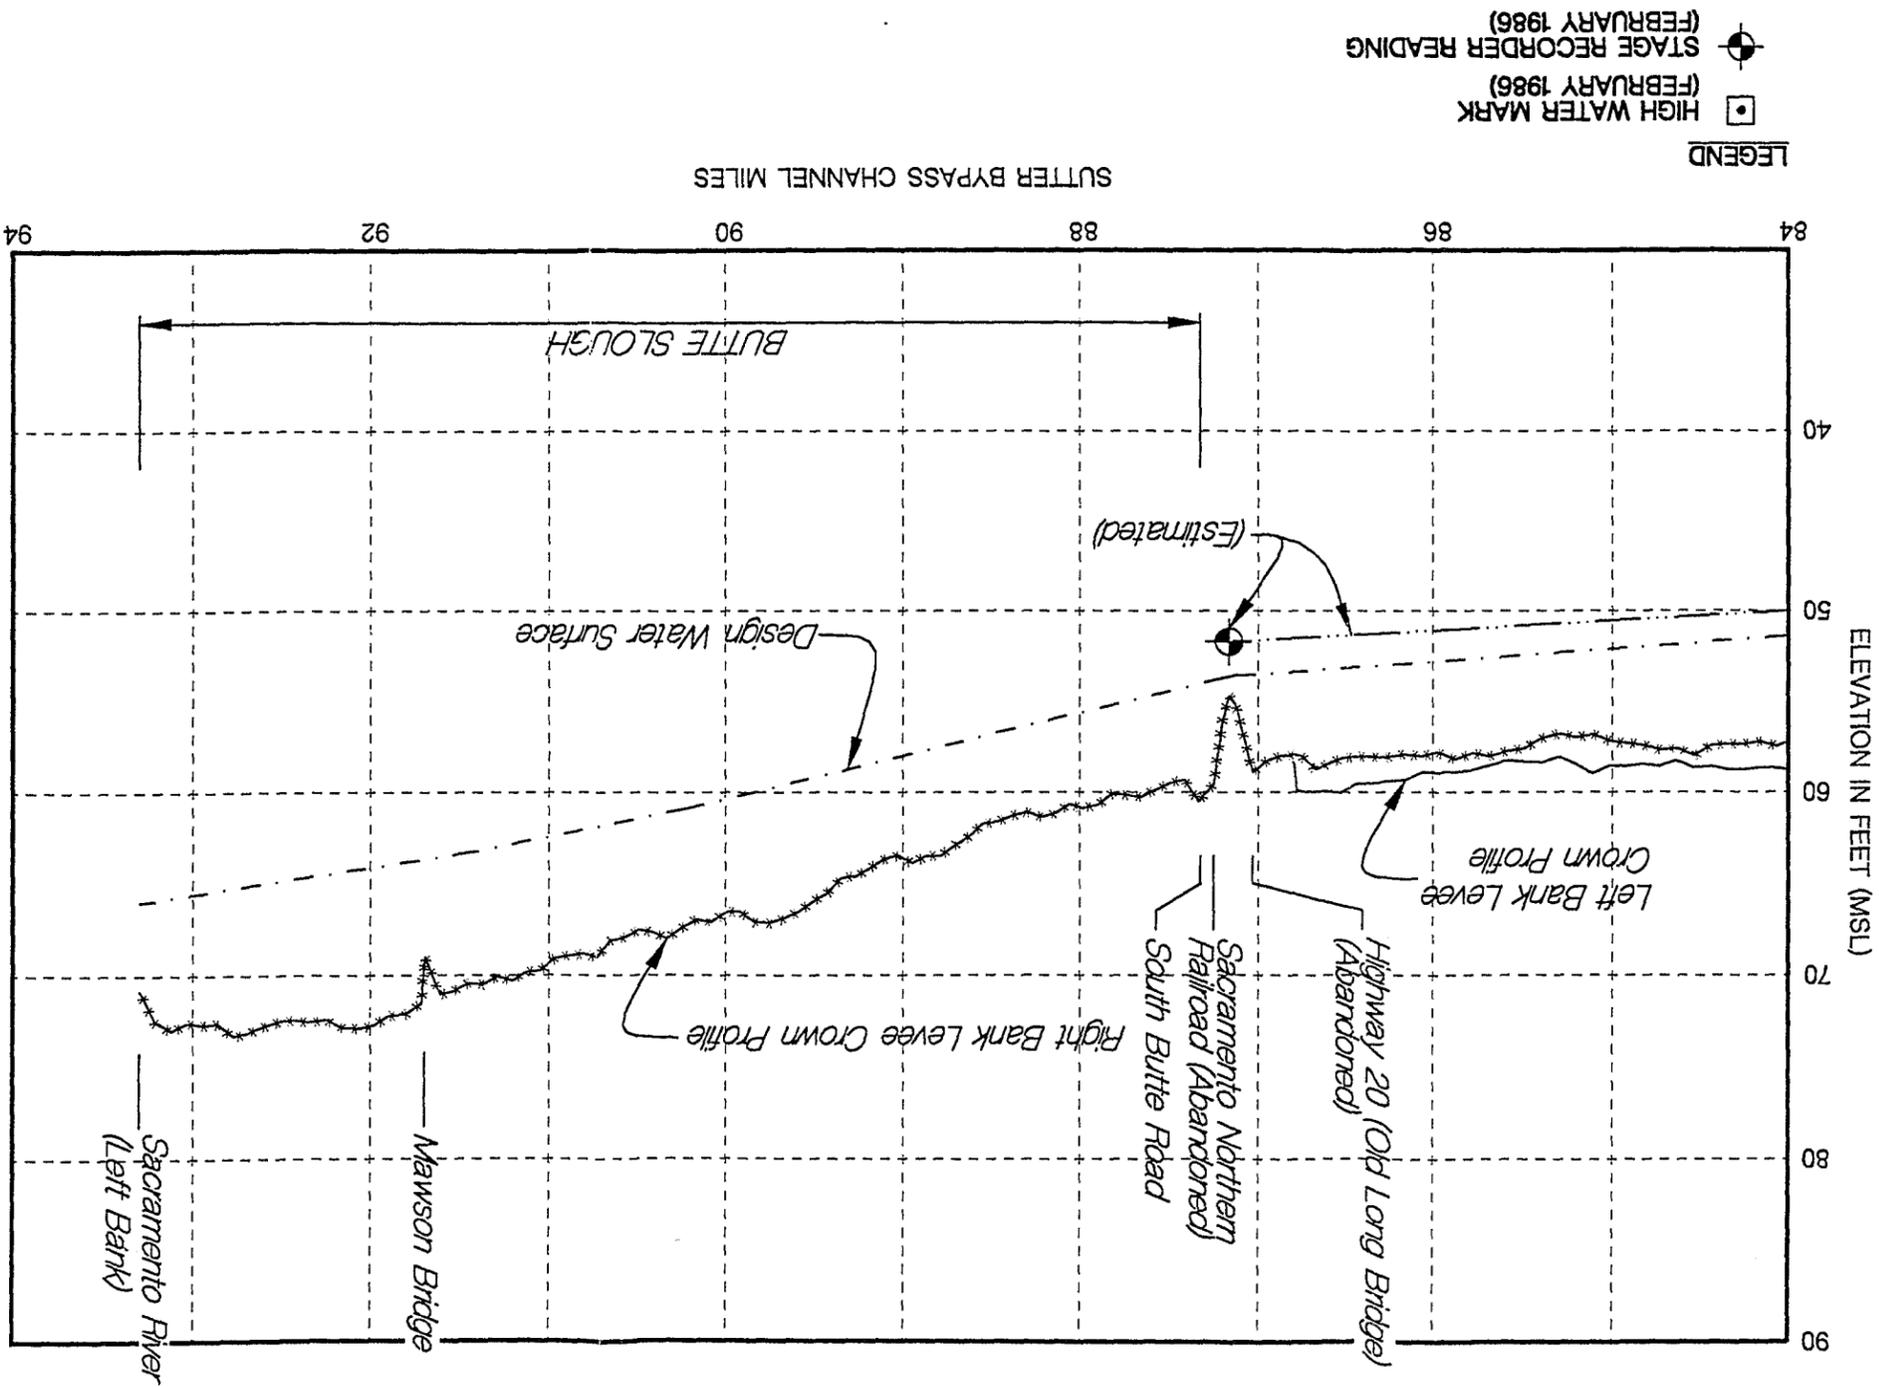
SACRAMENTO RIVER FLOOD CONTROL
 SYSTEM EVALUATION
 UPPER SACRAMENTO AREA
 LEVEE CROWN & DESIGN
 WATER SURFACE PROFILES
 SUTTER BYPASS
 SACRAMENTO DISTRICT, CORPS OF ENGINEERS
 MAY 1995
 PLATE 12
 Sheet 1 of 2

The Sutter Bypass in the study area had high-water marks about 1 foot to 2 feet (Plate 12, sheets 1 and 2) below the design water surface in the study area, with flows of 154,000 cfs at an elevation of 51.7 msl to flows of 178,000 cfs at State Pumping Plant No. 2 (Figures 17 and 18).
