San Francisco Bay Shoreline Study

Suisun Marsh Levee Evaluation

SUBJECT: Suisun Marsh Levee Evaluation

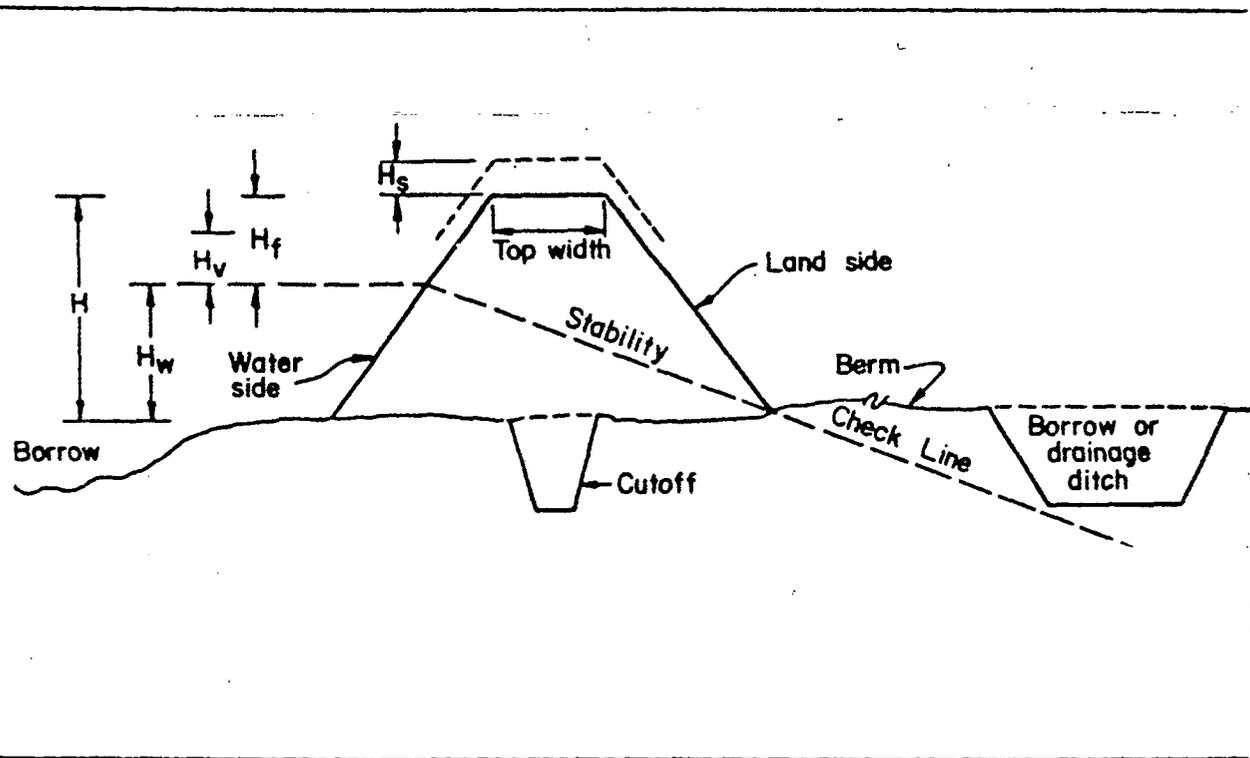
FIGURE 2-2
TYPICAL EXTERIOR LEVEE CROSS SECTION

Figure 2-2 provides a cross-sectional view of typical exterior levee construction. This is obtained from the 1975 Suisun Marsh Management Study which contains levee design and construction recommendations developed by the USDA Soil Conservation Service (SCS). The specific levee design criteria used in this study are presented in Chapter III. They conform to USDA recommendations for the Suisun Marsh.

The design height of the dike (H) will be the sum of the design high water storage (H_w), the added height (H_v) for wave action, if any, and the freeboard (H_f). The constructed height will include an allowance for settlement (H_s), which will depend on the foundation and material used in construction. The actual design high water stage should be based on the water surface profile.

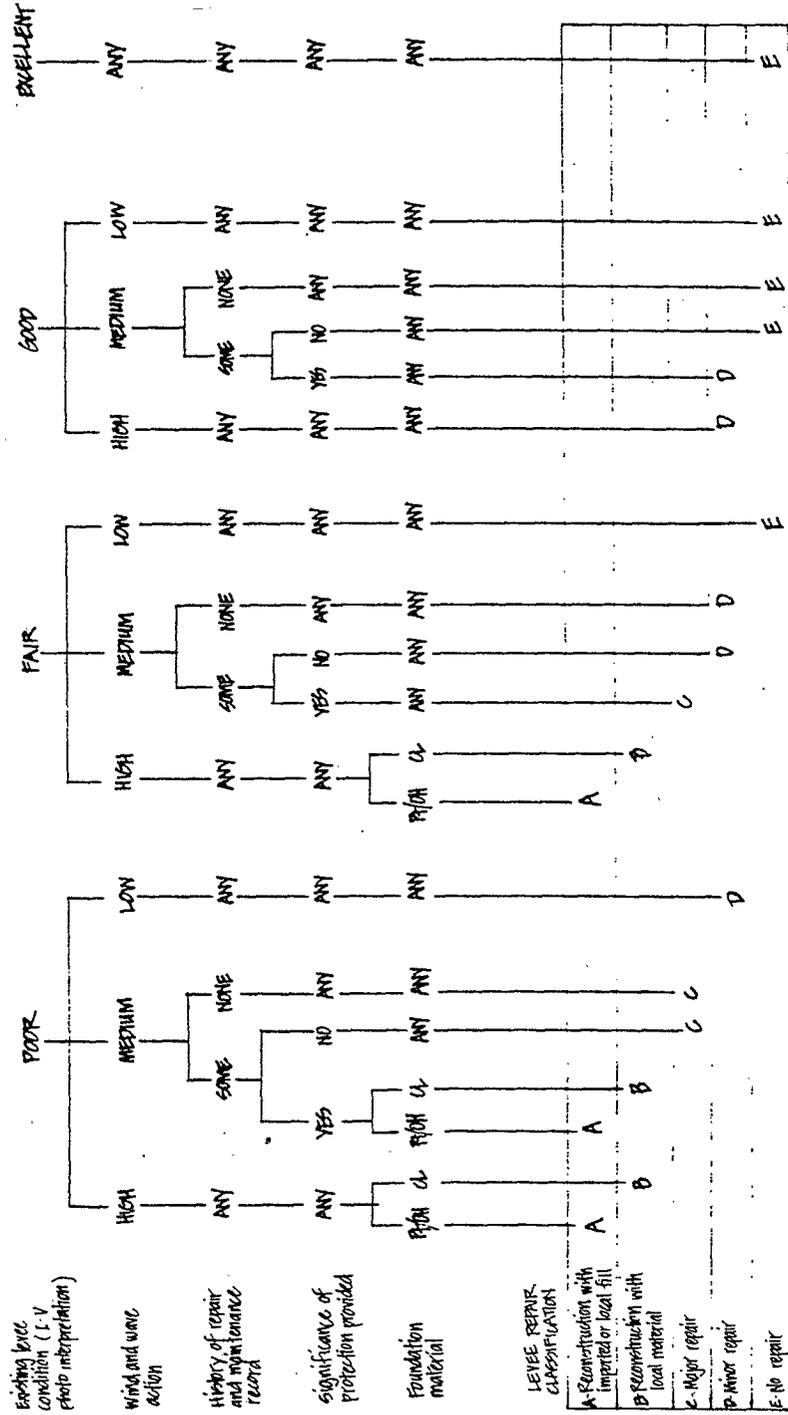
FIGURE 3-1

2. Decision Tree Matrix. The combined rating (Step 6 above) formed the starting point for levee classification using the decision tree shown in Figure 3-1. The other input information for levee segments was compiled separately by the study team and is provided in Supporting Project Documentation. The resulting levee classifications using this system were marked on a working map for field

DECISION TREE MATRIX FOR IN-HOUSE CLASSIFICATION

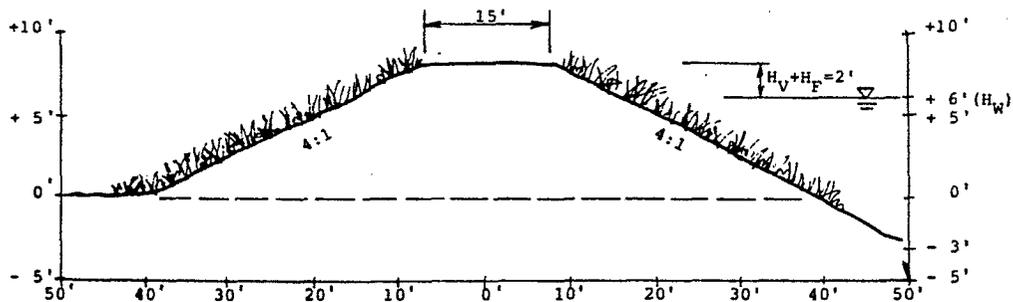
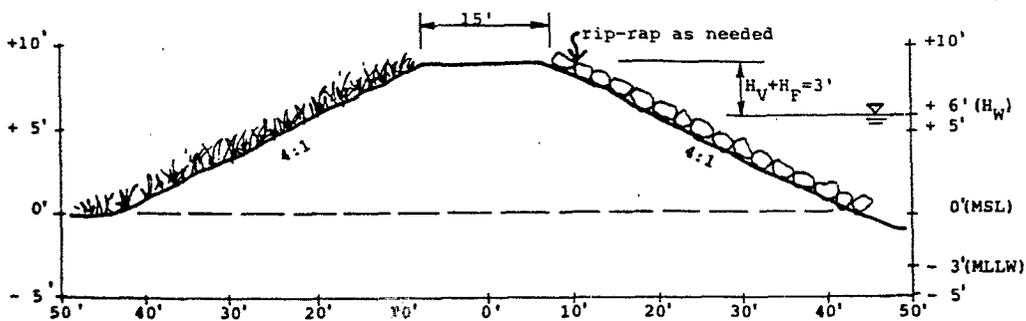
FIGURE 3-2

The design standards by which levee earthwork requirements were judged are shown in Figures 3-2 and 3-3. These conform to the general recommendations of the Suisun Resource Conservation District (SRCD). The specified levee breadth (i.e., top width and side-slopes) is slightly greater than the minimum SRCD recommendation; this is based on many years of practical experience with levee construction in this area by the chief construction estimator on the project (Dutra Construction Company).

DESIGN CROSS SECTIONS FOR EXTERIOR LEVEES
PEAT SOILS

A. Low Wind And Wave Action

B. High Wind And Wave Action

Cost estimates for levee modification were related to the standards for design and construction normally followed in the Suisun Marsh. These criteria are displayed in Table 3-5. Cross sections are illustrated in Figures 3-2 and 3-3. These design standards are based upon information contained in the Suisun Marsh Management Program and supplementary recommendations provided by the local dredging contractors.

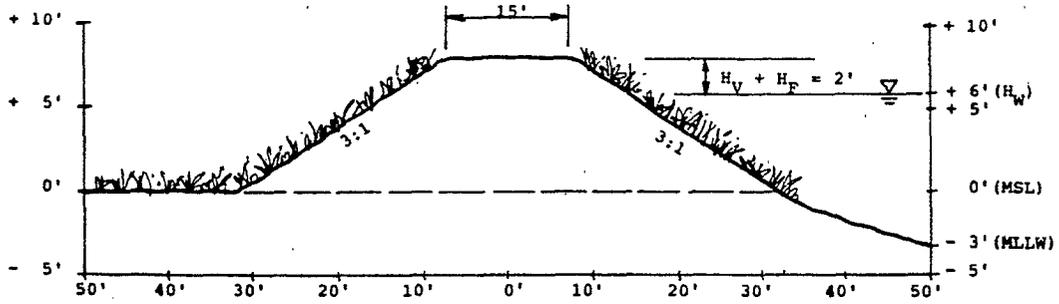
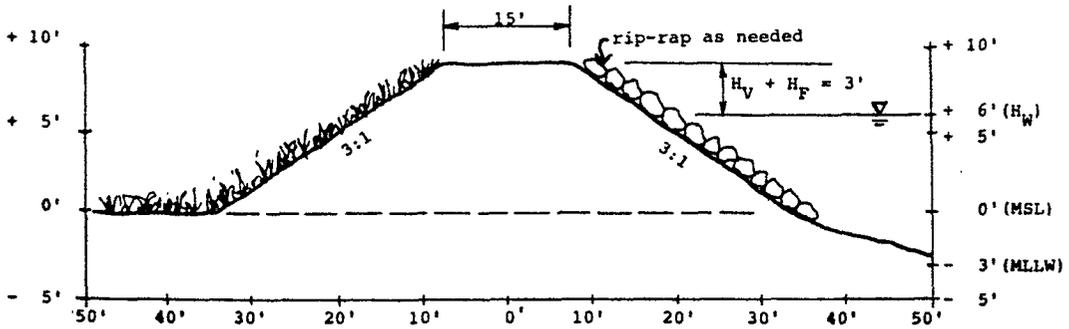
FIGURE 3-3

DESIGN CROSS SECTIONS FOR EXTERIOR LEVELS
ORGANIC AND CLAY/MINERAL SOILS

A. Low Wind And Wave Action

B. High Wind And Wave Action

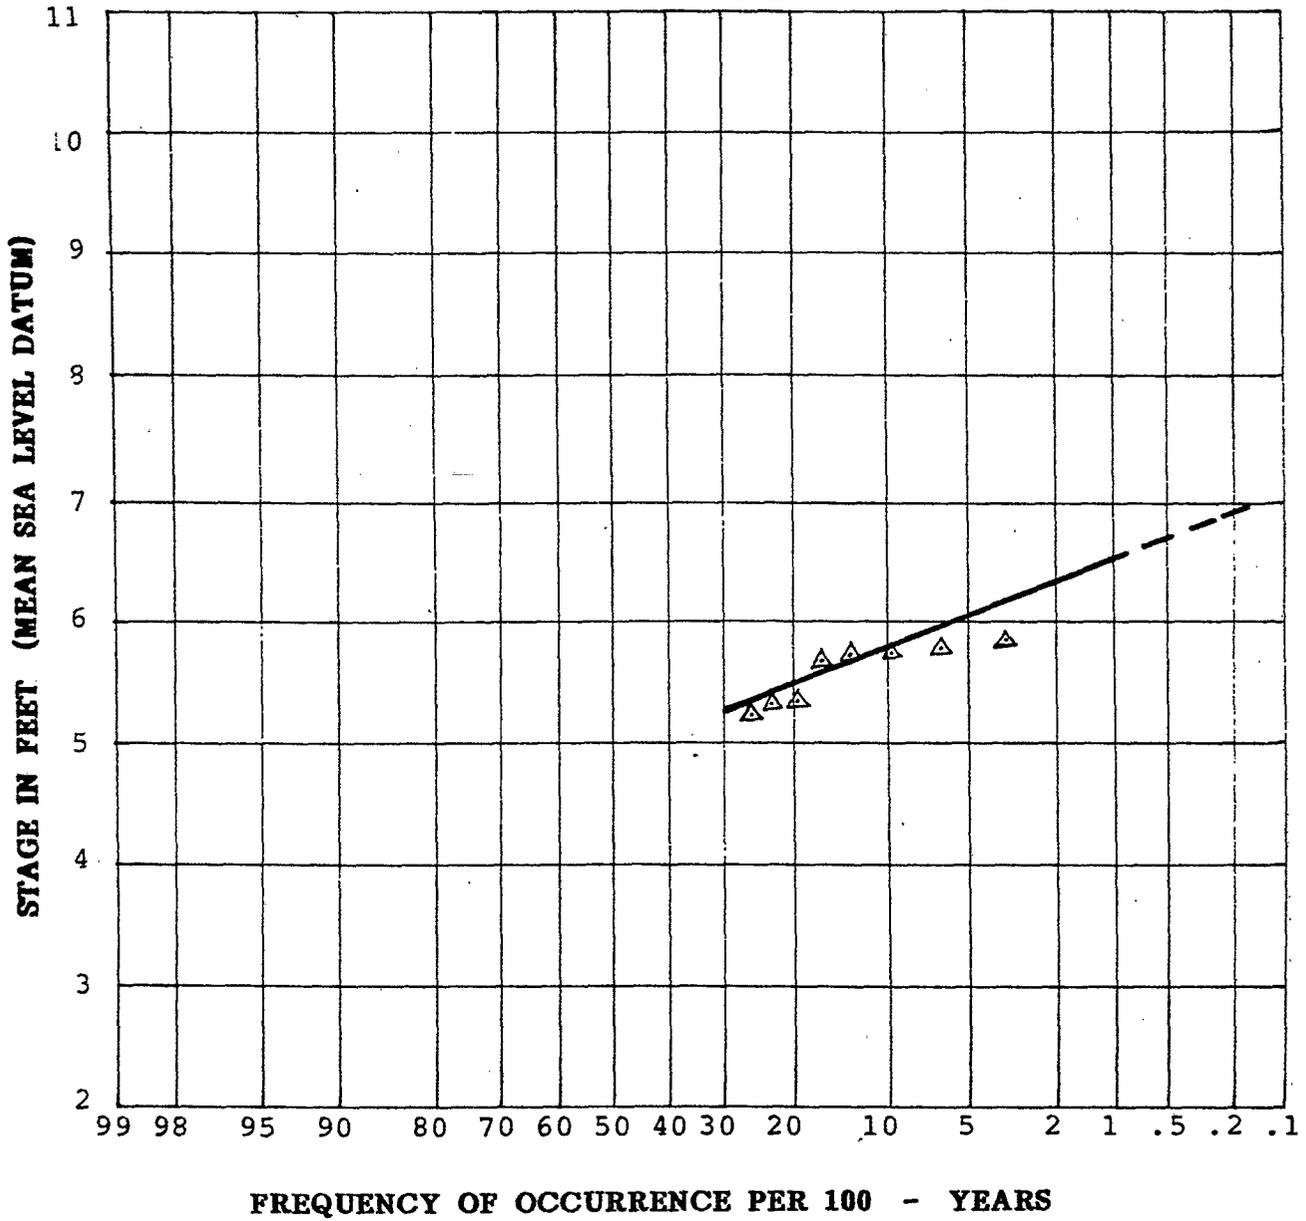
FIGURE 3-4

After the hydrological data is plotted on a probability paper, a curve is fitted to the plotted points. The stage-frequency curve developed for the Suisun Marsh is shown in Figure 3-4.

HIGHER - HIGH STAGE FREQUENCY RELATIONSHIP
FOR SUISUN MARSH

[From Corps Of Engineers, Sacramento District's
Sacramento - San Joaquin Delta Investigation Of
July 1976]

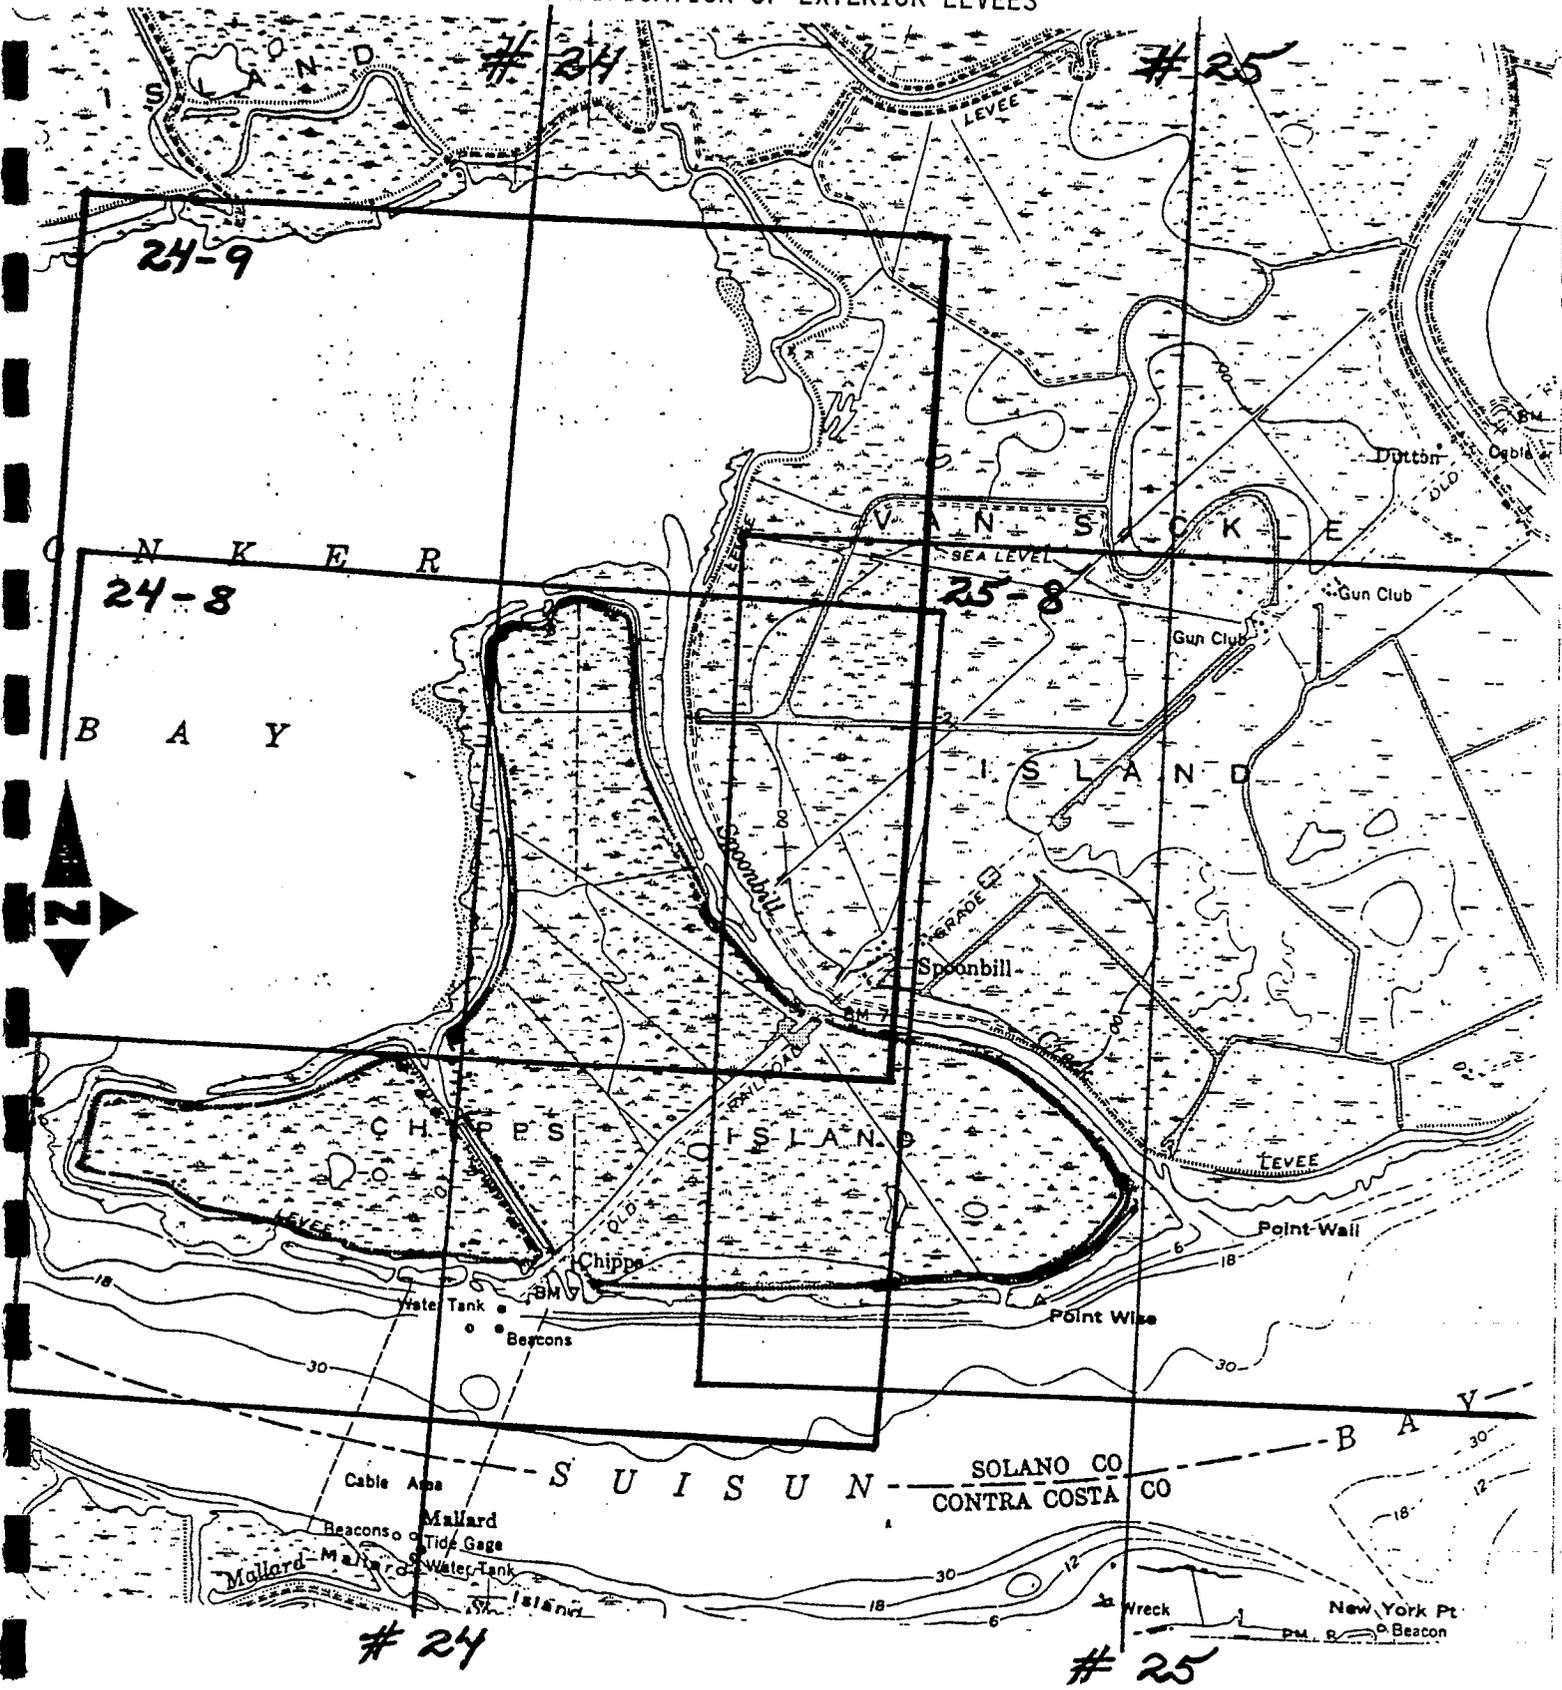
FIGURE C-1
IDENTIFICATION OF EXTERIOR LEVELS

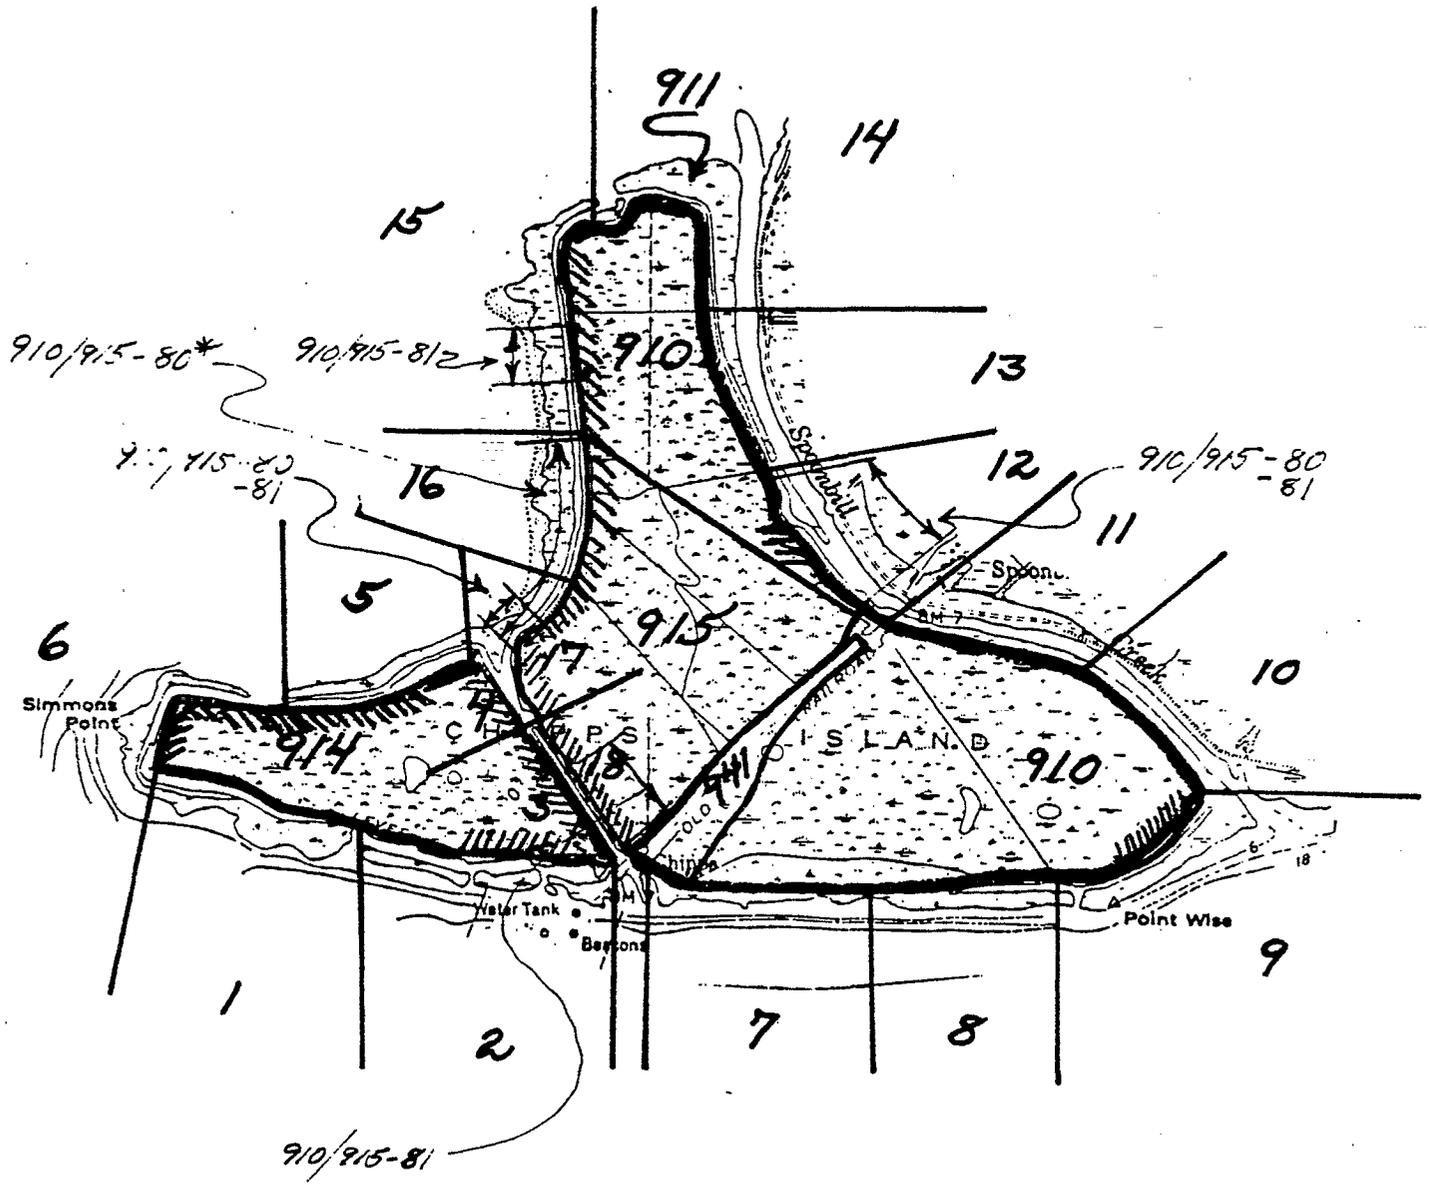
FIGURE C-2

SOIL CLASSIFICATION AND REPAIR HISTORY

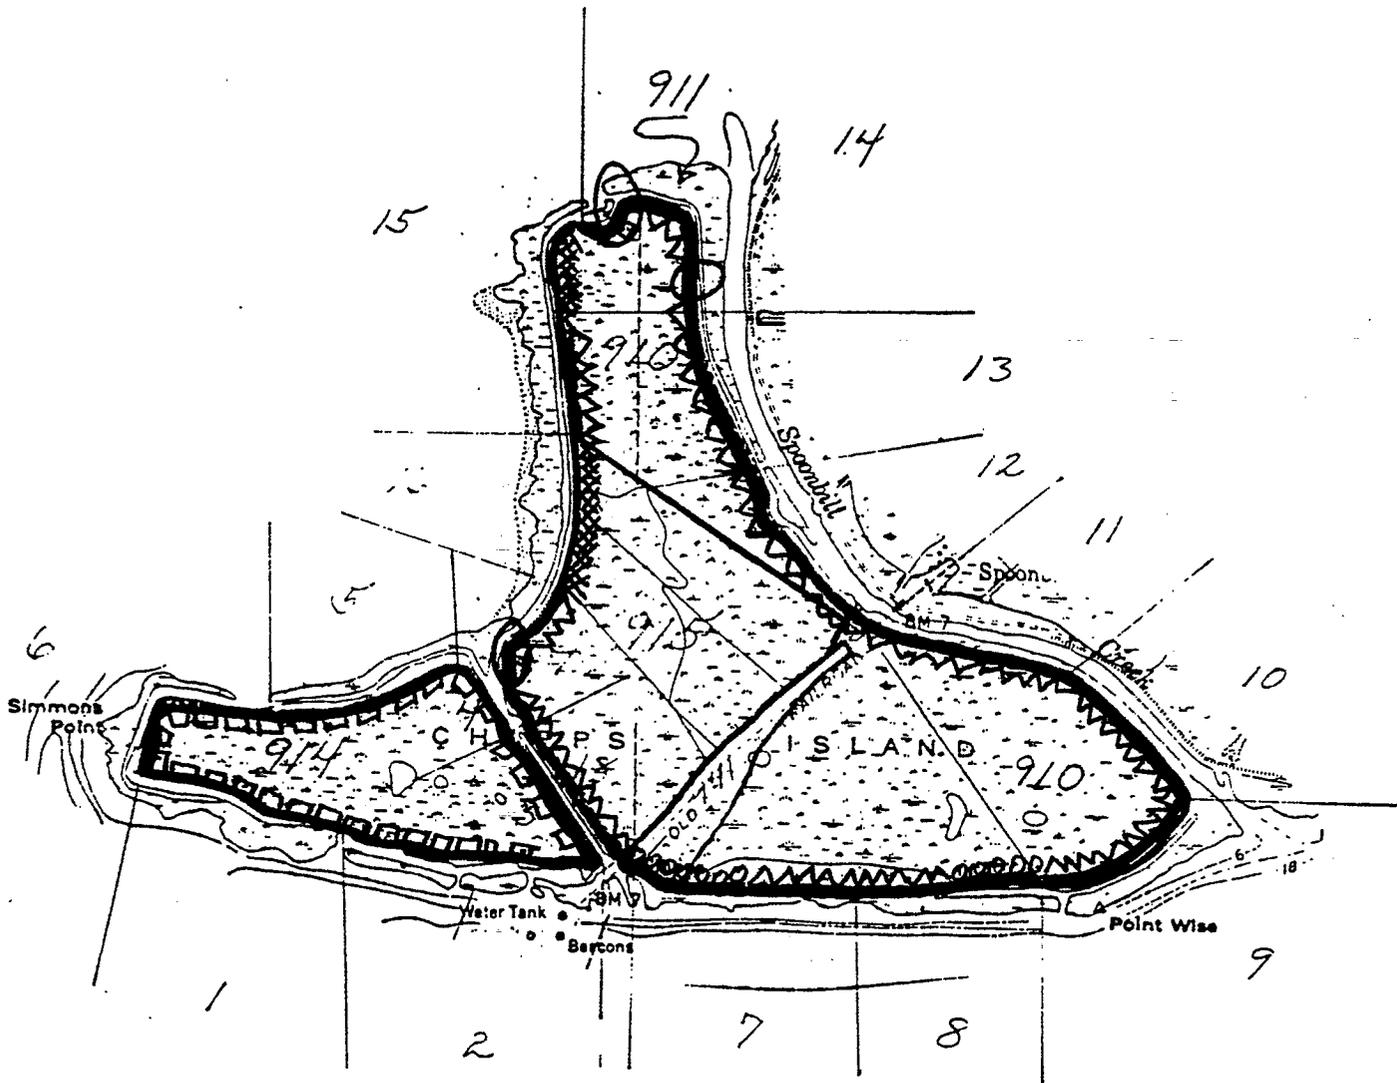
FIGURE C-3

LEEVE CLASSIFICATION BASED ON RESULTS OF PHOTO INTERPRETATION

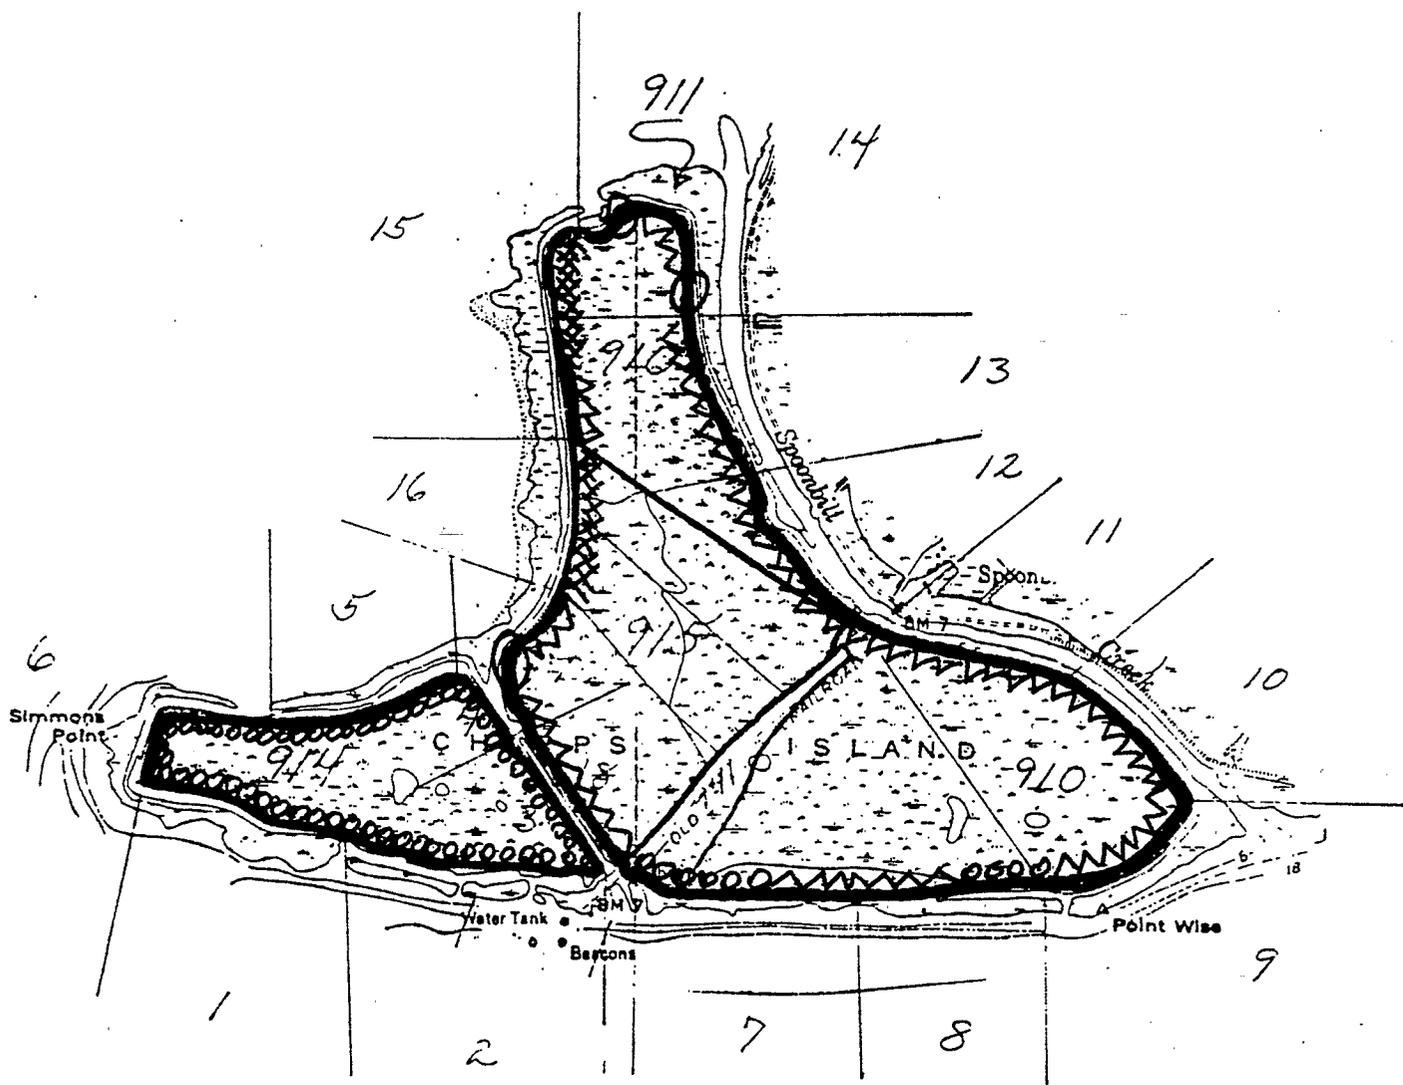
FIGURE C-4
IN-HOUSE LEVEE CLASSIFICATION

- Type A
- Type B
- Type C
- Type D
- Type E
- Field Check
